Beavers, Birdwatchers And A Critical Wastewater Forcemain Can Coexist!

Metro Vancouver – Liquid Waste Services

Sperling Avenue Forcemain

Summary: Sperling Avenue Forcemain Condition Assessment Project

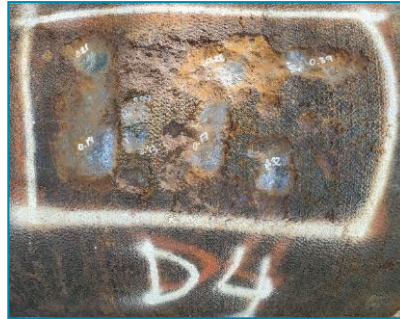
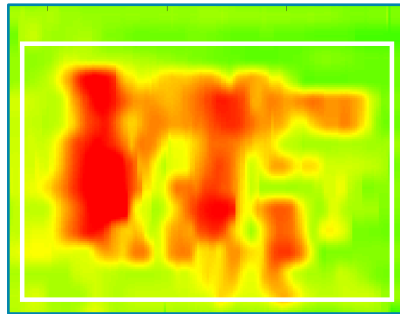
Validated Pipe Defect

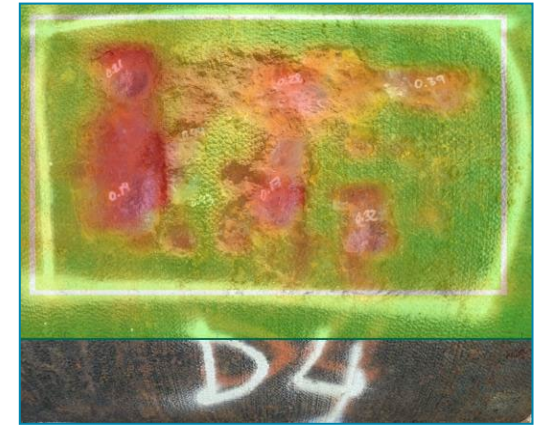
Inspection data defect heat map

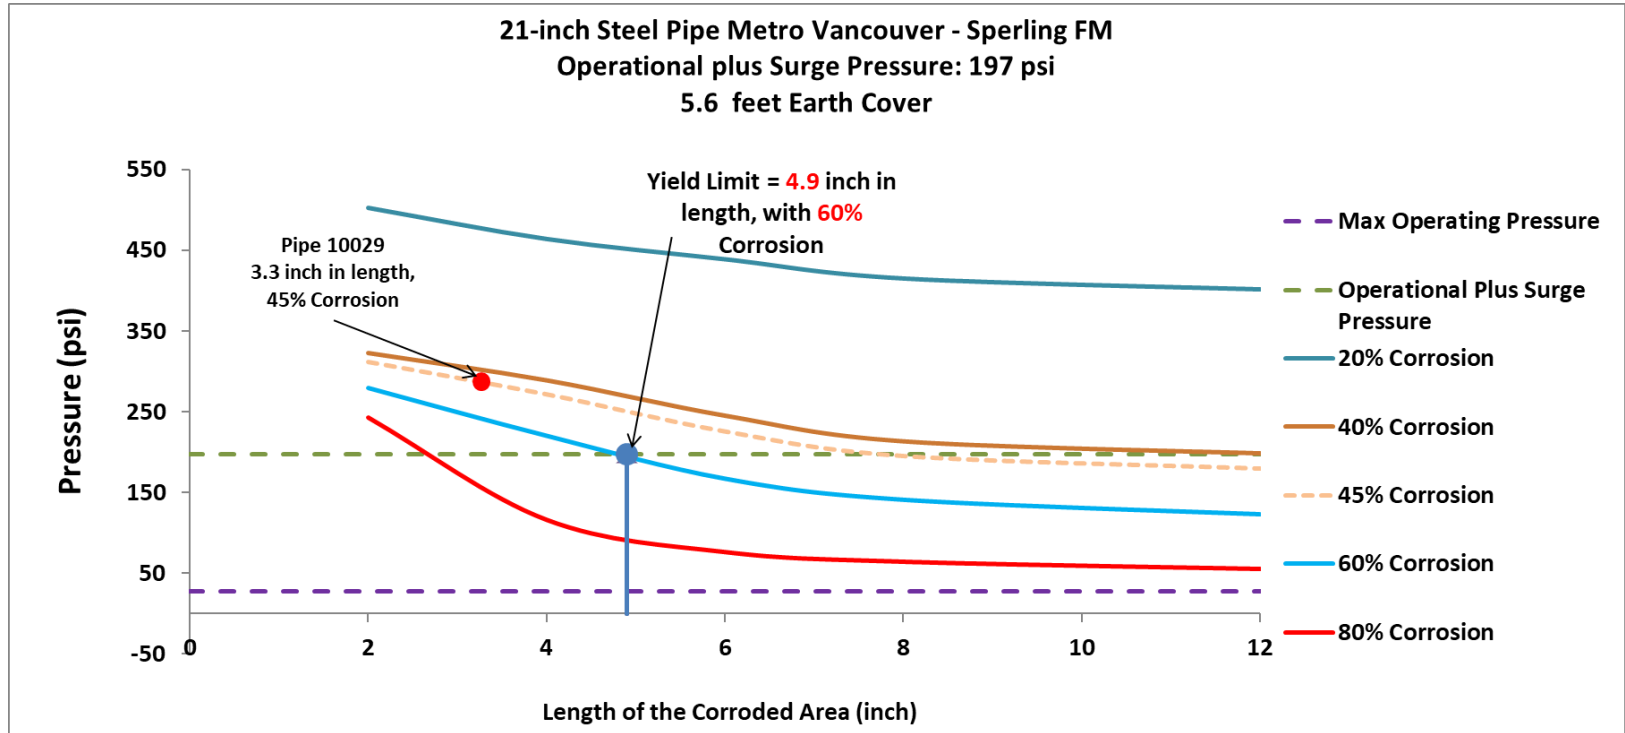
Sperling Avenue Forcemain – FEA / Failure Curve

ENGINEERING ASSESSMENT
Data shows pipe is in
serviceable condition

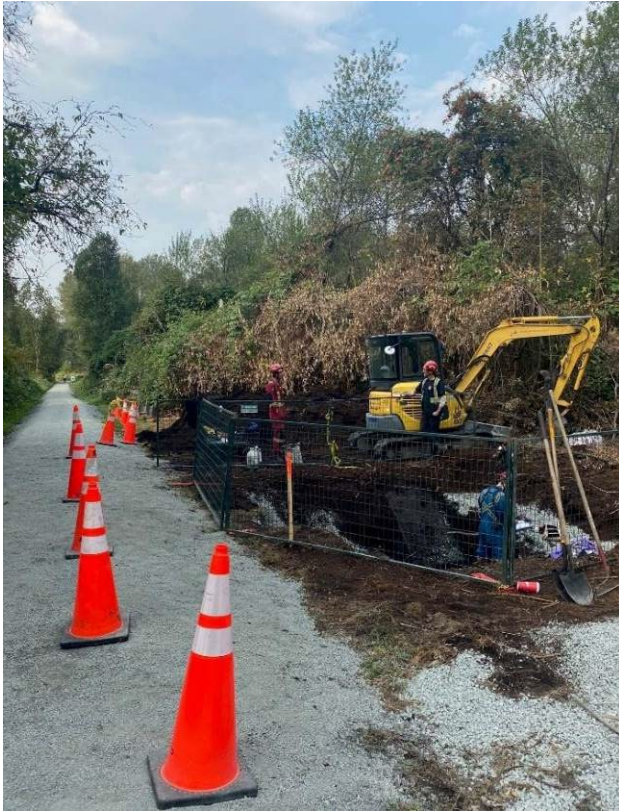
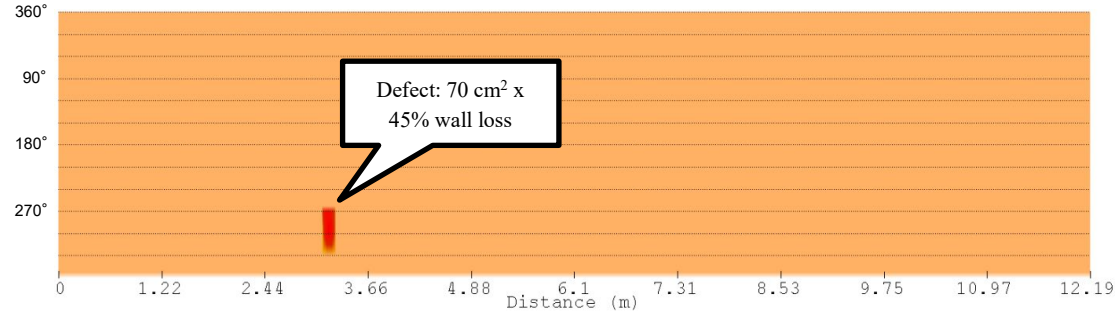
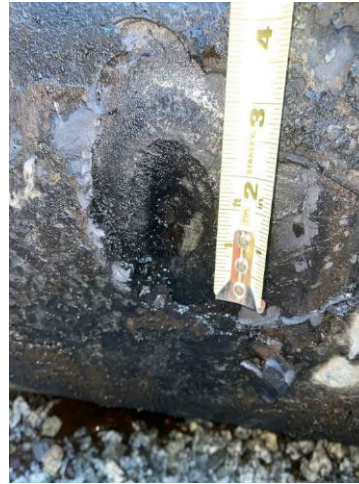
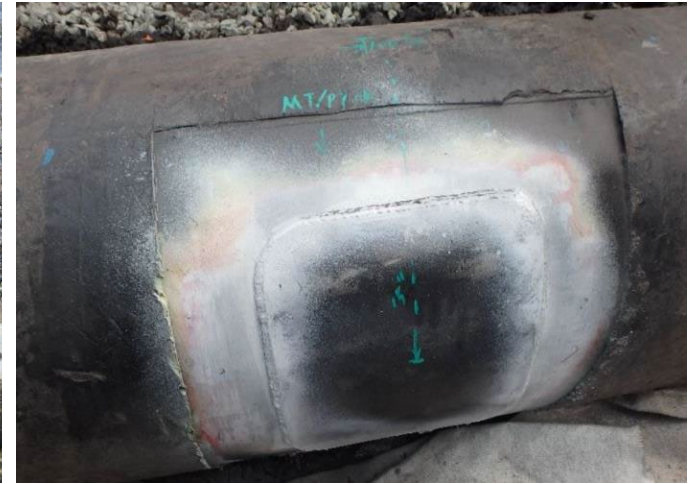
Sperling Avenue Forcemain – defect validation and repair

PIPEDIVER INSPECTION
1 defect (approx. 3.5 in x
3.5 in) with 45% wall loss

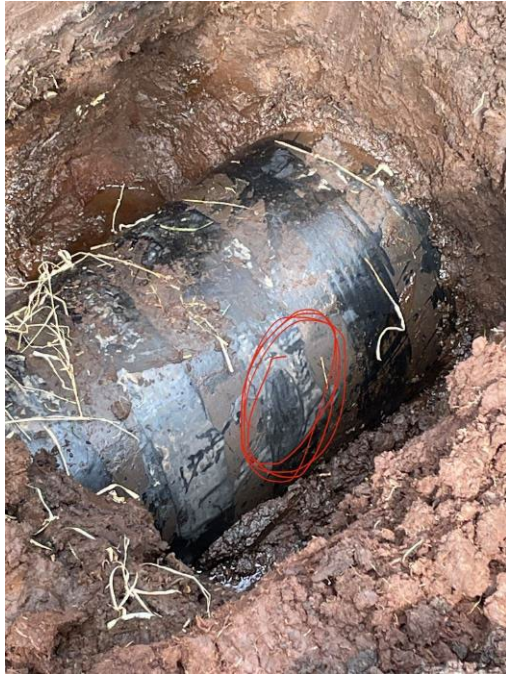
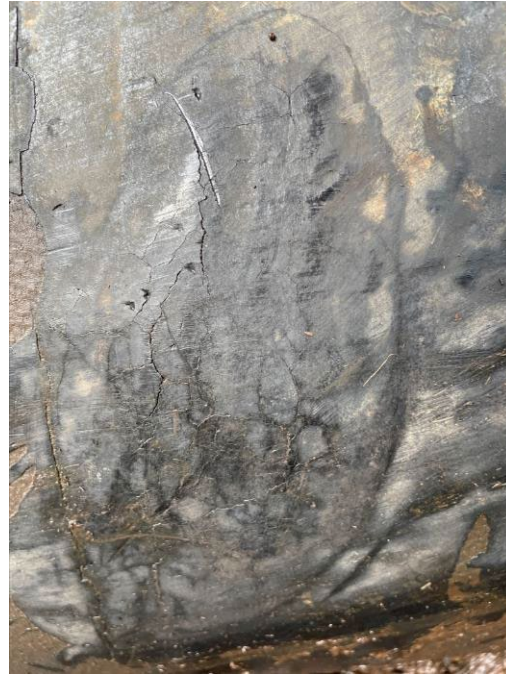
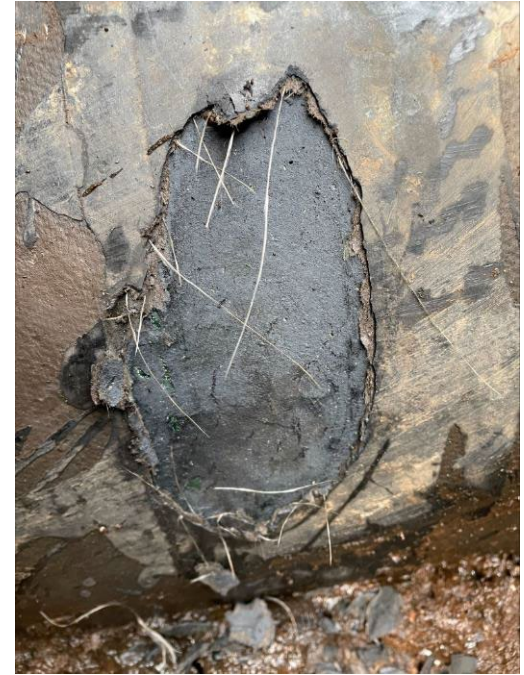
Sperling Avenue Forcemain – XLI coating anomaly (anomaly #2)

SPECTRUM XLI INSPECTION
Detected a large coating
defect near PipeDiver wall
loss and 1 additional
coating defect
