Looking back at Calgary's 1950mm (78") PCCP Feeder Main Failure

November 3, 2025

Presented by:
Justin Hebner
Pure Technologies Ltd., a Xylem brand

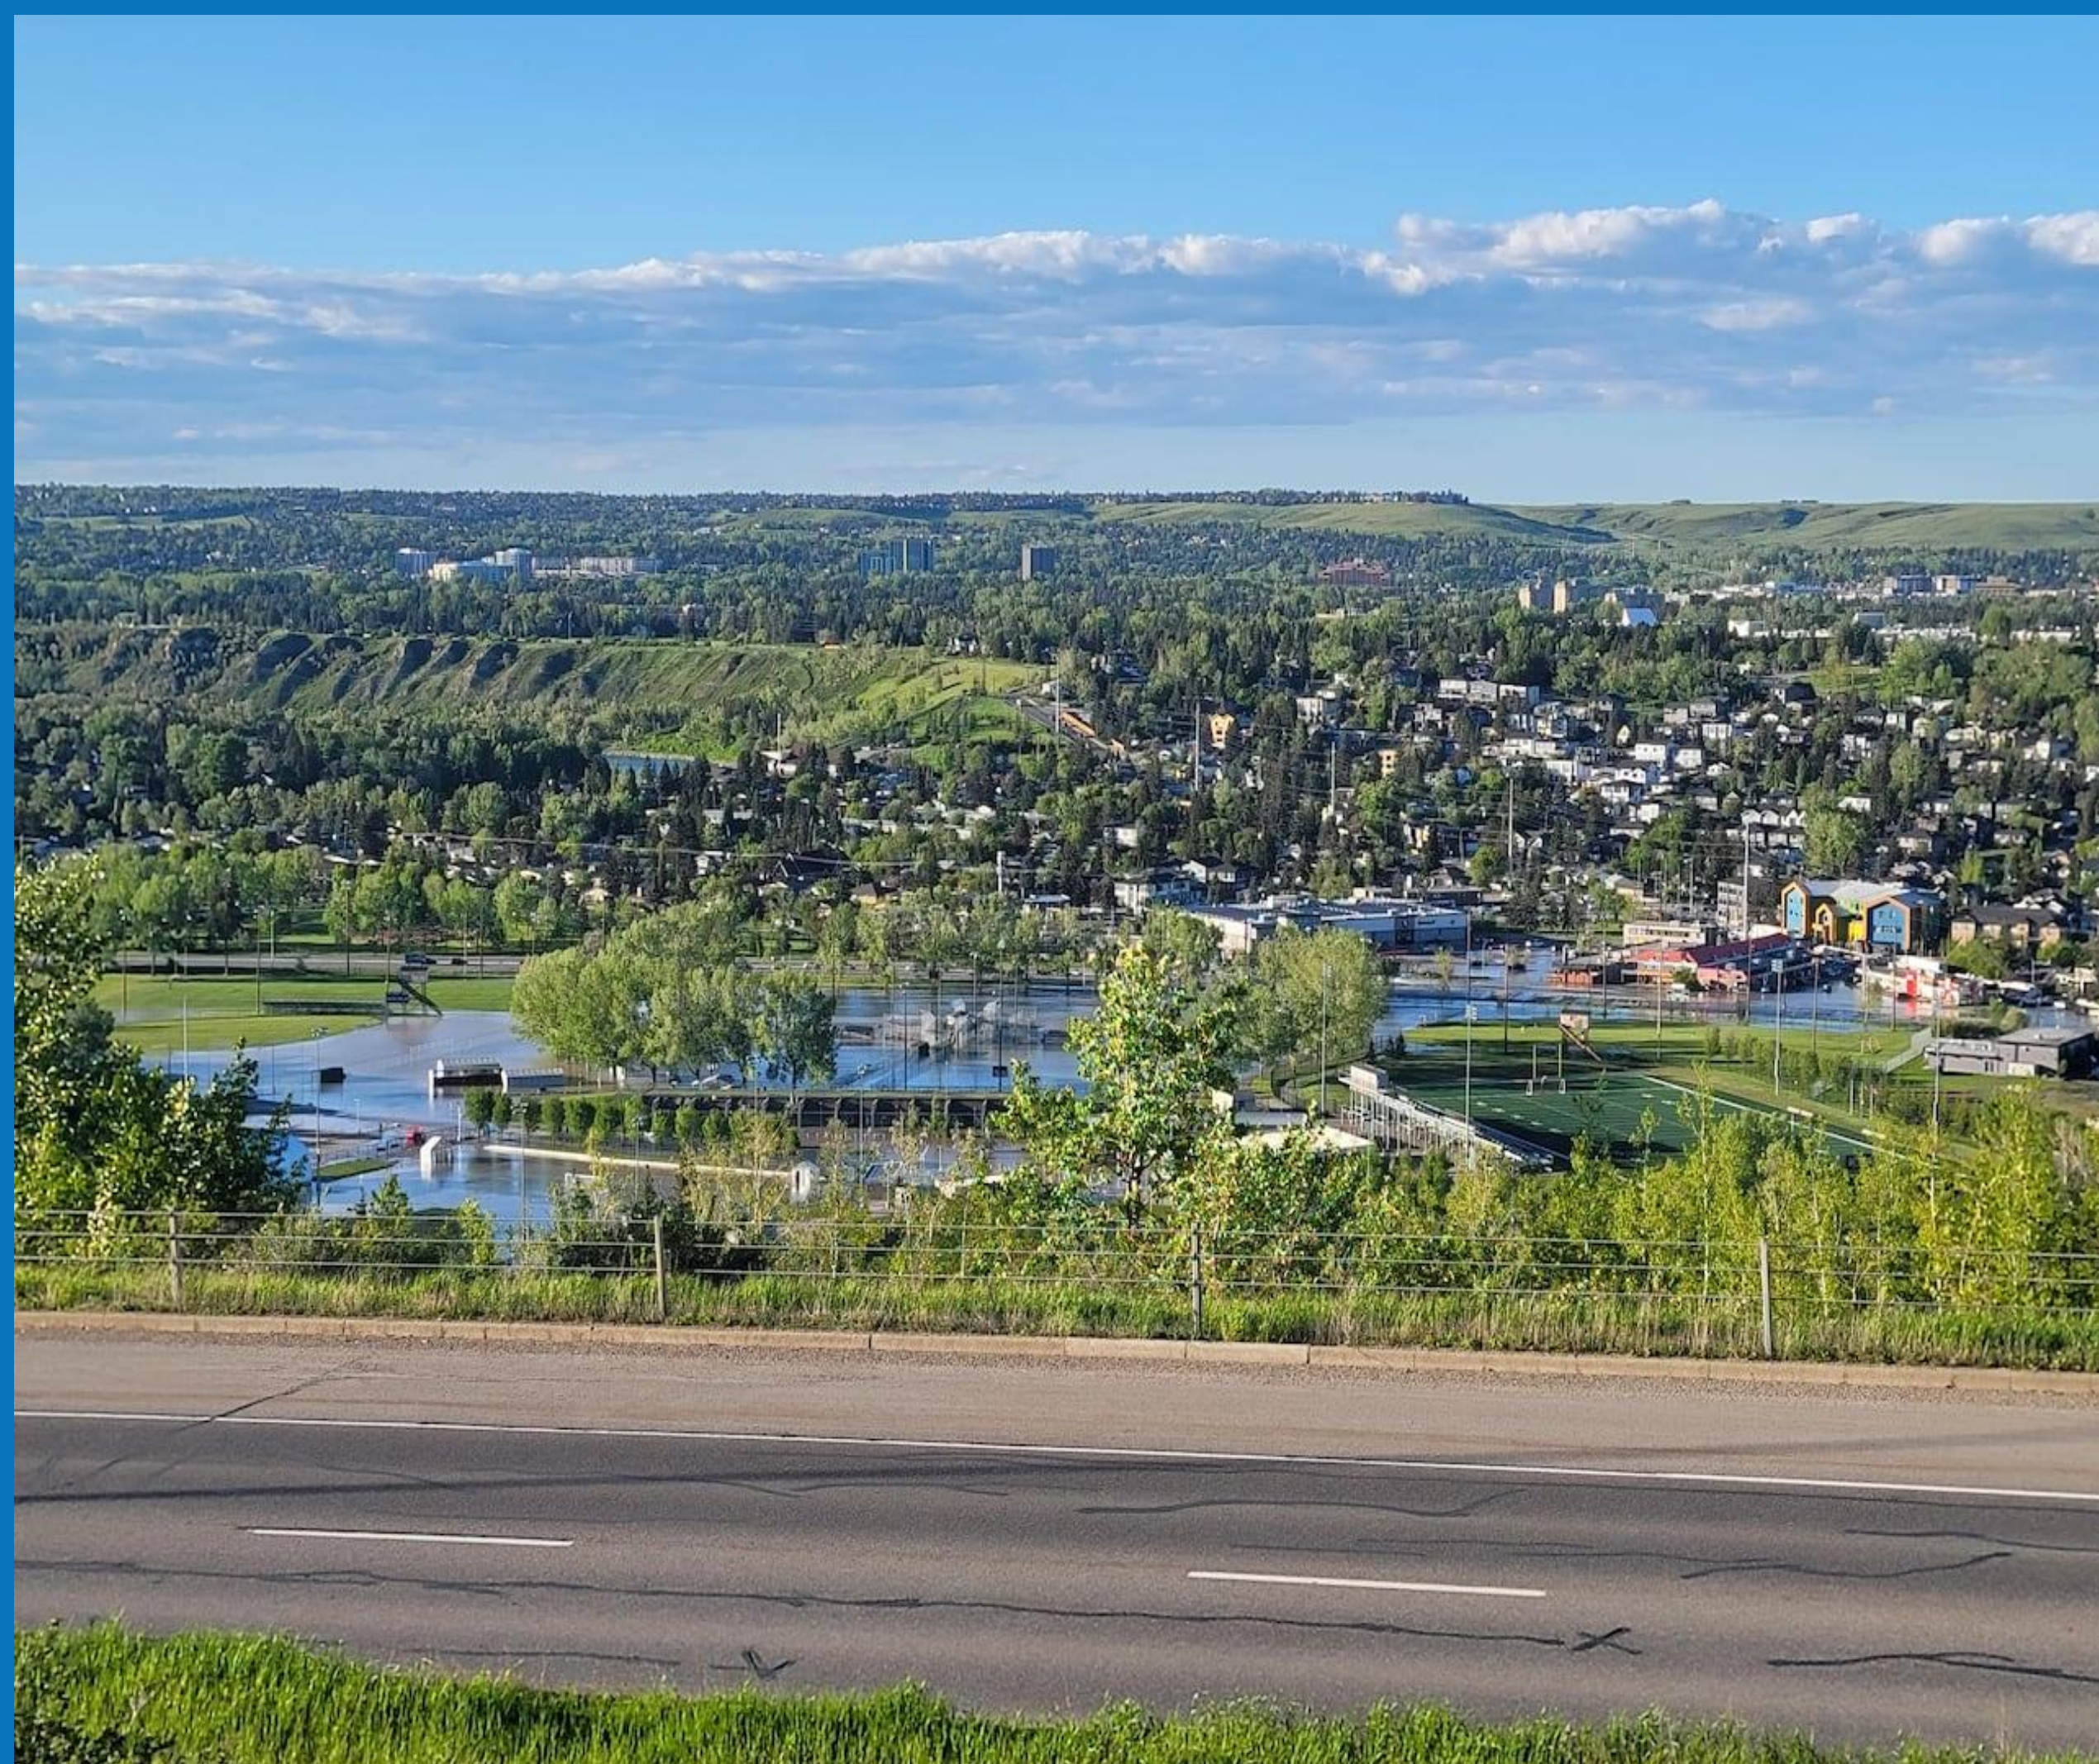
2024 Failure – Bearspaw South Feeder Main

- On June 5, the 1950mm (78”) C301-E PCCP Bearspaw South Feeder Main failed
- Supplies up to 60% of City’s water – prompted Stage 4 Water Restrictions (53 days total)
- Condition assessment was scheduled for Fall 2024

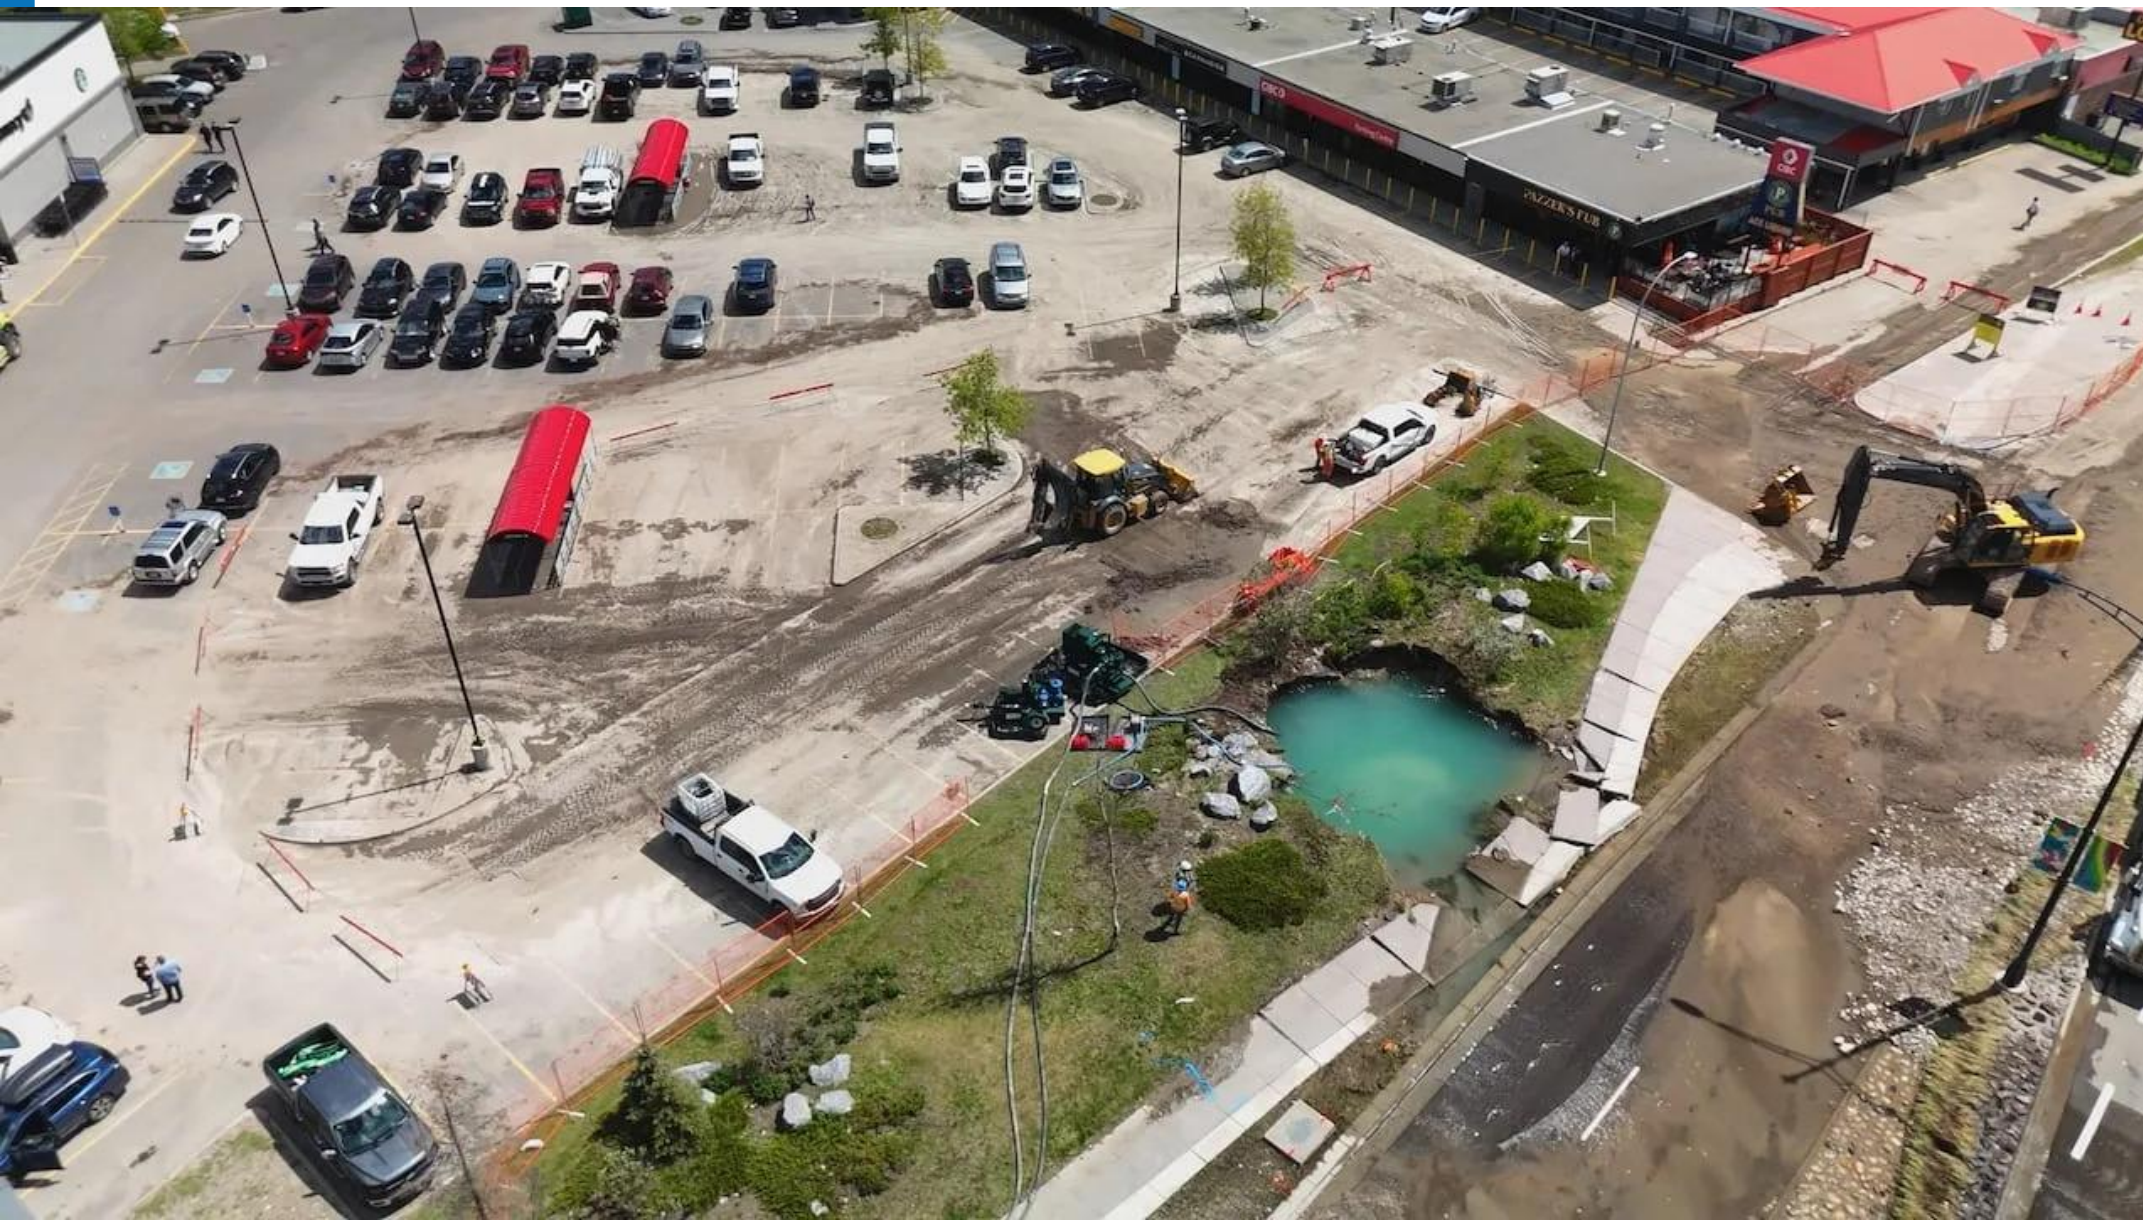
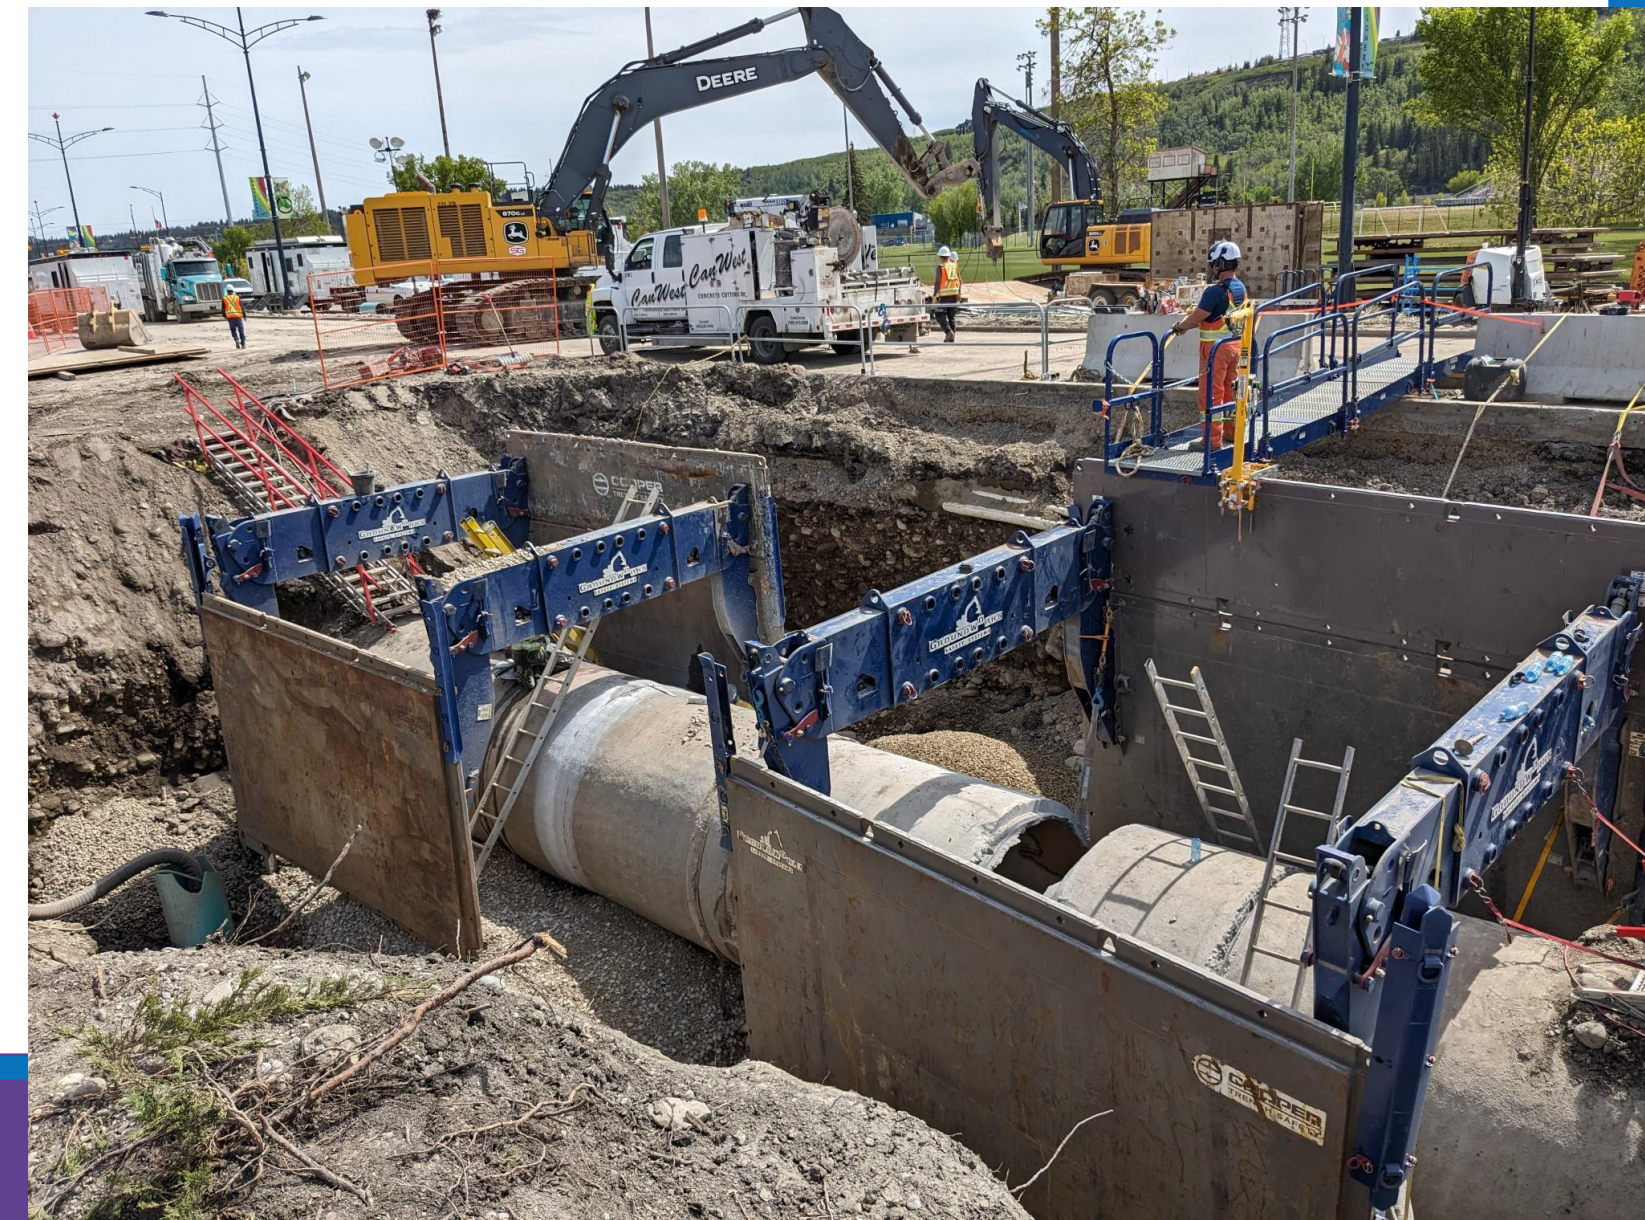
- June 5, 2024: BPSFM catastrophic failure.
- Week of June 17: failure repaired; 5 “hot spots” identified/repaired.

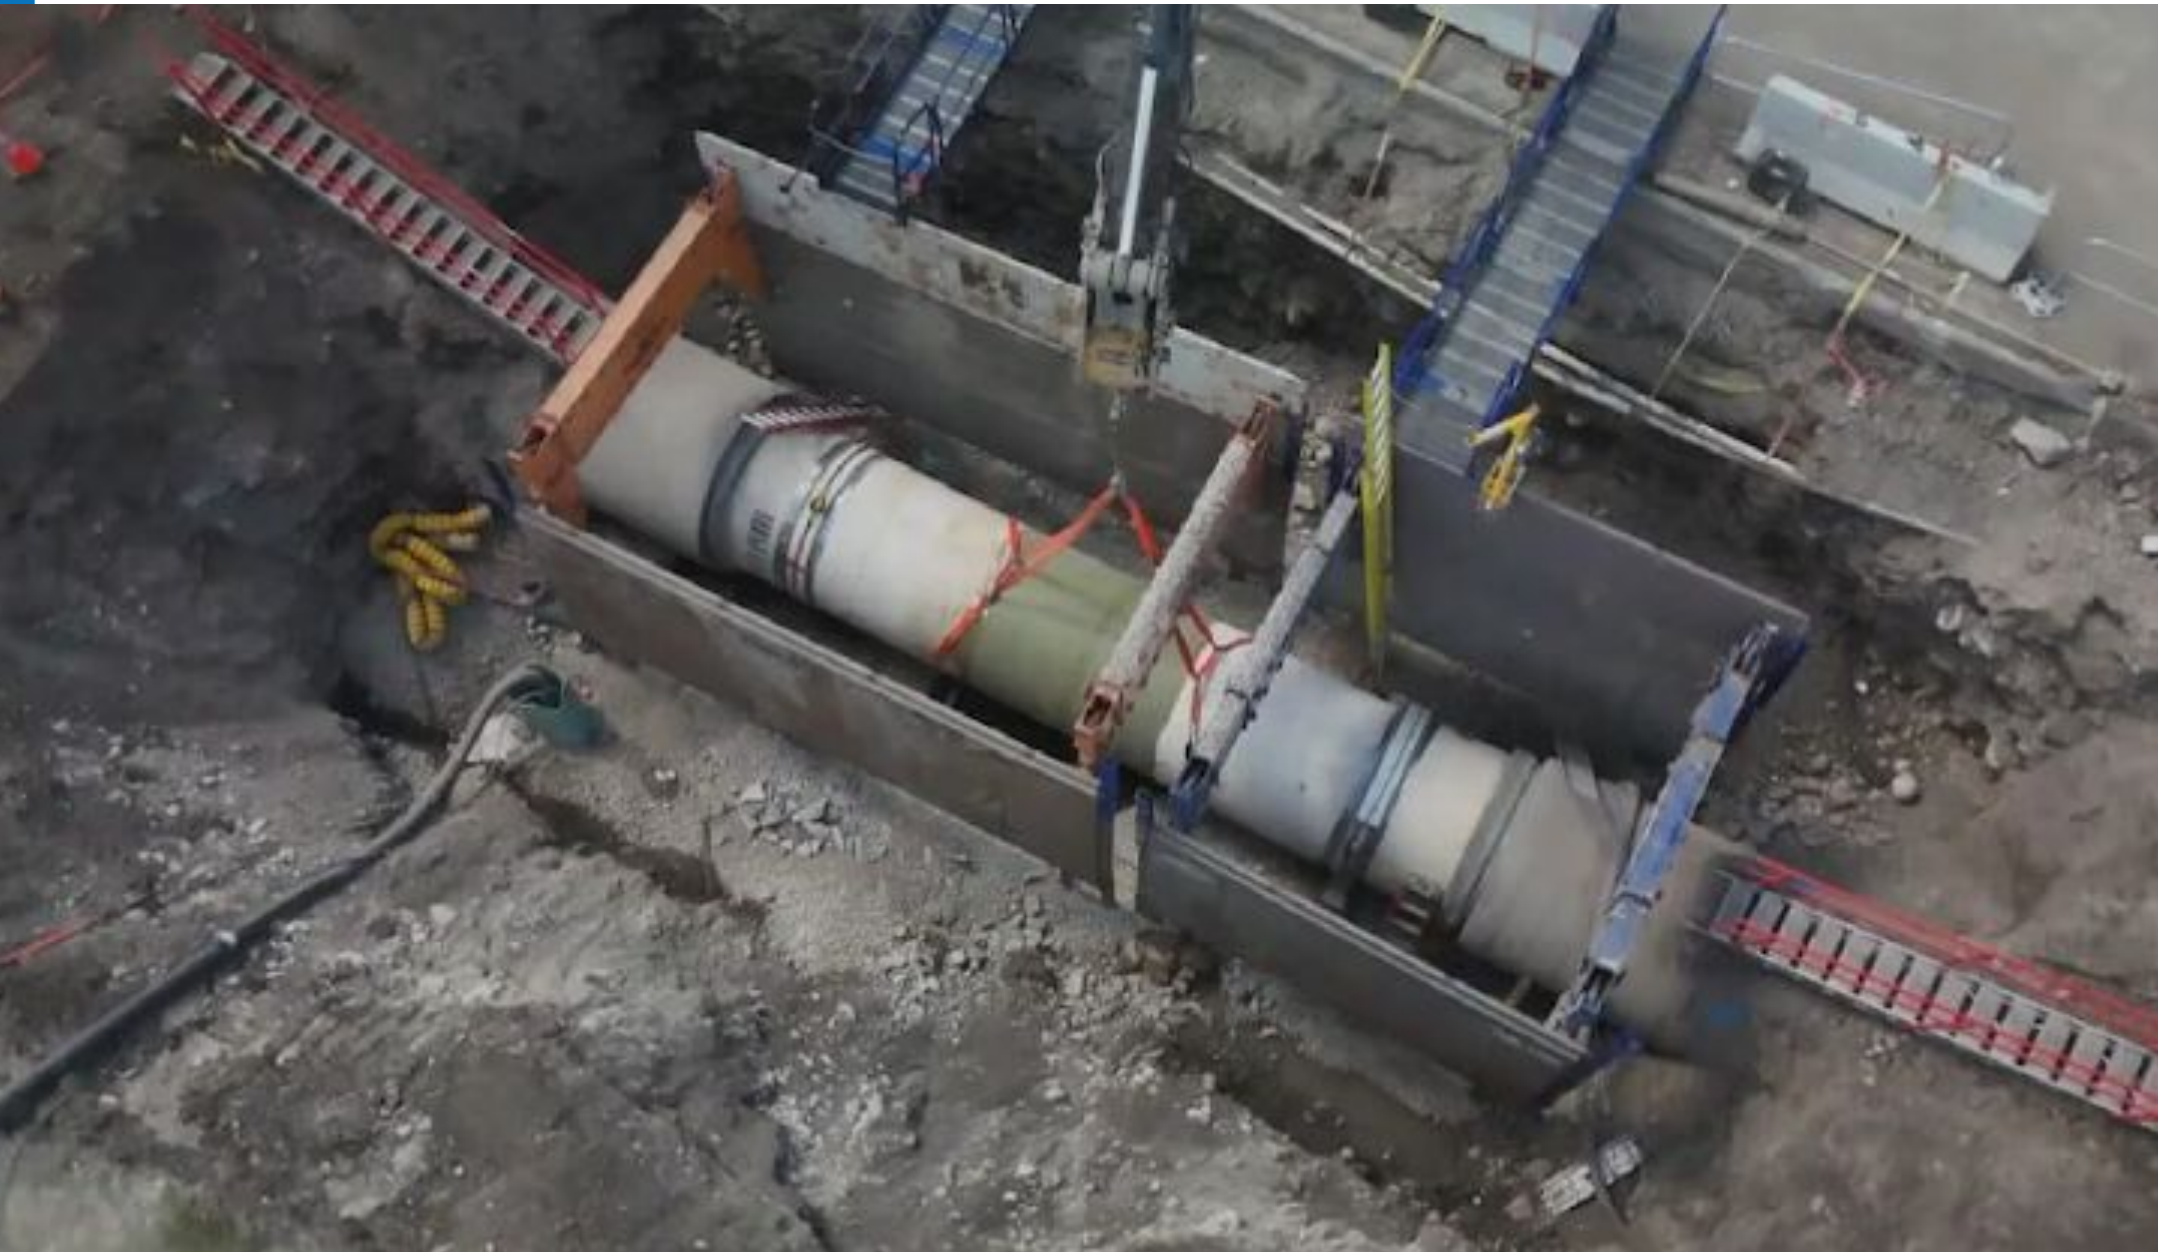
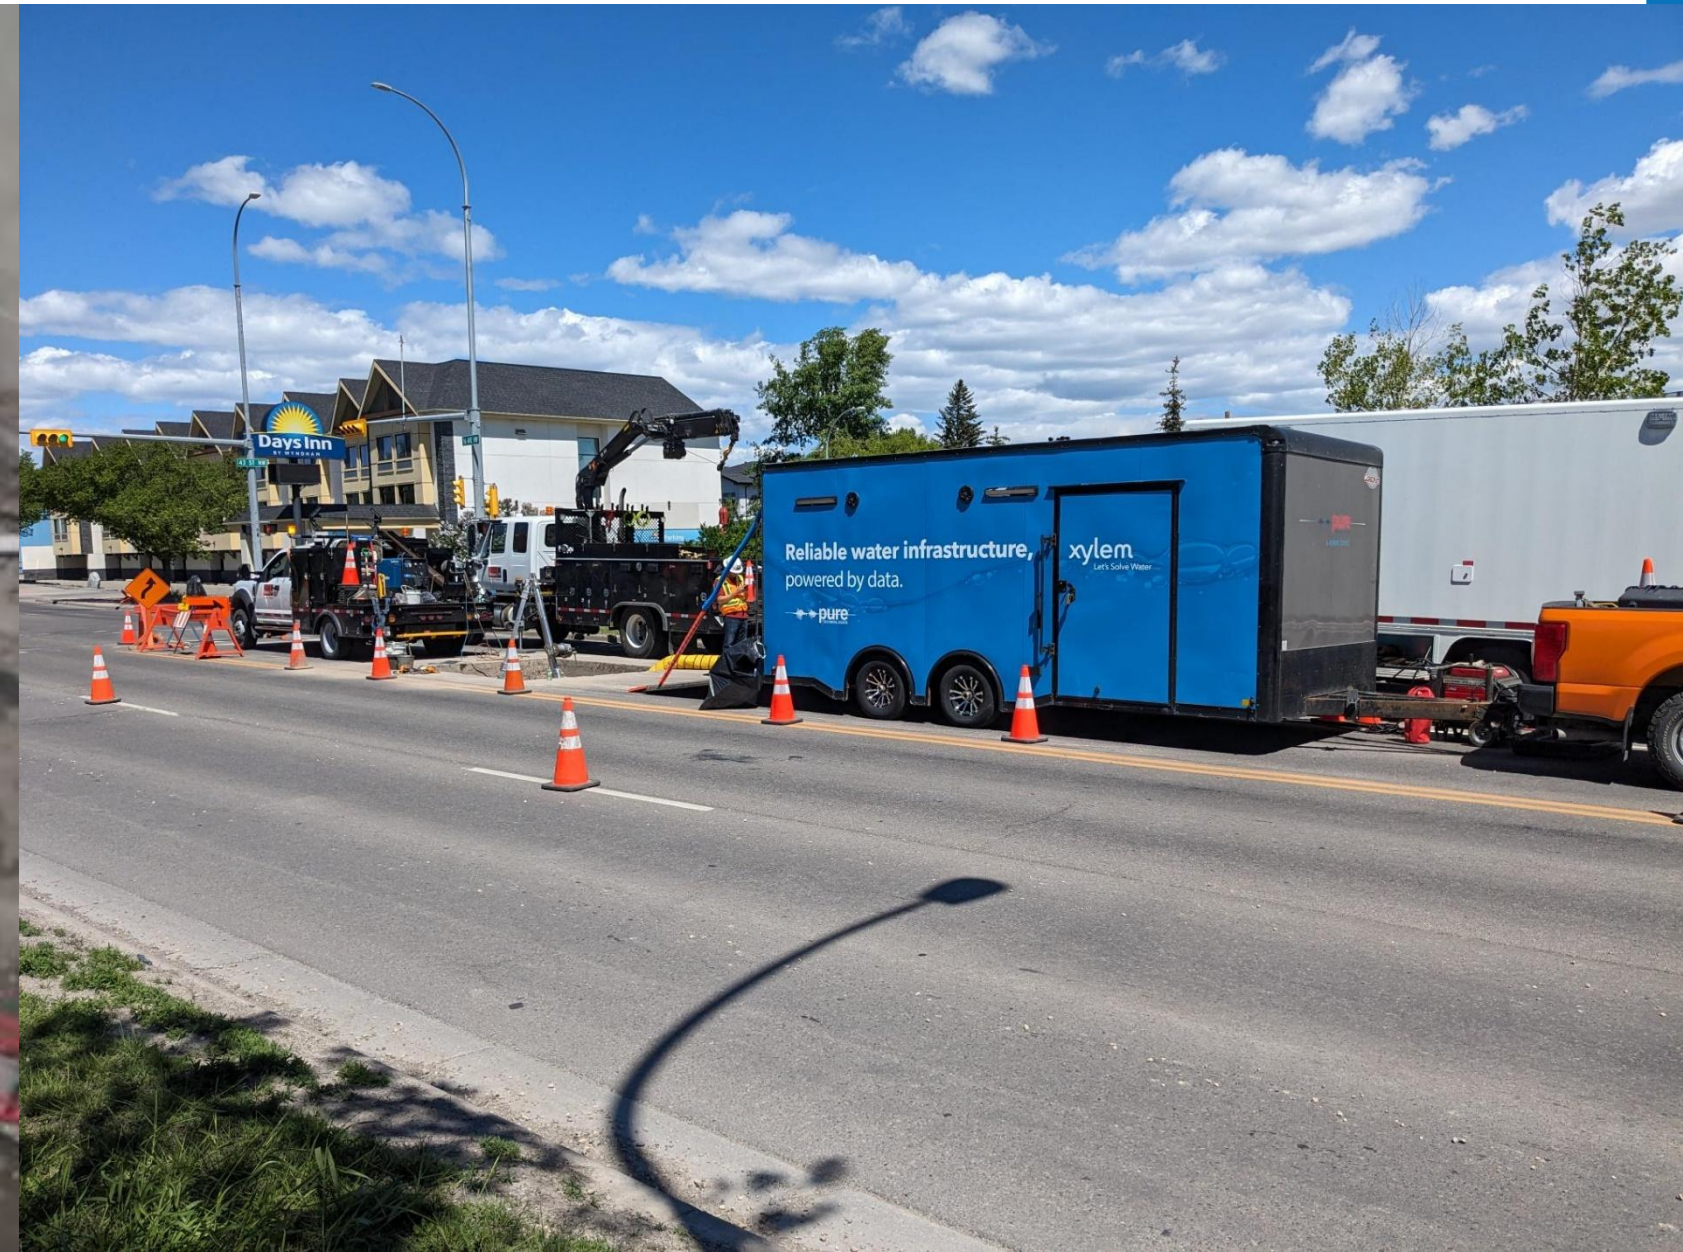
- June 5, 2024: BPSFM catastrophic failure.
- Week of June 17: failure repaired; 5 “hot spots” identified/repaired.
- July 5: BPSFM brought back into service; more assessment and monitoring system installed.

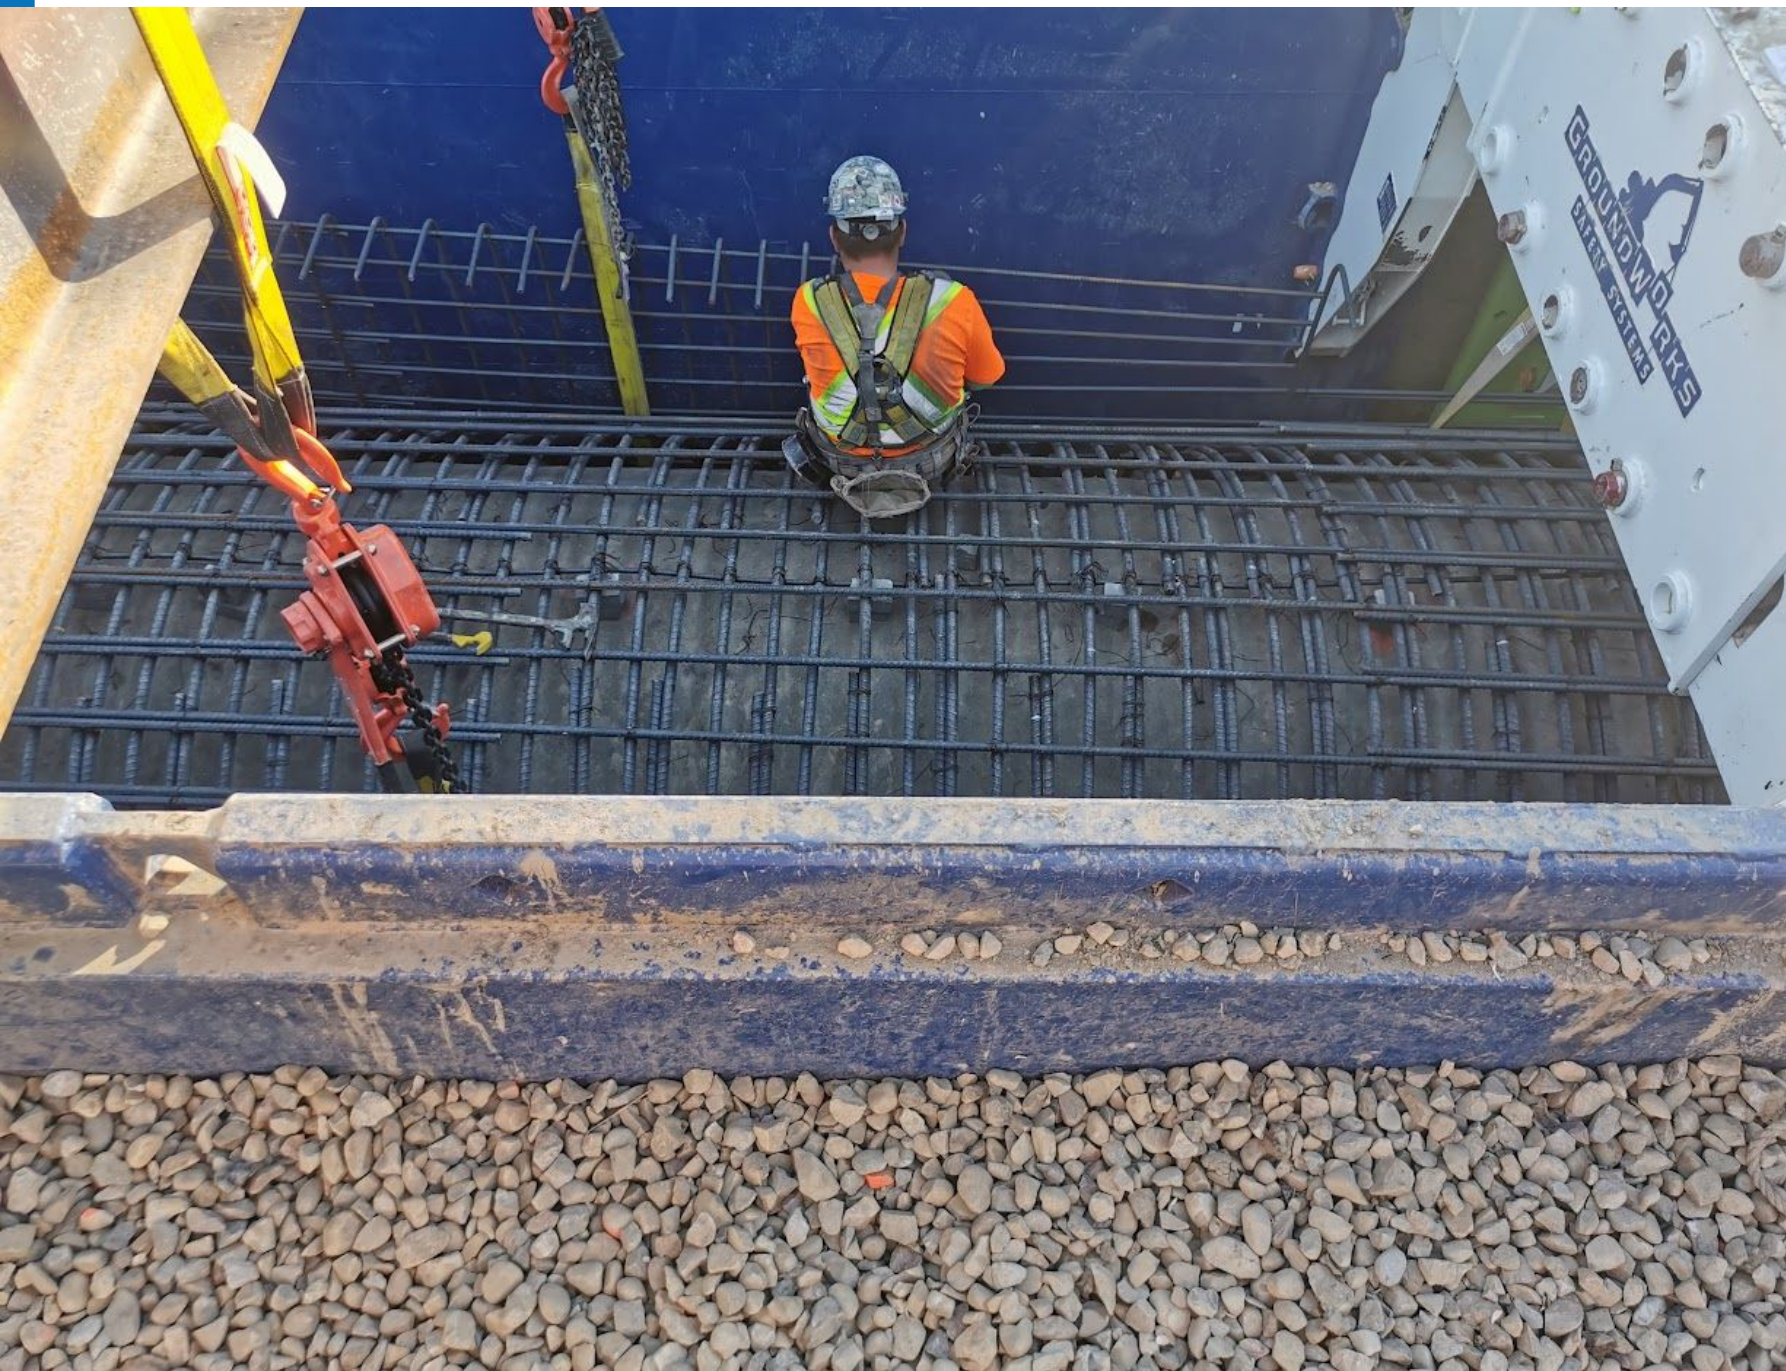
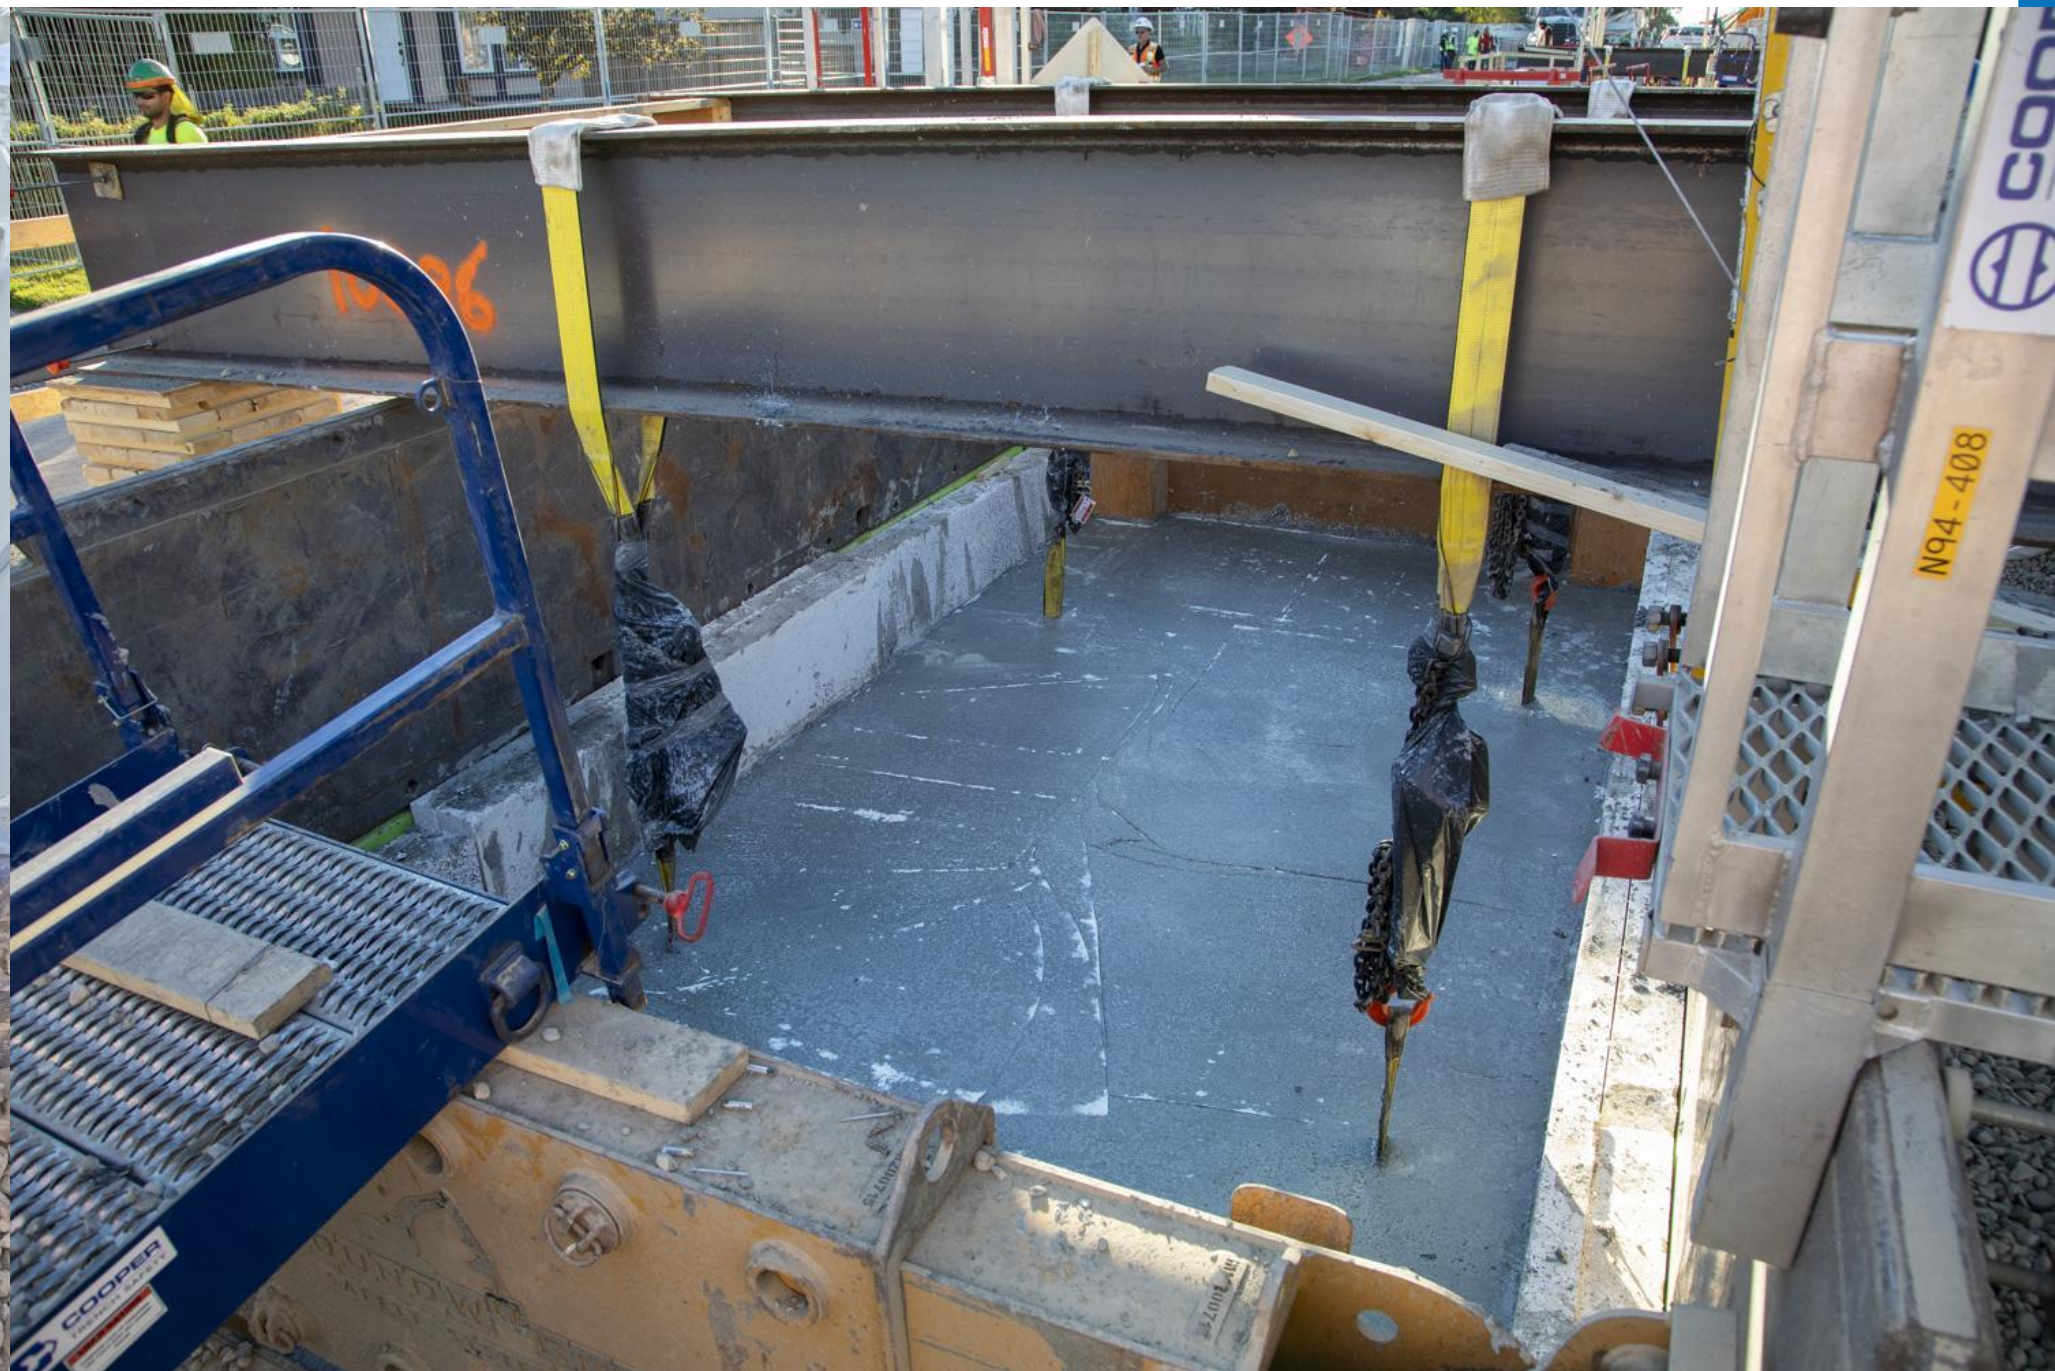
- June 5, 2024: BPSFM catastrophic failure.
- Week of June 17: failure repaired; 5 “hot spots” identified/repaired.
- July 5: BPSFM brought back into service; more assessment and monitoring system installed.
- August/September: additional repair work on 21 segments (identified by PipeDiver).
- Mid-October: 2 additional 1500mm segments (identified by PipeDiver) repaired (29 total).
