# From Risk Proactive Assessme Prioritized

Crofton Mill's Critical Water Supply Pipeline

November 03, 2025

# Crofton Mill Water Supply Pipeline

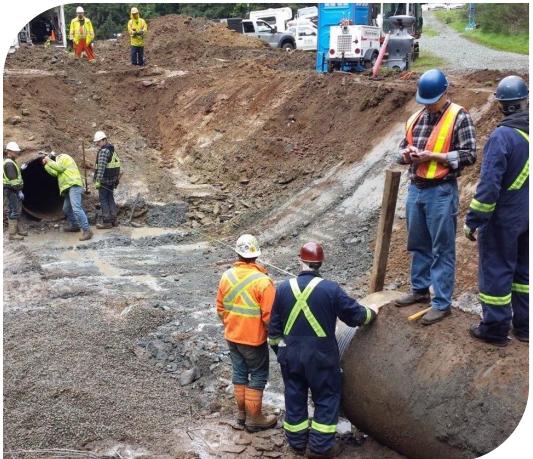
April 2016 Failure

**Location: STA 324 + 64  
(Section 2)**

**2016: Farming area, low  
depth of cover, external  
corrosion**  
**2017: Pipe was identified  
with distress in 2005**  
**2020 : Failed near anomalous  
pipe**

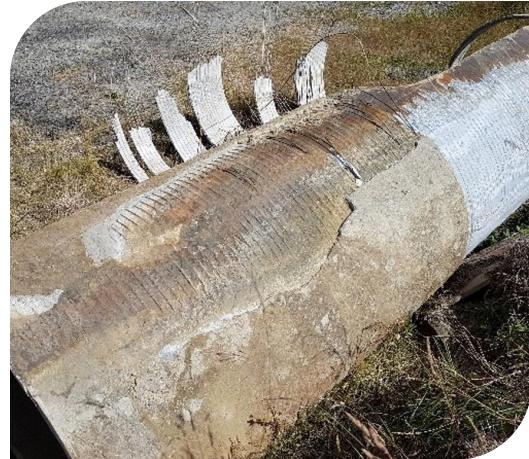
June 2017 Failure

**Location: STA 17 + 96  
(Section 1)**

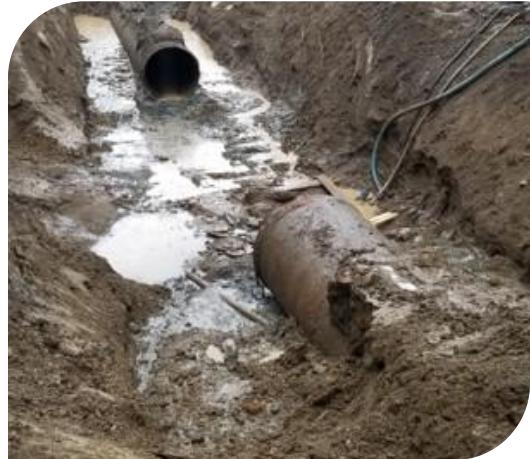
February 2020 Failure

**Location: Upstream of  
Somenos Road Crossing**

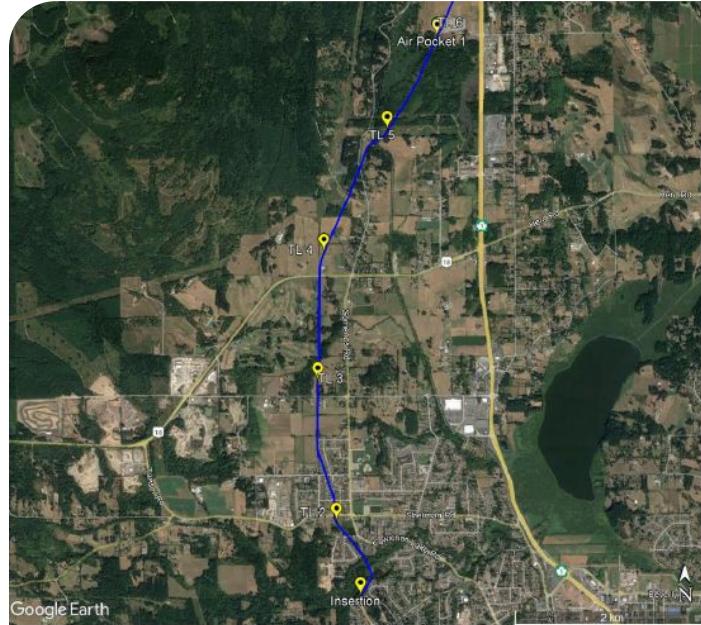
**Section 1:**  
No leaks and air pockets.

**Section 2:**  
No leaks  
01 air pocket and 1 entrained air.

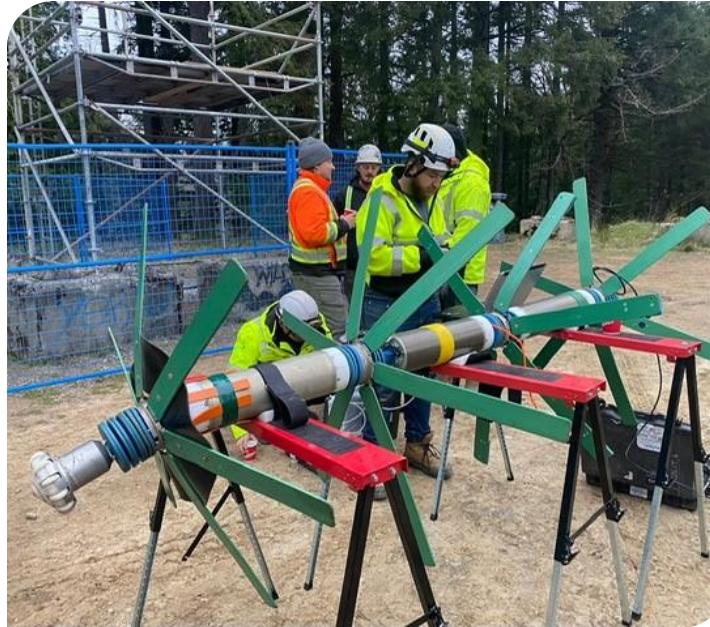
01 pipe identified with broken bar wraps.

17 pipe identified with broken bar wraps.

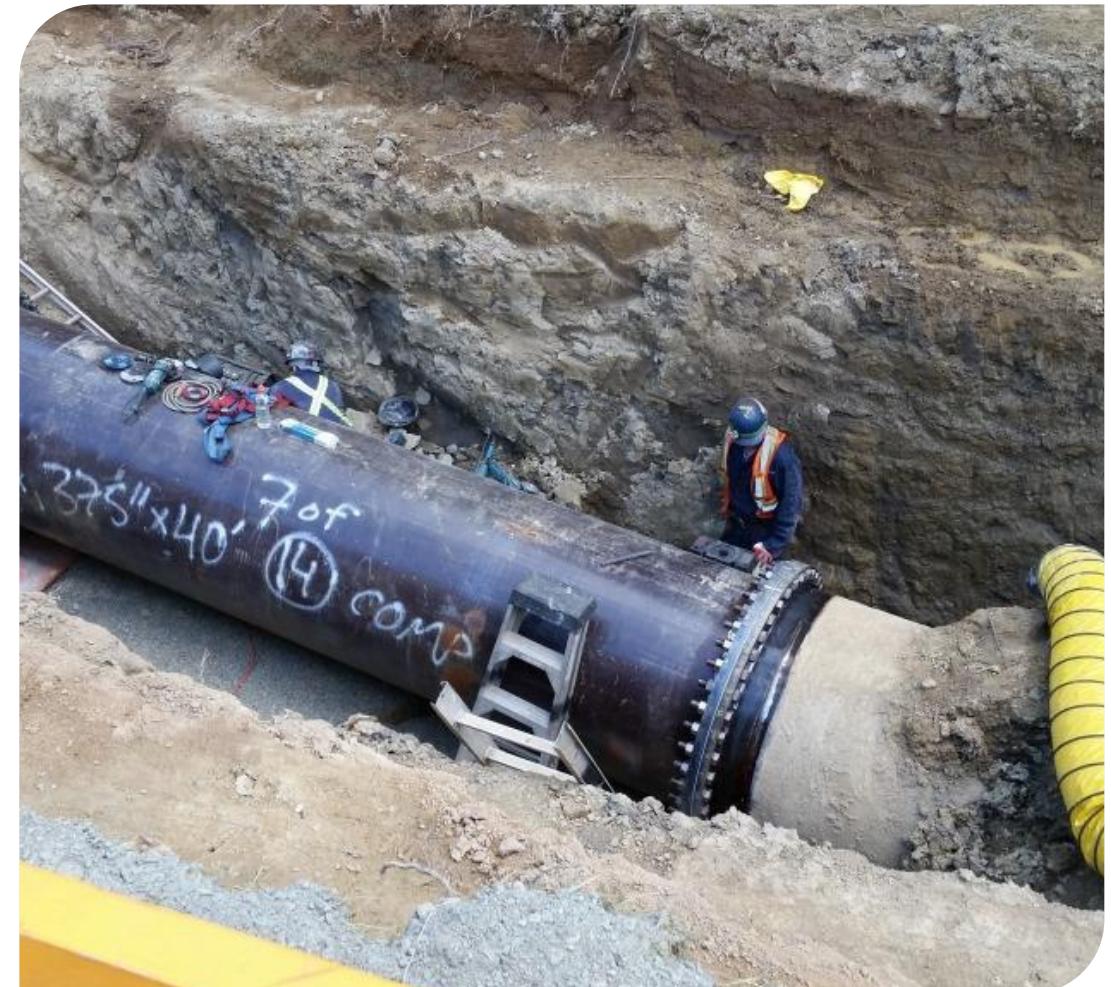
- 1 Four (4) pipes have become newly distressed since the 2018 inspection.
- 2 Four (4) pipes exhibited an increase in broken bar wraps due to distress growth since the 2018 inspection.
- 3 Total of 25 previously distressed pipes have been replaced with HDPE pipes.

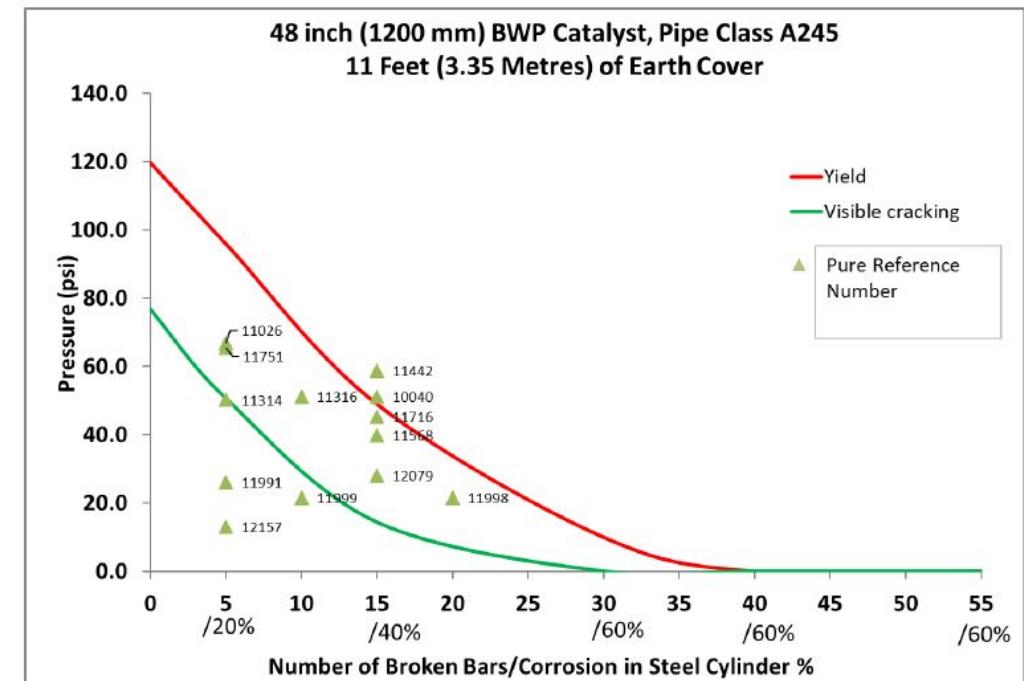
FEA Based Performance Curve

- 1 FEA model to predicts that the pipe meets or exceeds the Yield Limit.
- 2 Other variables should be evaluated when determining the risk.
- 3 02 pipes exceed their yield limits.
- 4 10 pipes exceed their visible cracking limit

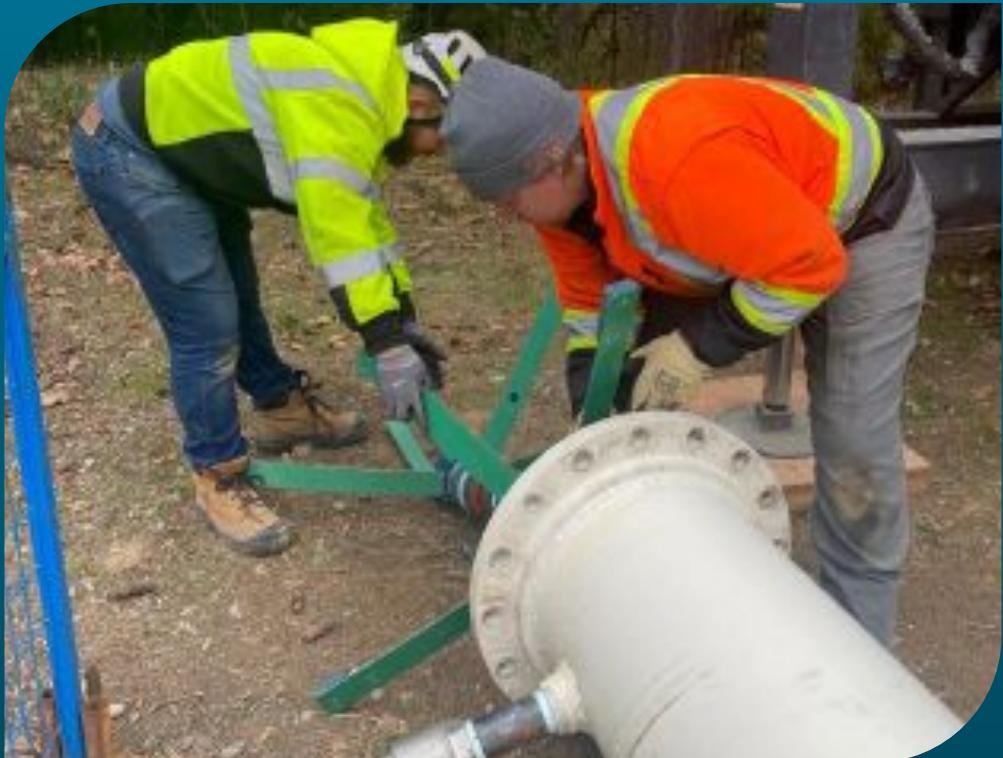
- 
- 1 **18 pipes between 5 and 25 broken bar wraps.** (*4 taken out of service in 2025*)
  - 2 **02 pipes exceeded yield limits.** (*Both pipes were taken out of service in 2025*)
  - 3 **Consider opportunistic repair on pipe nearing yield limits.** (*Planning in progress*)
  - 4 **Inspect air release valves**  
(*Valves are on a periodic inspection route*)
  - 5 **Reinspection in 5 years.** (*Reinspection being planned following the next TMO*)
