# Small-scale thermal hydrolysis to optimise biosolids management Case studies from North America

Dr Bill Barber

13 November 2023

# Clinton River Water Resource Recovery Facility

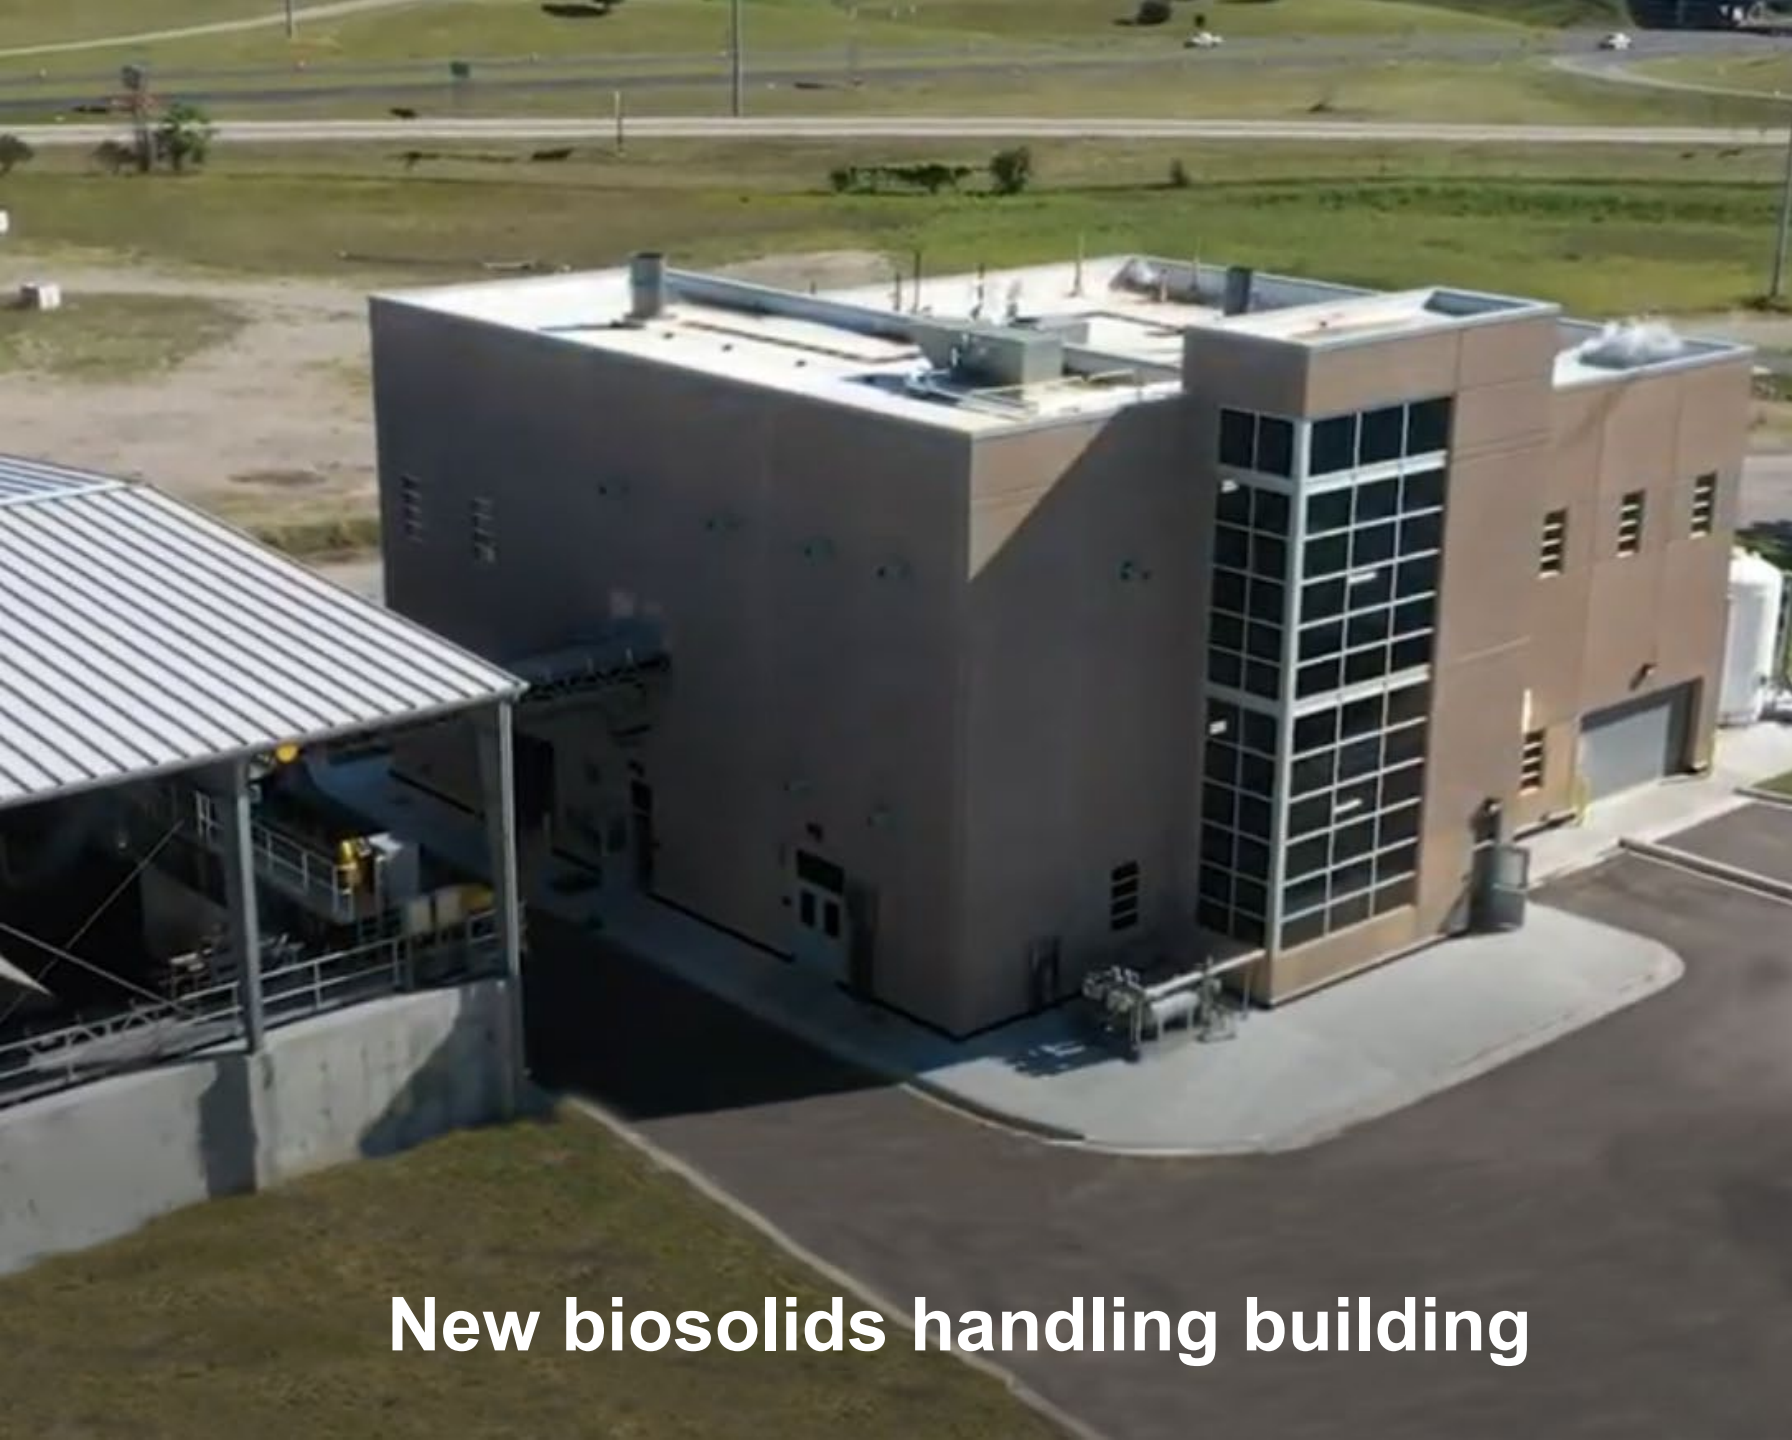
**New biosolids handling building**

- 2-story building of 15,880 ft<sup>2</sup> with processing capacity of 550 kl/d concentrated sludge
- 2 x sludge blending tanks
- Hydro sludge screens receiving sludge at 3% DS
- 2 x Andritz centrifuge pre-thickening
- Cambi Thermal hydrolysis
- 2 x Andritz dewatering centrifuges

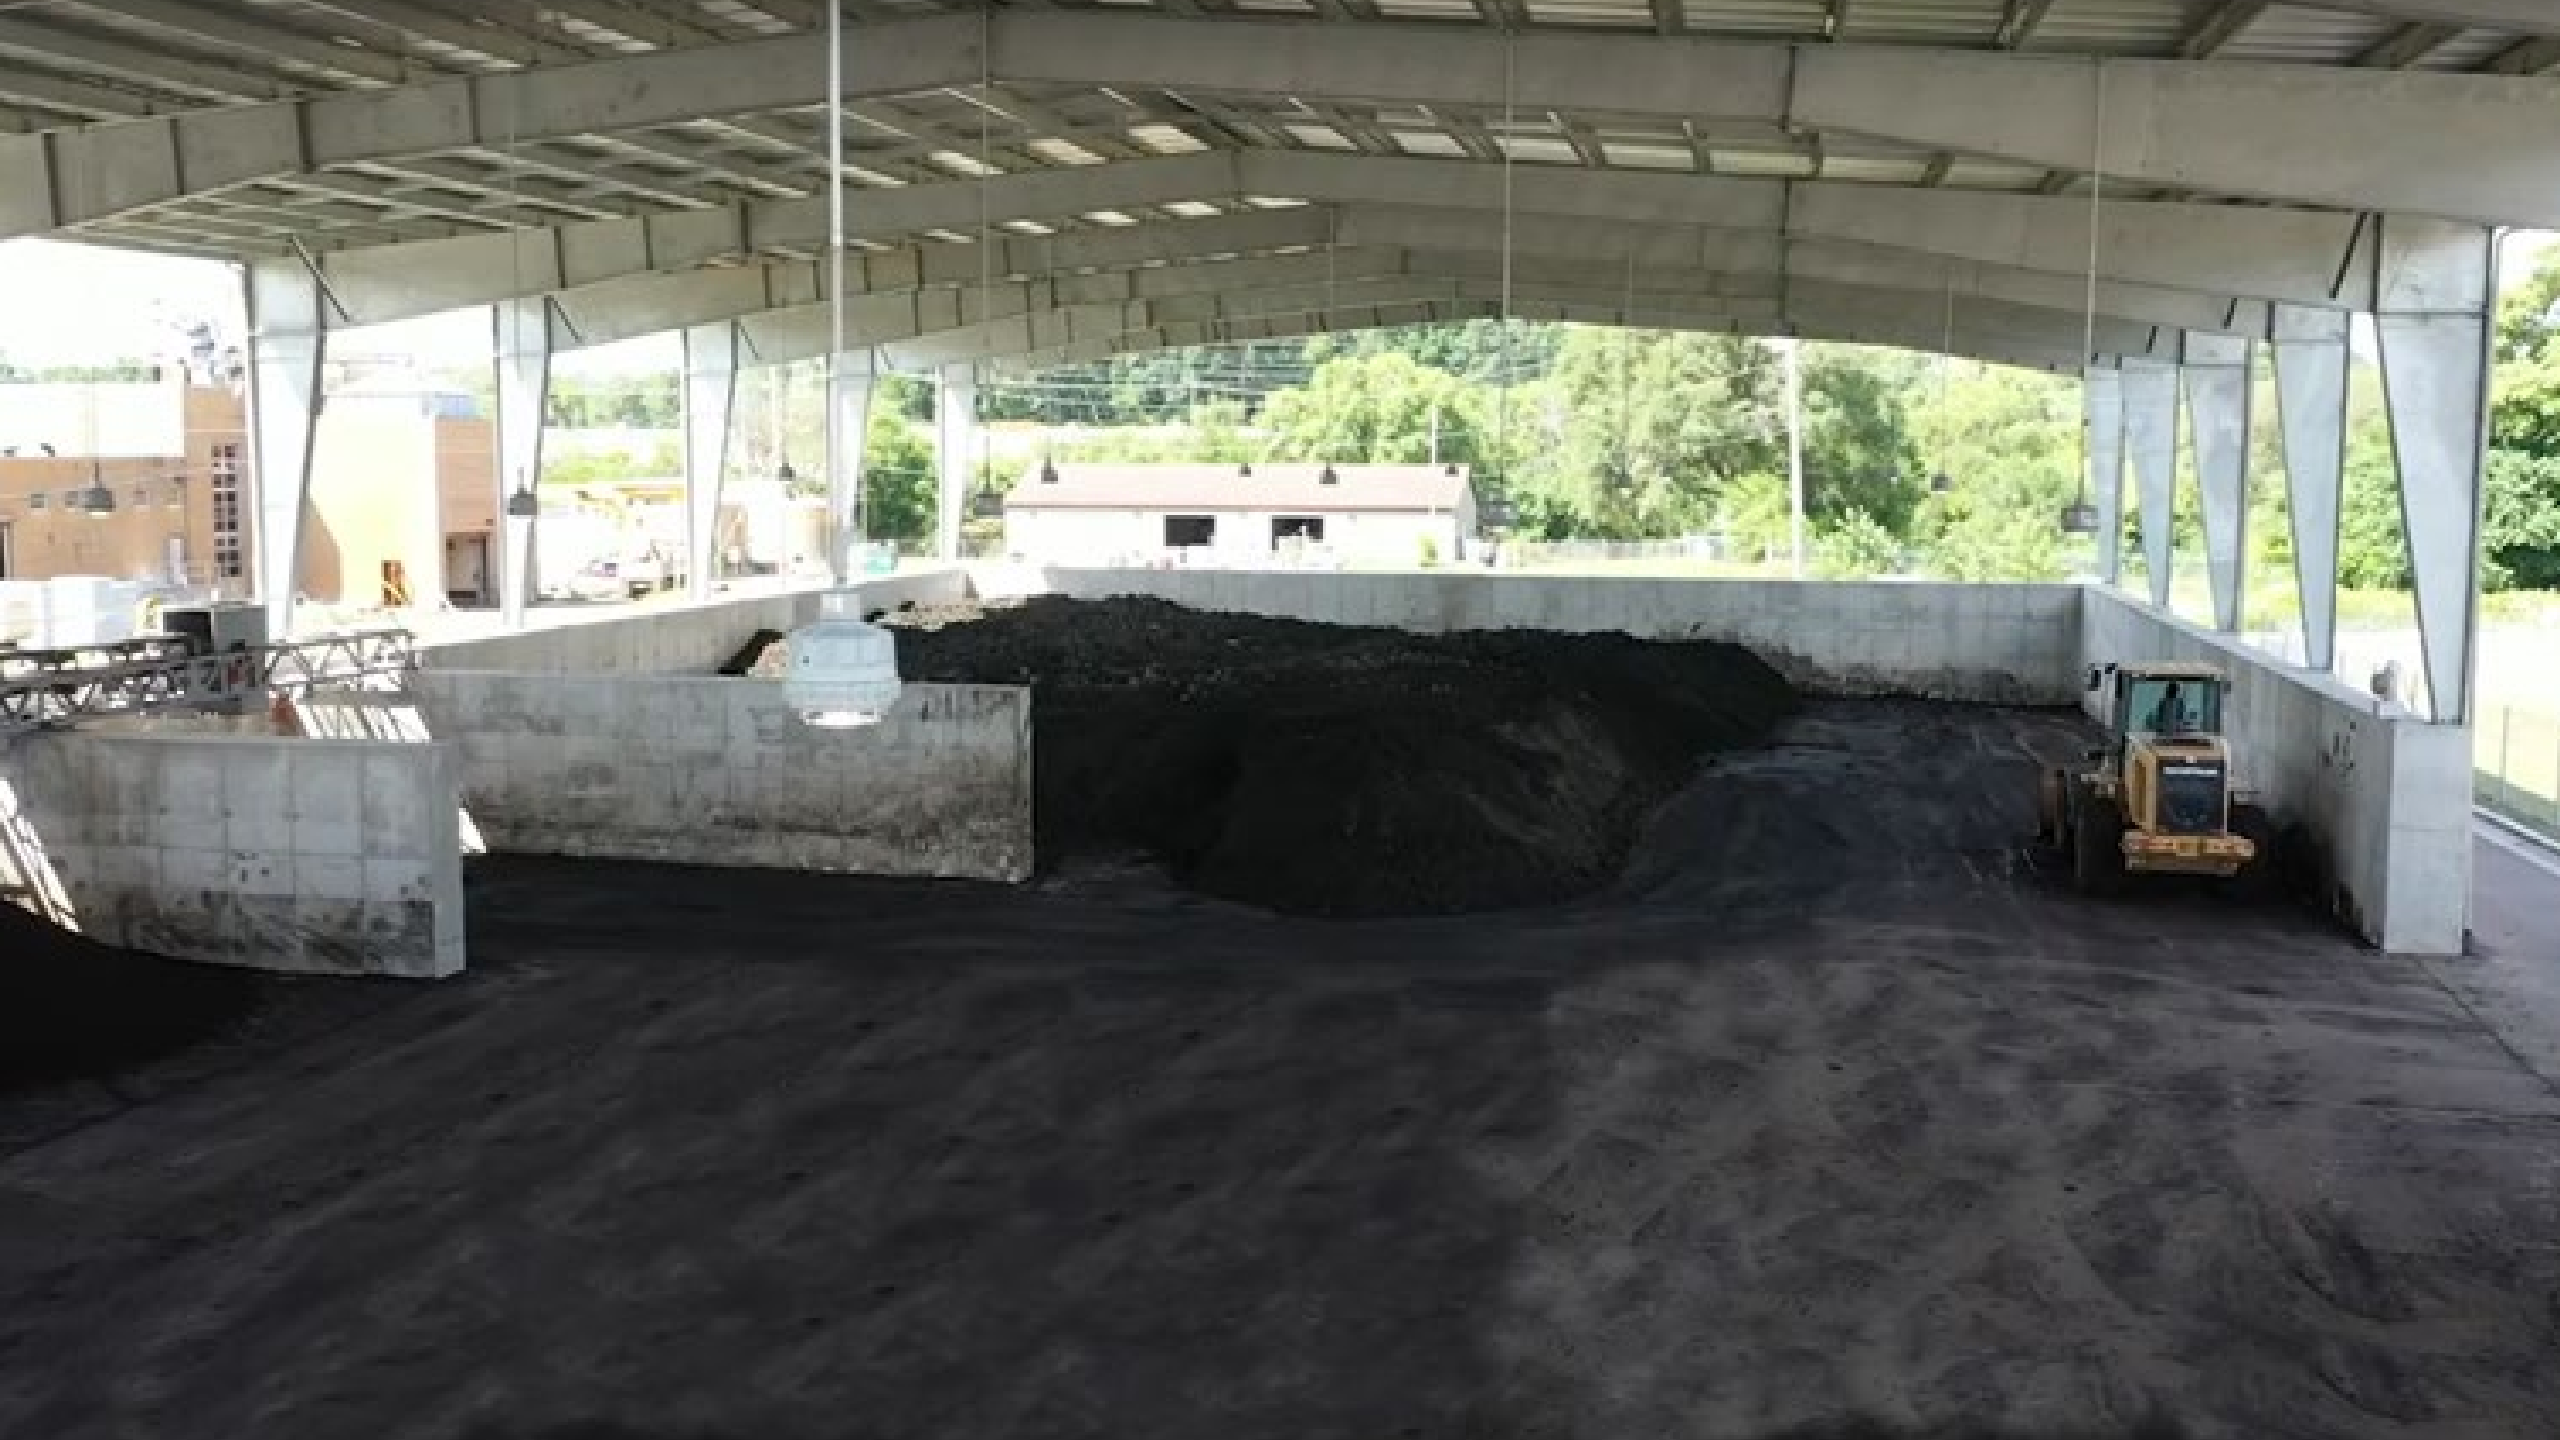
**Covered biosolids storage area**

- 4 biosolids storage holding bays
- 20,000 sq ft storage area
- Can store 7000 cu. yards of biosolids
- Approx. 180 days

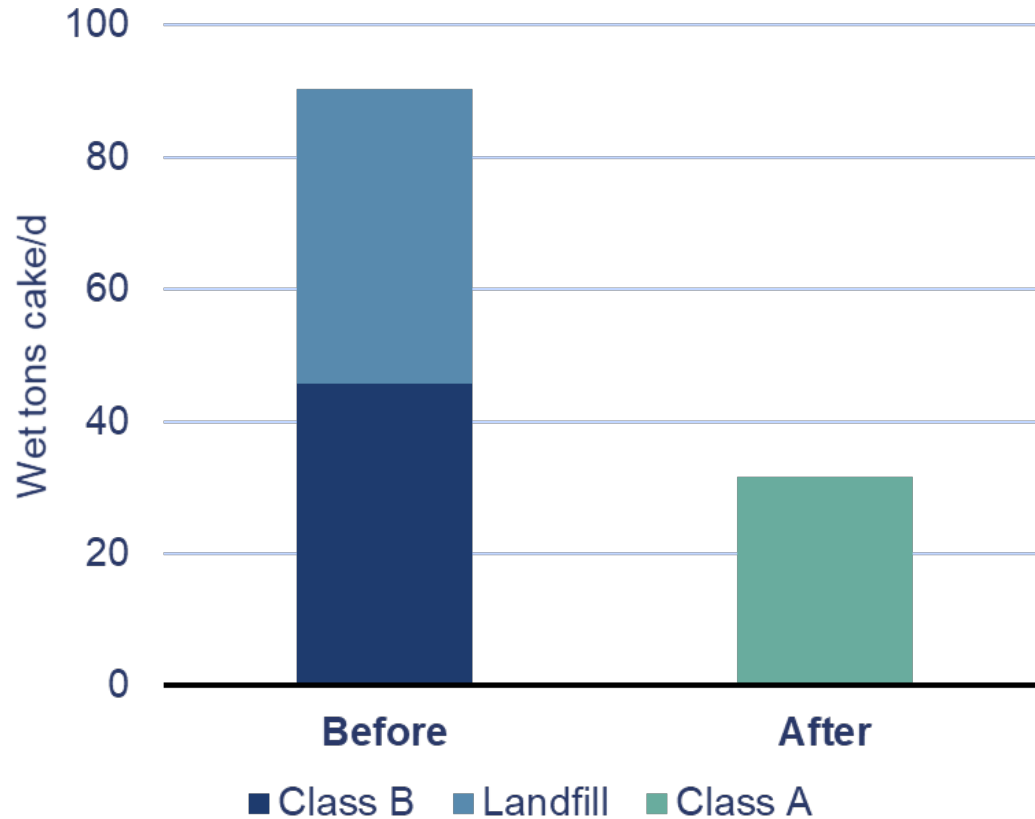
Cake Production

- 65% less cake
- Class A
- No landfill

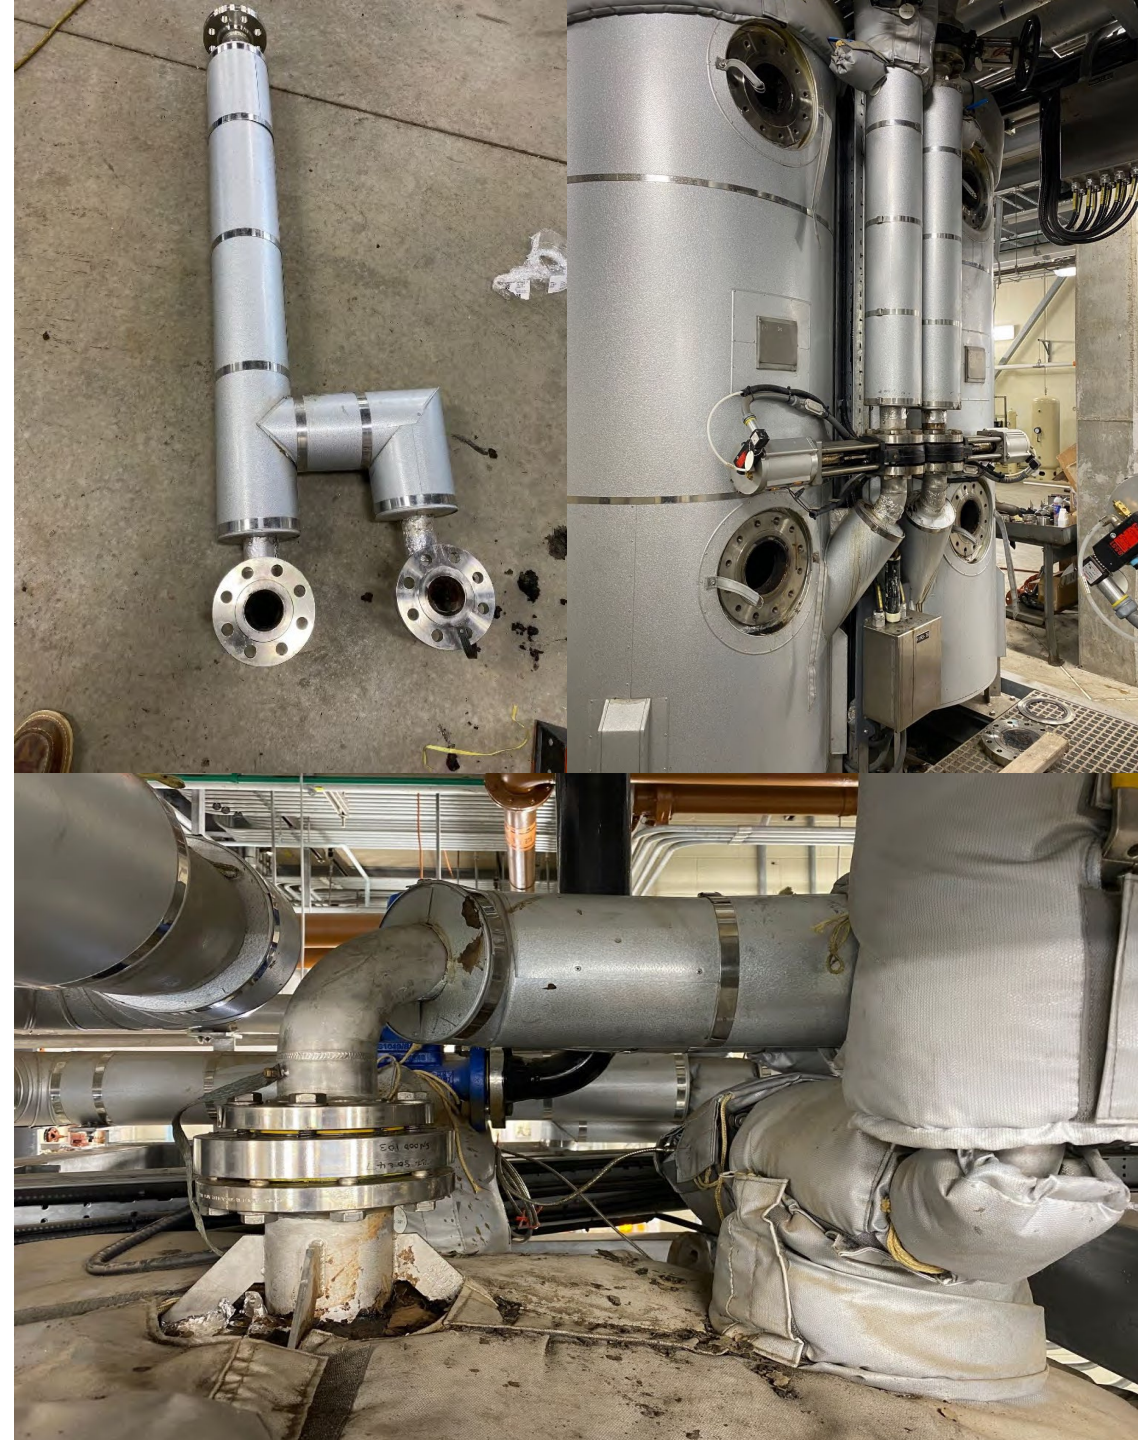
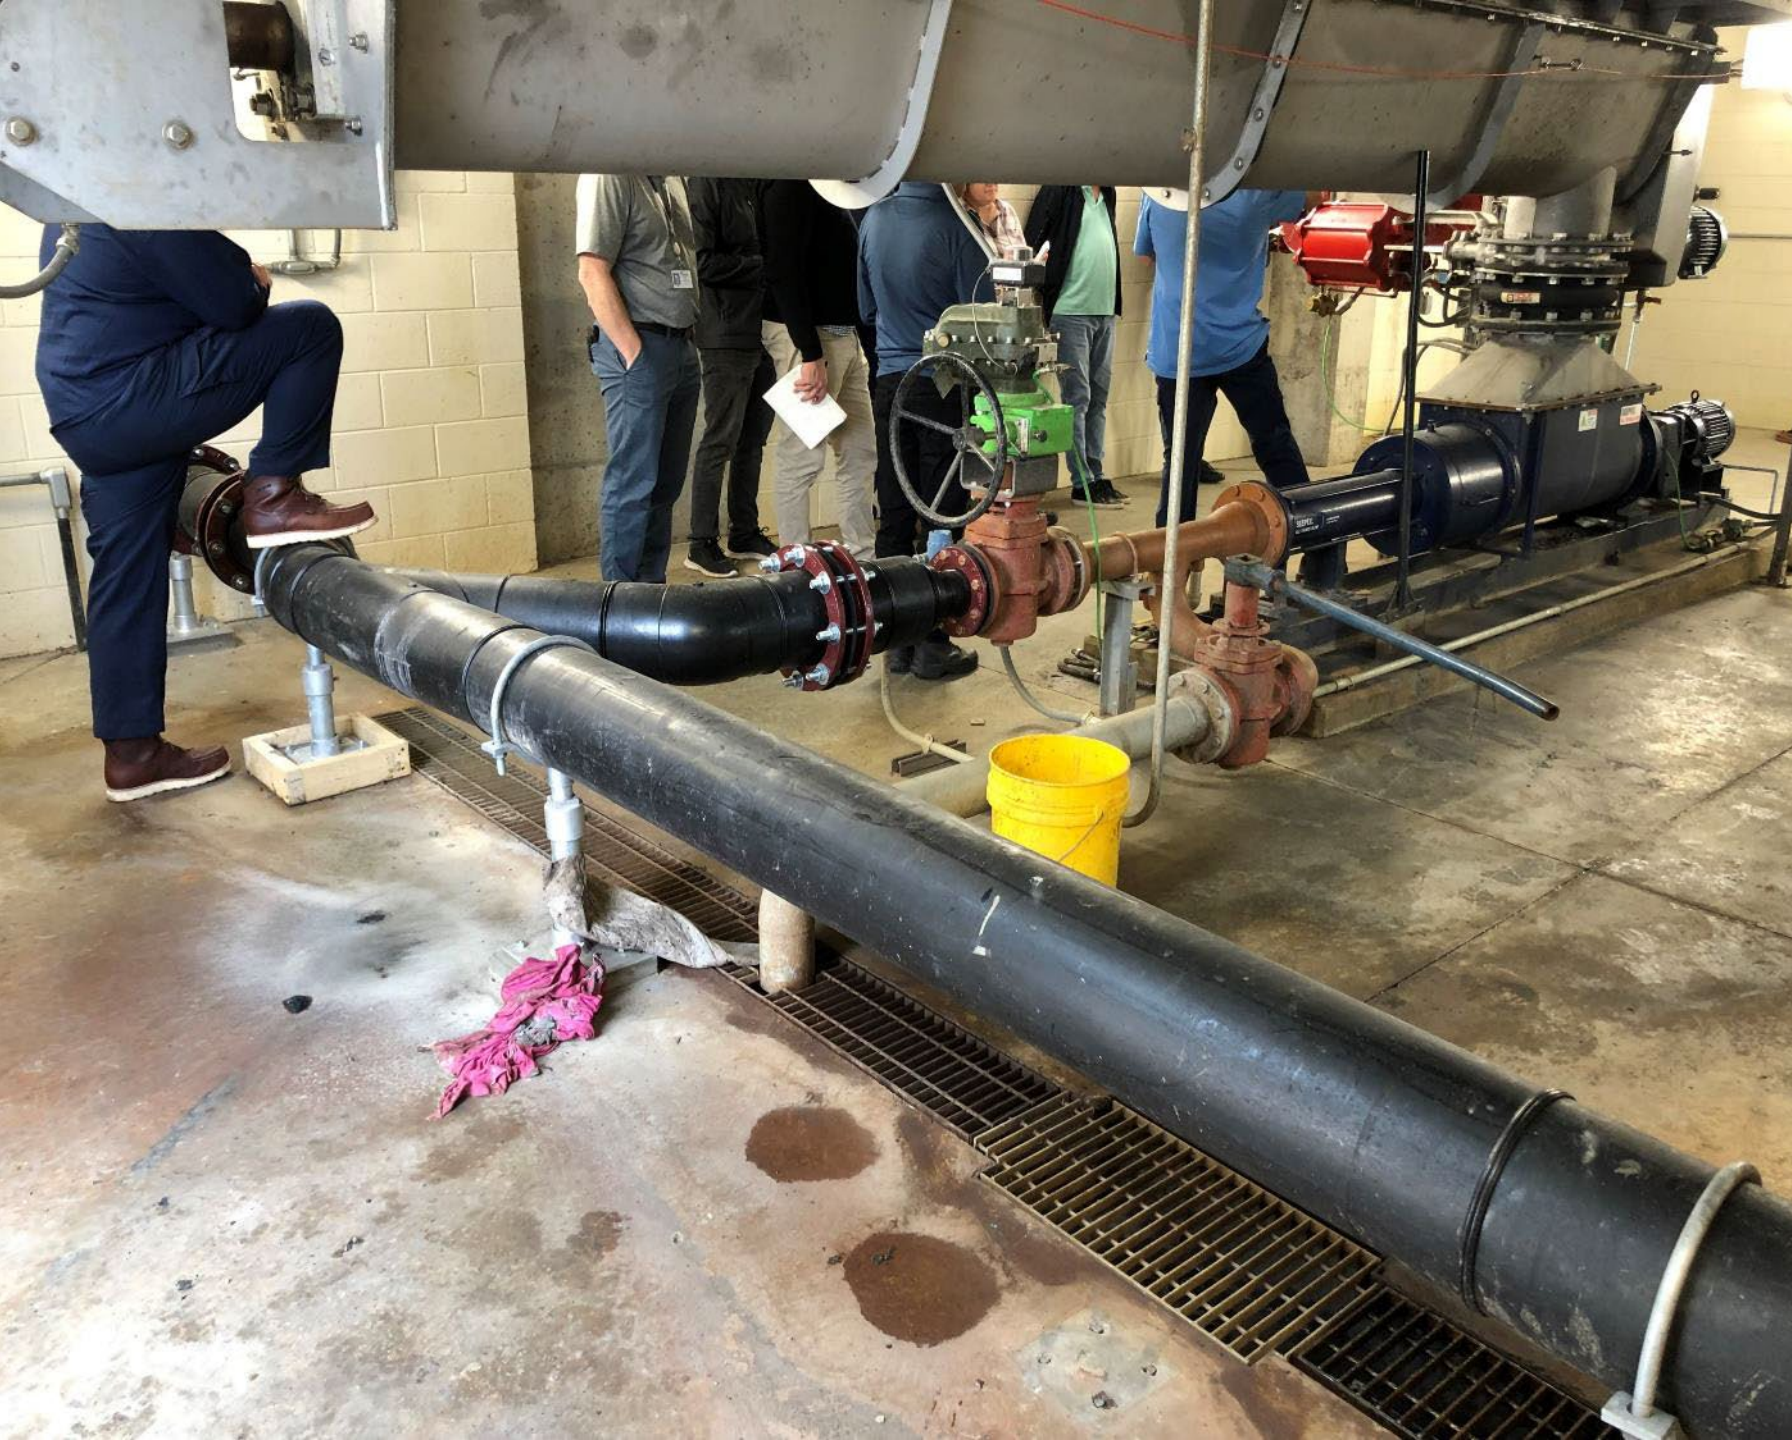
- Pre-dewatered cake hopper
- Single stage PC pump
- 4" stainless pipe to THP inlet
- 4" pipe changed to 8" HDPE pipe
- Mixing could be improved with the pump
- Recommend 4 stage pump, spend a little more money and eliminate any risk

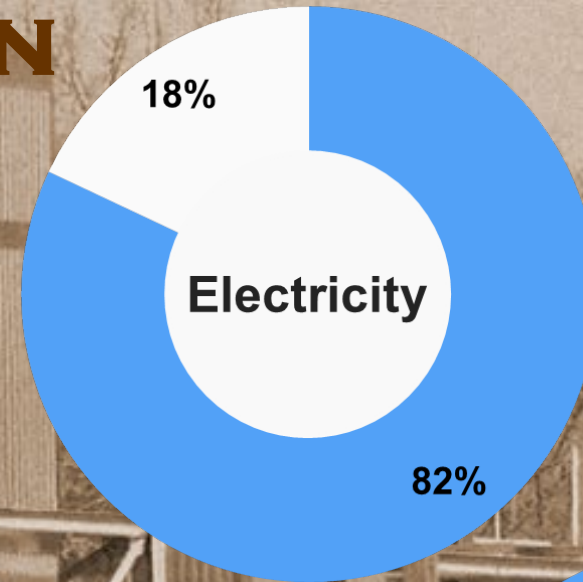
# ZIMPRO WET AIR OXIDATION

- Oxidized sludge at high temperature and pressure
- Produced EQ Biosolids
- Extensive training process for operators
- Energy Inefficient
- Difficult and Expensive to maintain
- 40 + years old
- \$17 M to refurbish

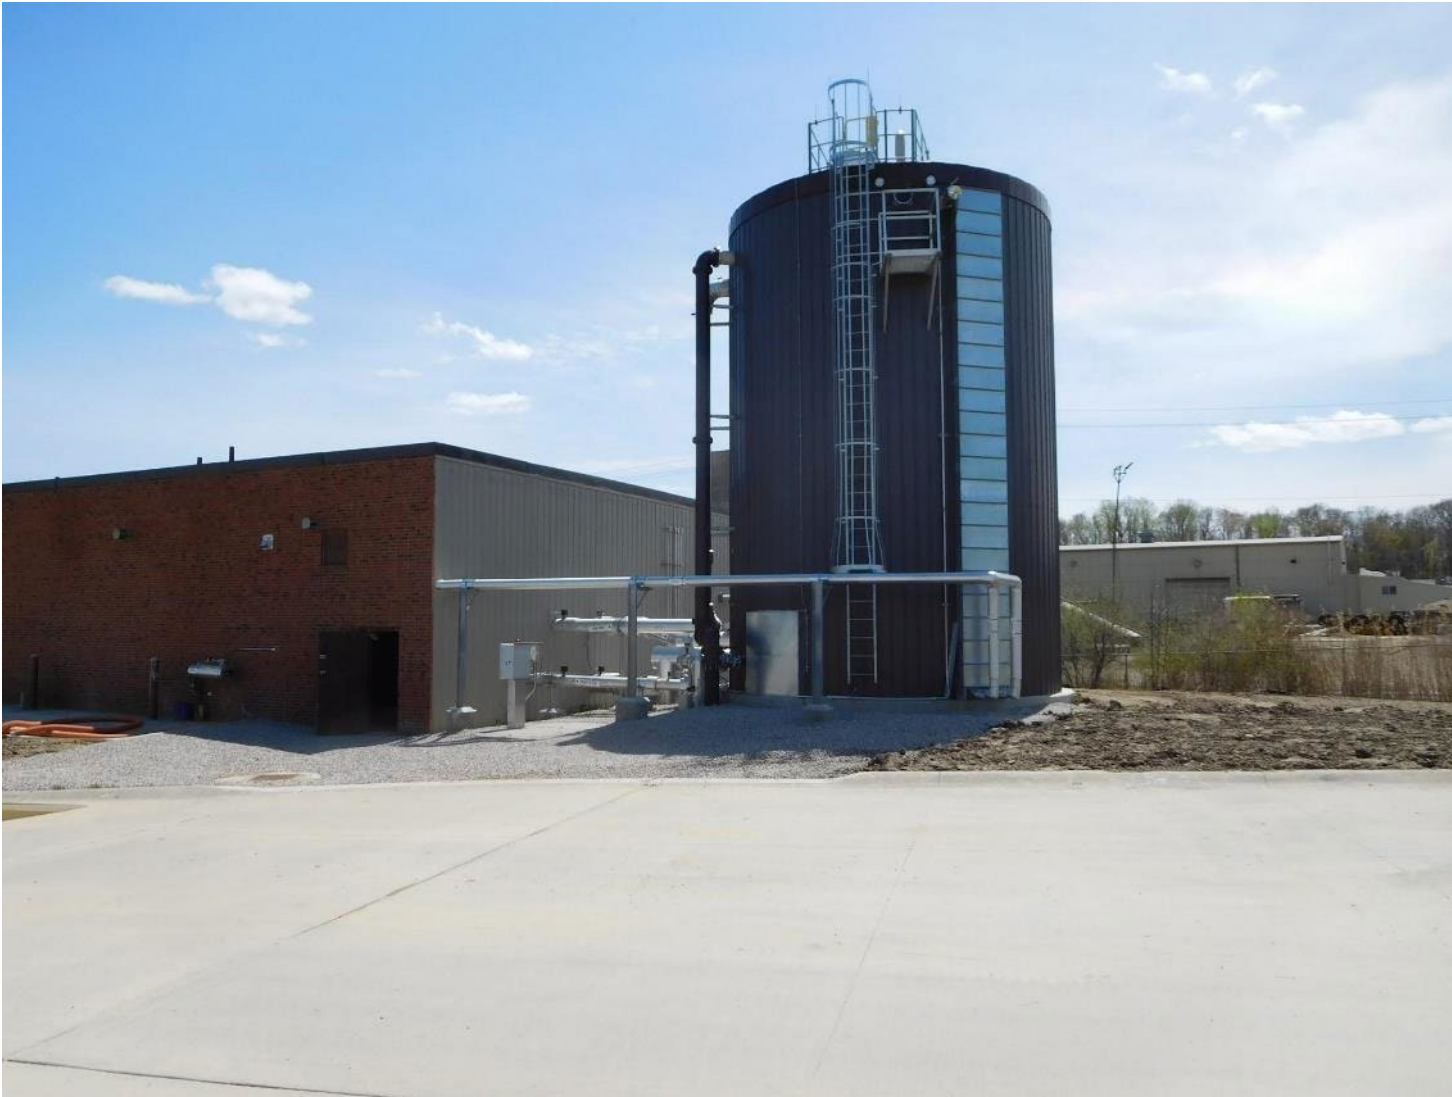
# Co-digestion

- Accepts FOG and DAF Solids and local food waste
- Preheated from Generator Cooling Loop
- Used for Dilution of THP Feed
