Regina Wastewater Treatment Plant

Clean-up of a Hydrocarbon Spill at a WWTP

EPCOR: Alec Mackenzie, P.Eng.
November 2023

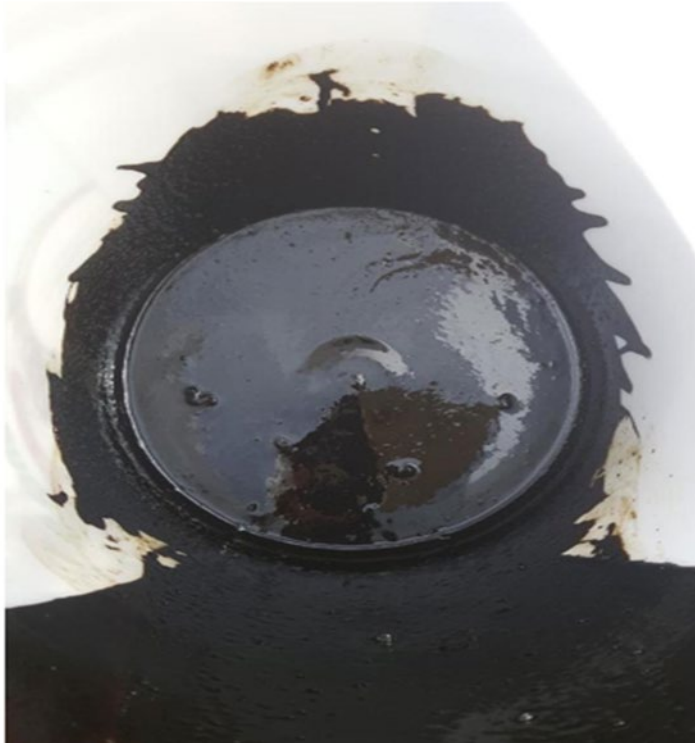
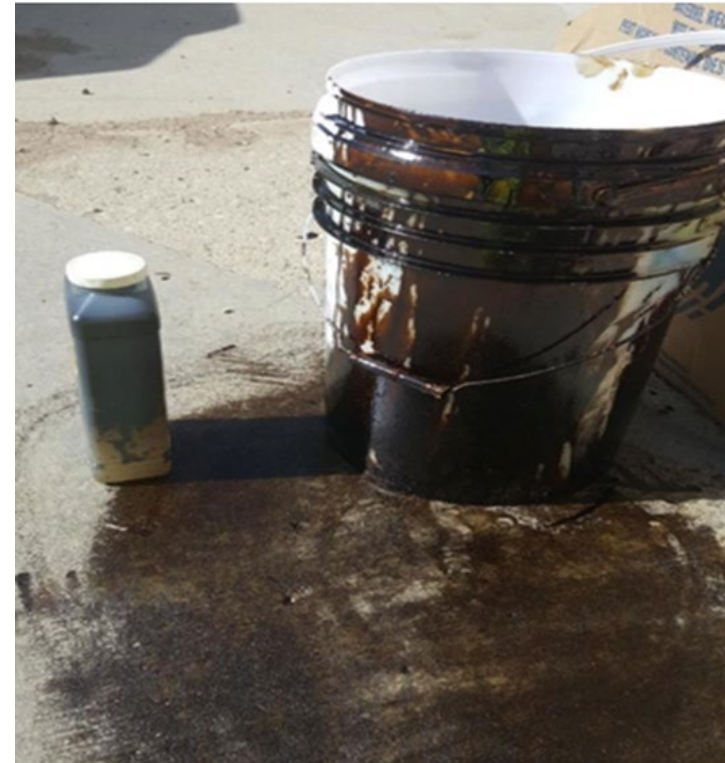
May 22 & 23, 2020

- EPCOR Operators reduced the flow to the WWTP to limit the impact. The remainder of the raw wastewater was diverted to Cell 2A.
- Throughout the morning the impacts of the contamination started to become clear:
 - Testing throughout the plant and effluent resulted in cause for alarm
 - Bioreactors began to foam significantly
 - Flow to the digesters was reduced to prevent further contamination and foaming
 - All flow was diverted to the lagoons
 - One bioreactor was isolated to preserve any good bacteria
- The City contract representative and Water Security Agency were notified. The City contacted the industrial user.

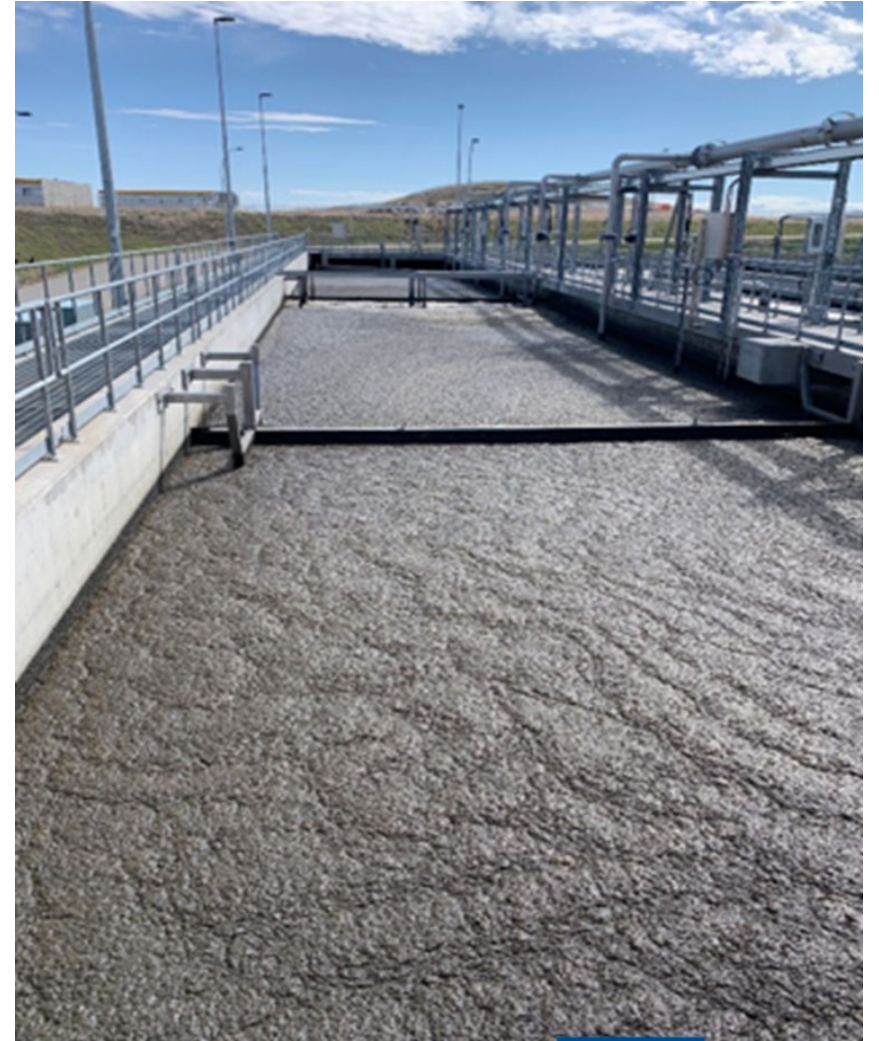
- Cell 2A is used as the primary wet weather storage cell the WWTP.
- Existing aeration system from the lagoon-based treatment plant is still in place and used to maintain aerobic conditions as needed.
- Was part of the old WWTP aerated cell configuration.
- Cell 2A had approximately 33,000 m^3 of sludge prior to the event (important issue for later on).

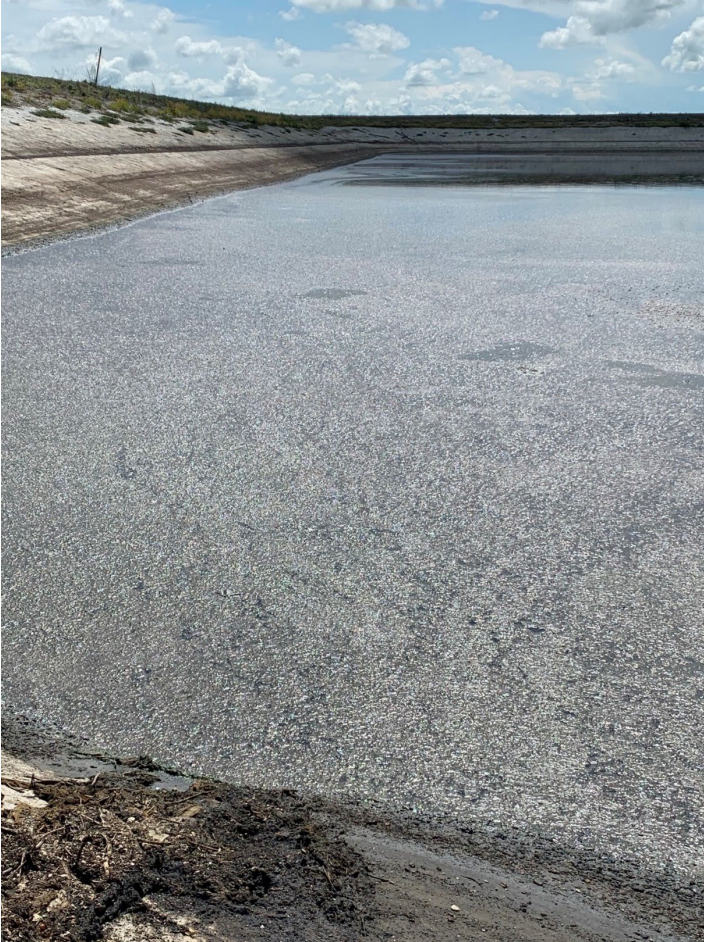
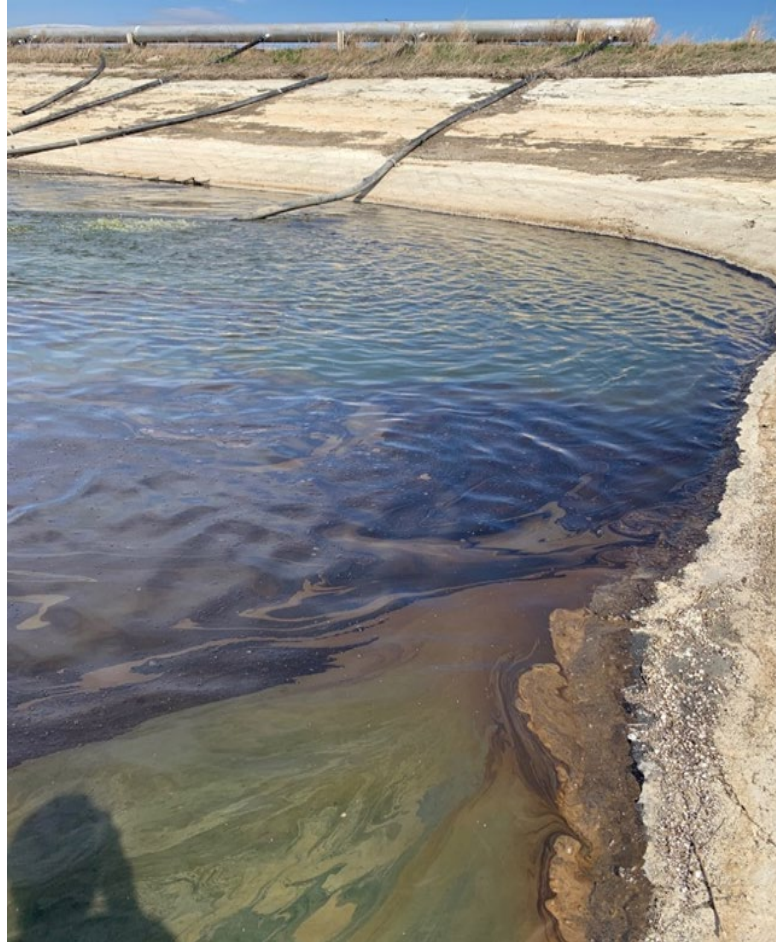
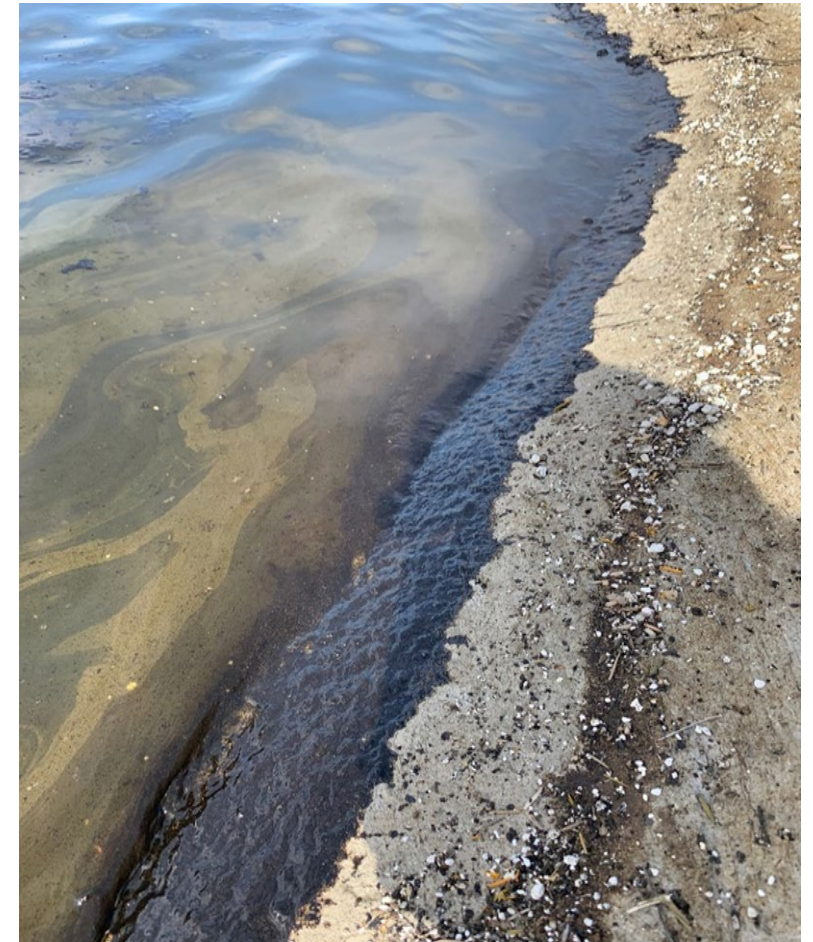
The Oil Slick

- May 22 & 23, 2022 – Impacts seen on Cell 2A

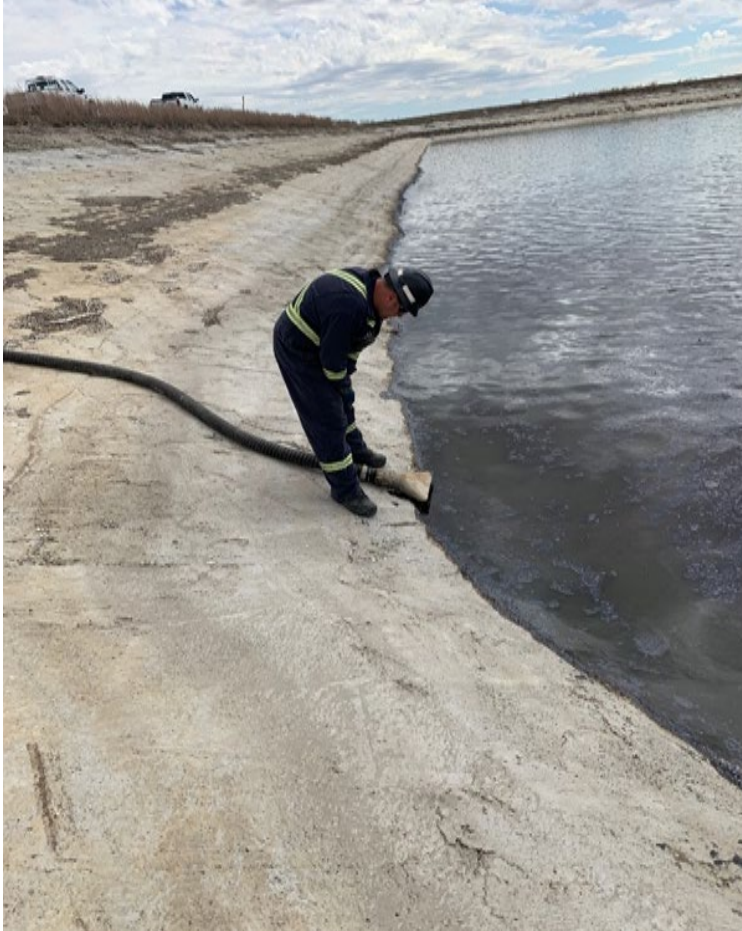
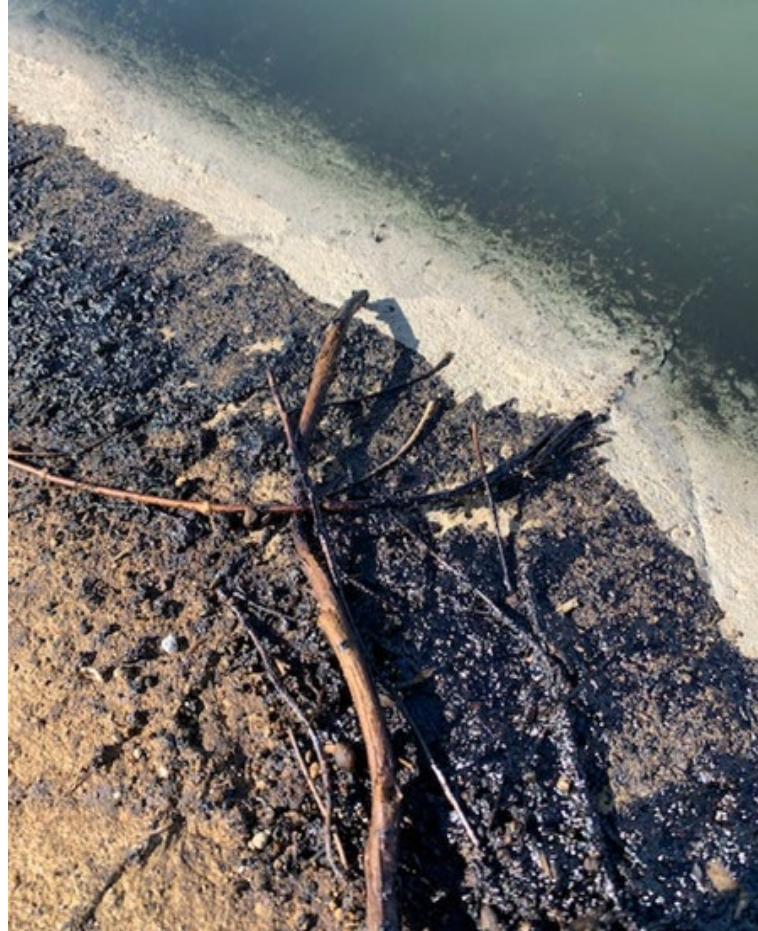
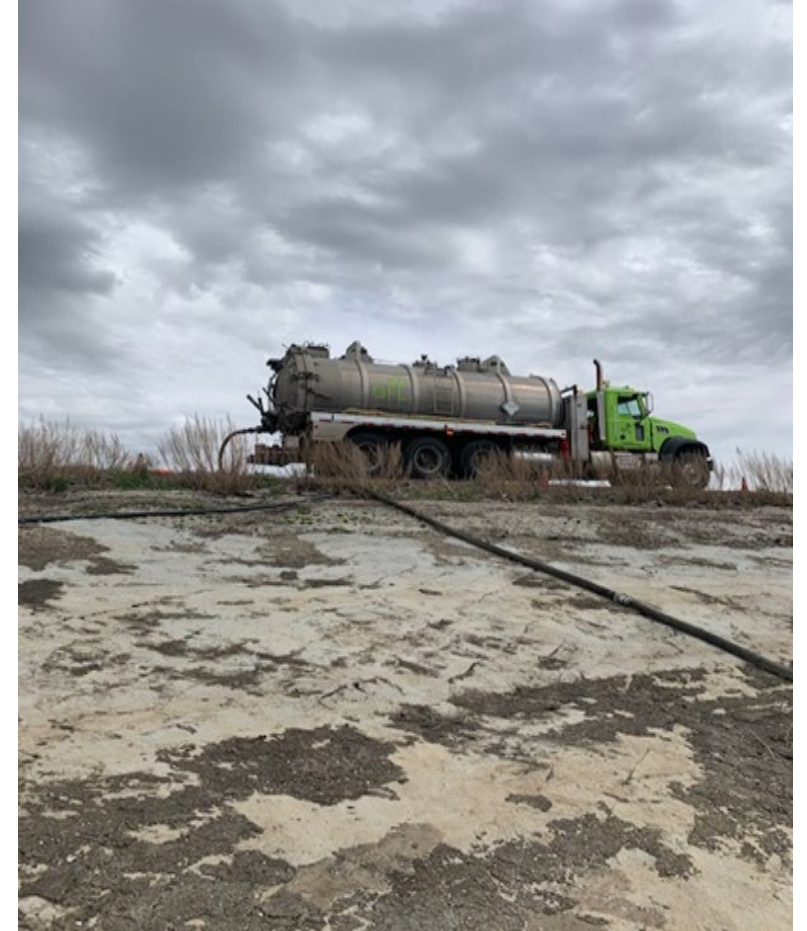
Initial Cleanup Attempt

- May 22 – 29, 2022 – attempted to clean using Hydrovac

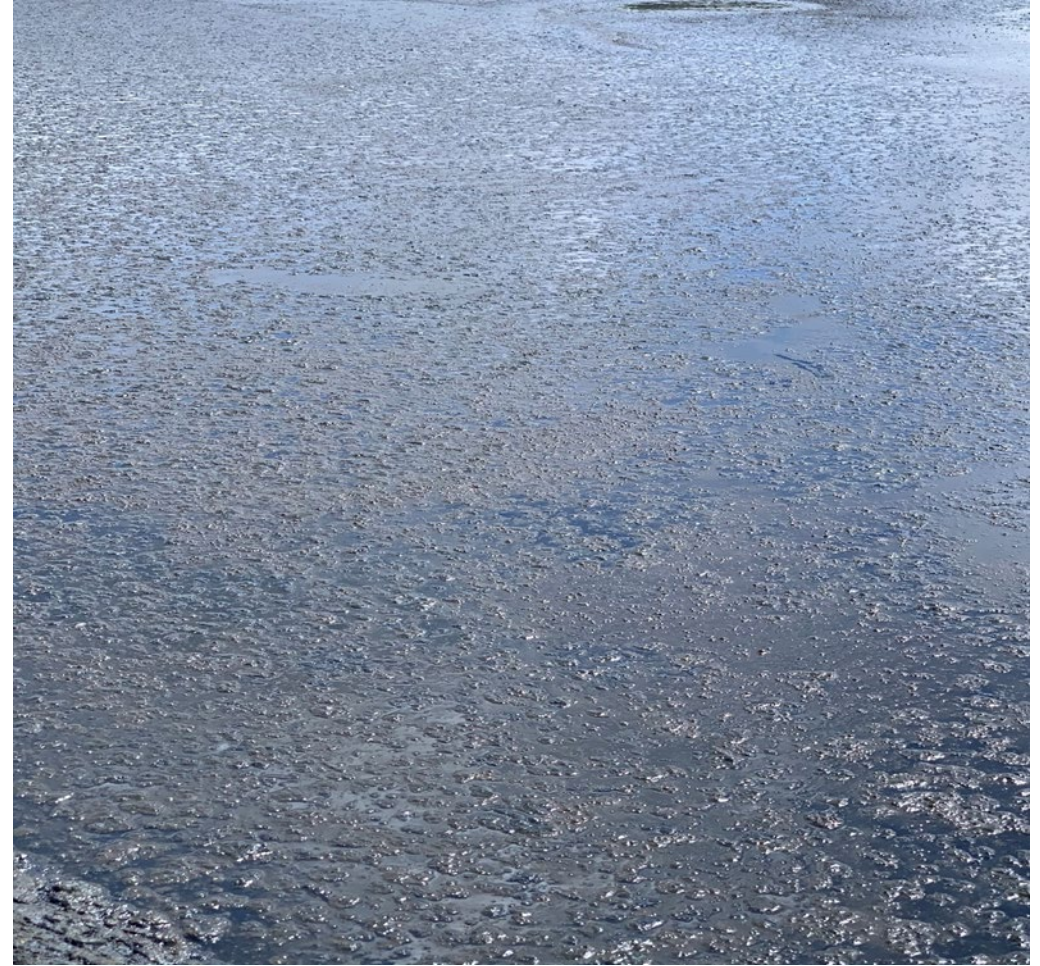
Need to Review Additional Solutions

- Associated was contacted in May to provide an environmental assessment and further remediation recommendations as to how to clean the contaminated sludges and mitigate the other damages that were possibly caused by the incident.

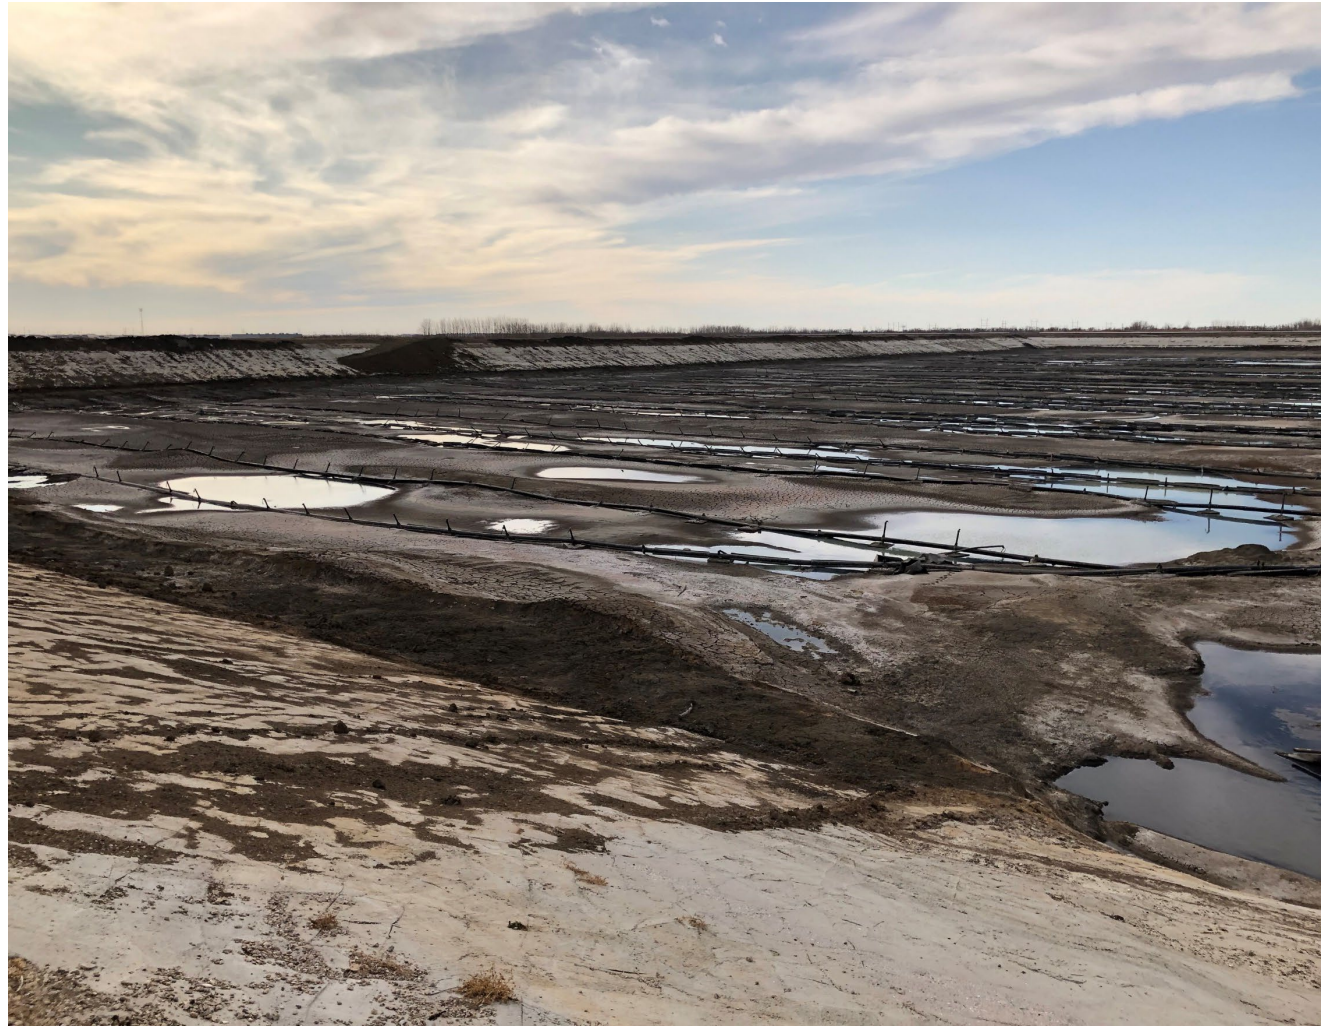
Step 1 - Dewatering

- Water column held very little oil
- Majority found in sludge
- Decision to pump Cell 2A dry – oil boom used and floated around the intake
- Attempt to dry sludge

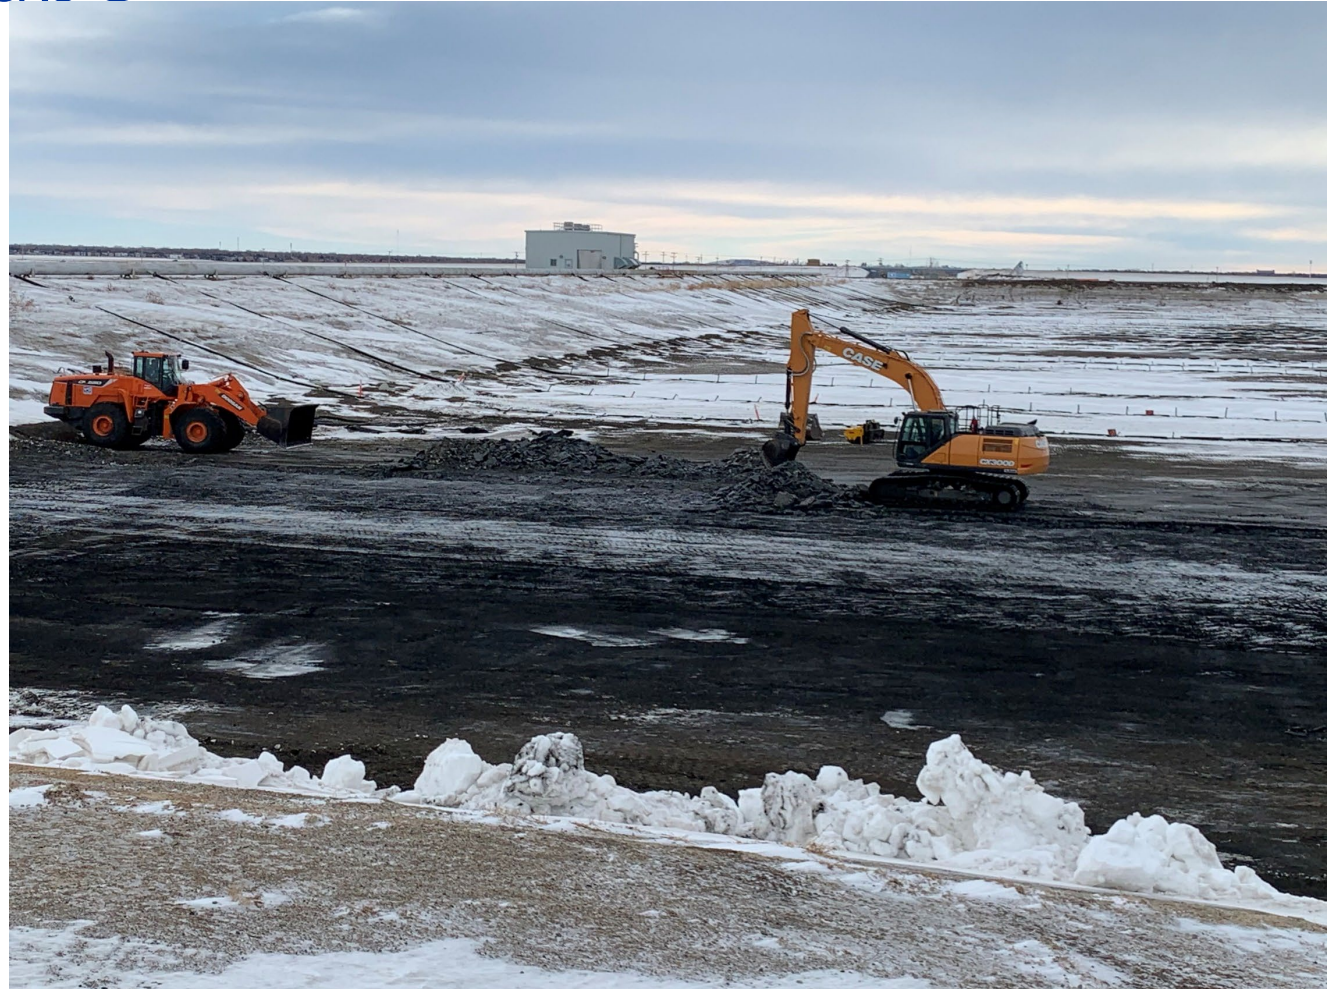
Step 2 - Freeze and Scrape

- Ultimate solution was to let the sludge freeze and remove the top 300 mm.
- Frozen sludge allowed for heavy equipment use
- Hope for a late spring
