THERMAL HYDROLYSIS

MAXIMIZING WATER TREATMENT ACROSS
CITY OF FRANKLIN, OHIO'S MEDINA COUNTY, AND MICHIGAN'S OAKLAND COUNTY

**FRANKLIN WATER RECLAMATION
THERMAL HYDROLYSIS SYSTEM**

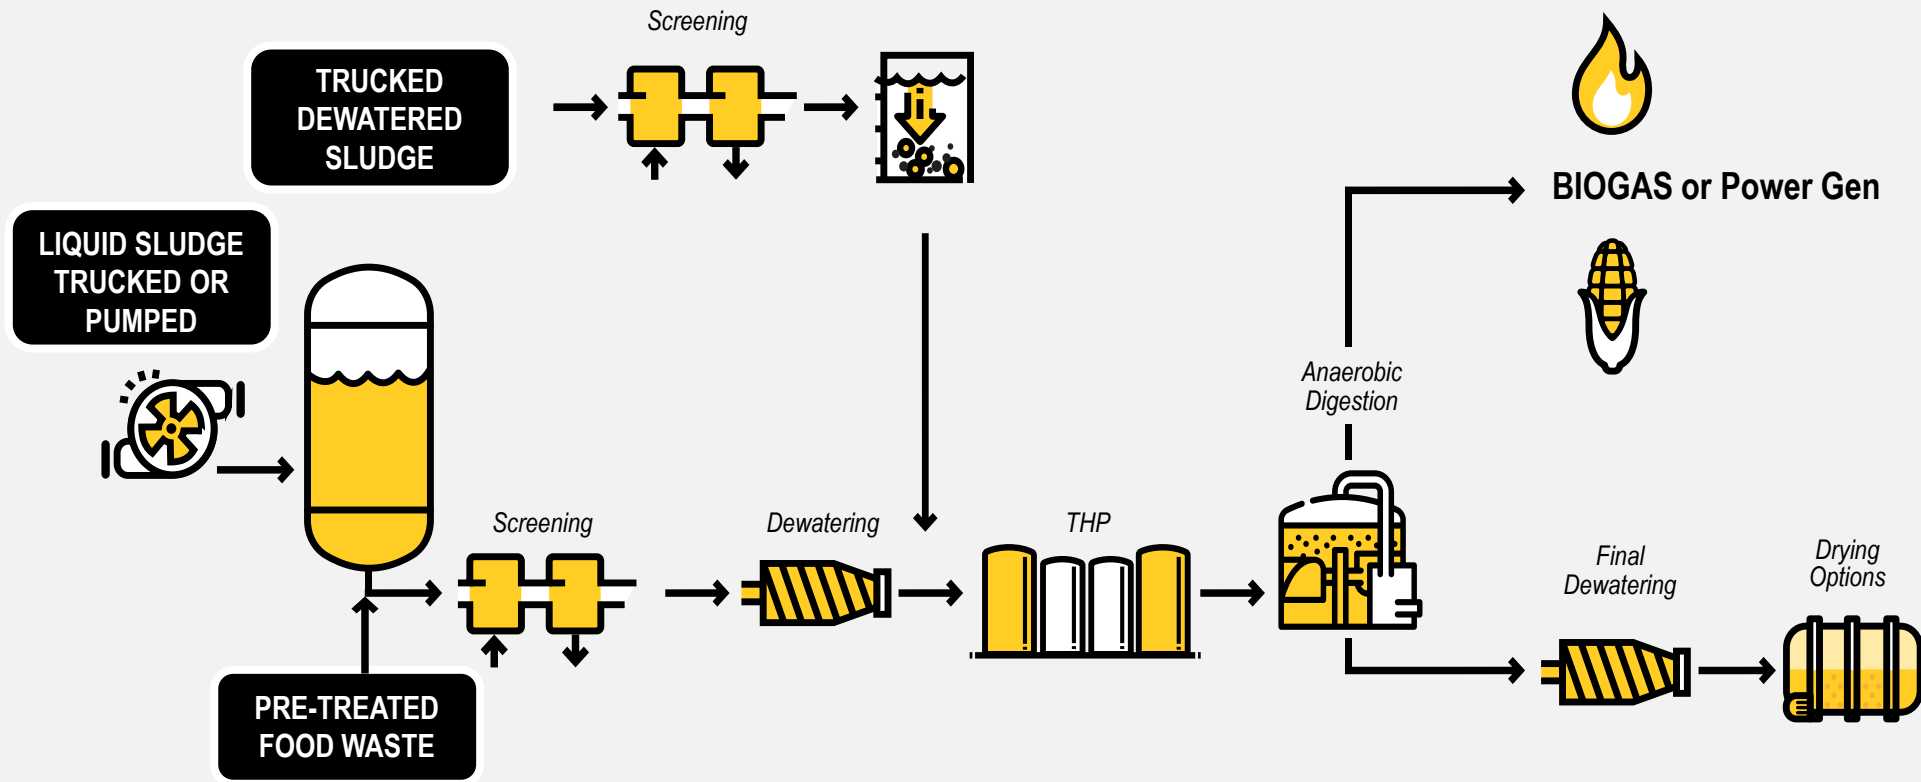
ANAEROBIC DIGESTION DEWATERING & DRYING

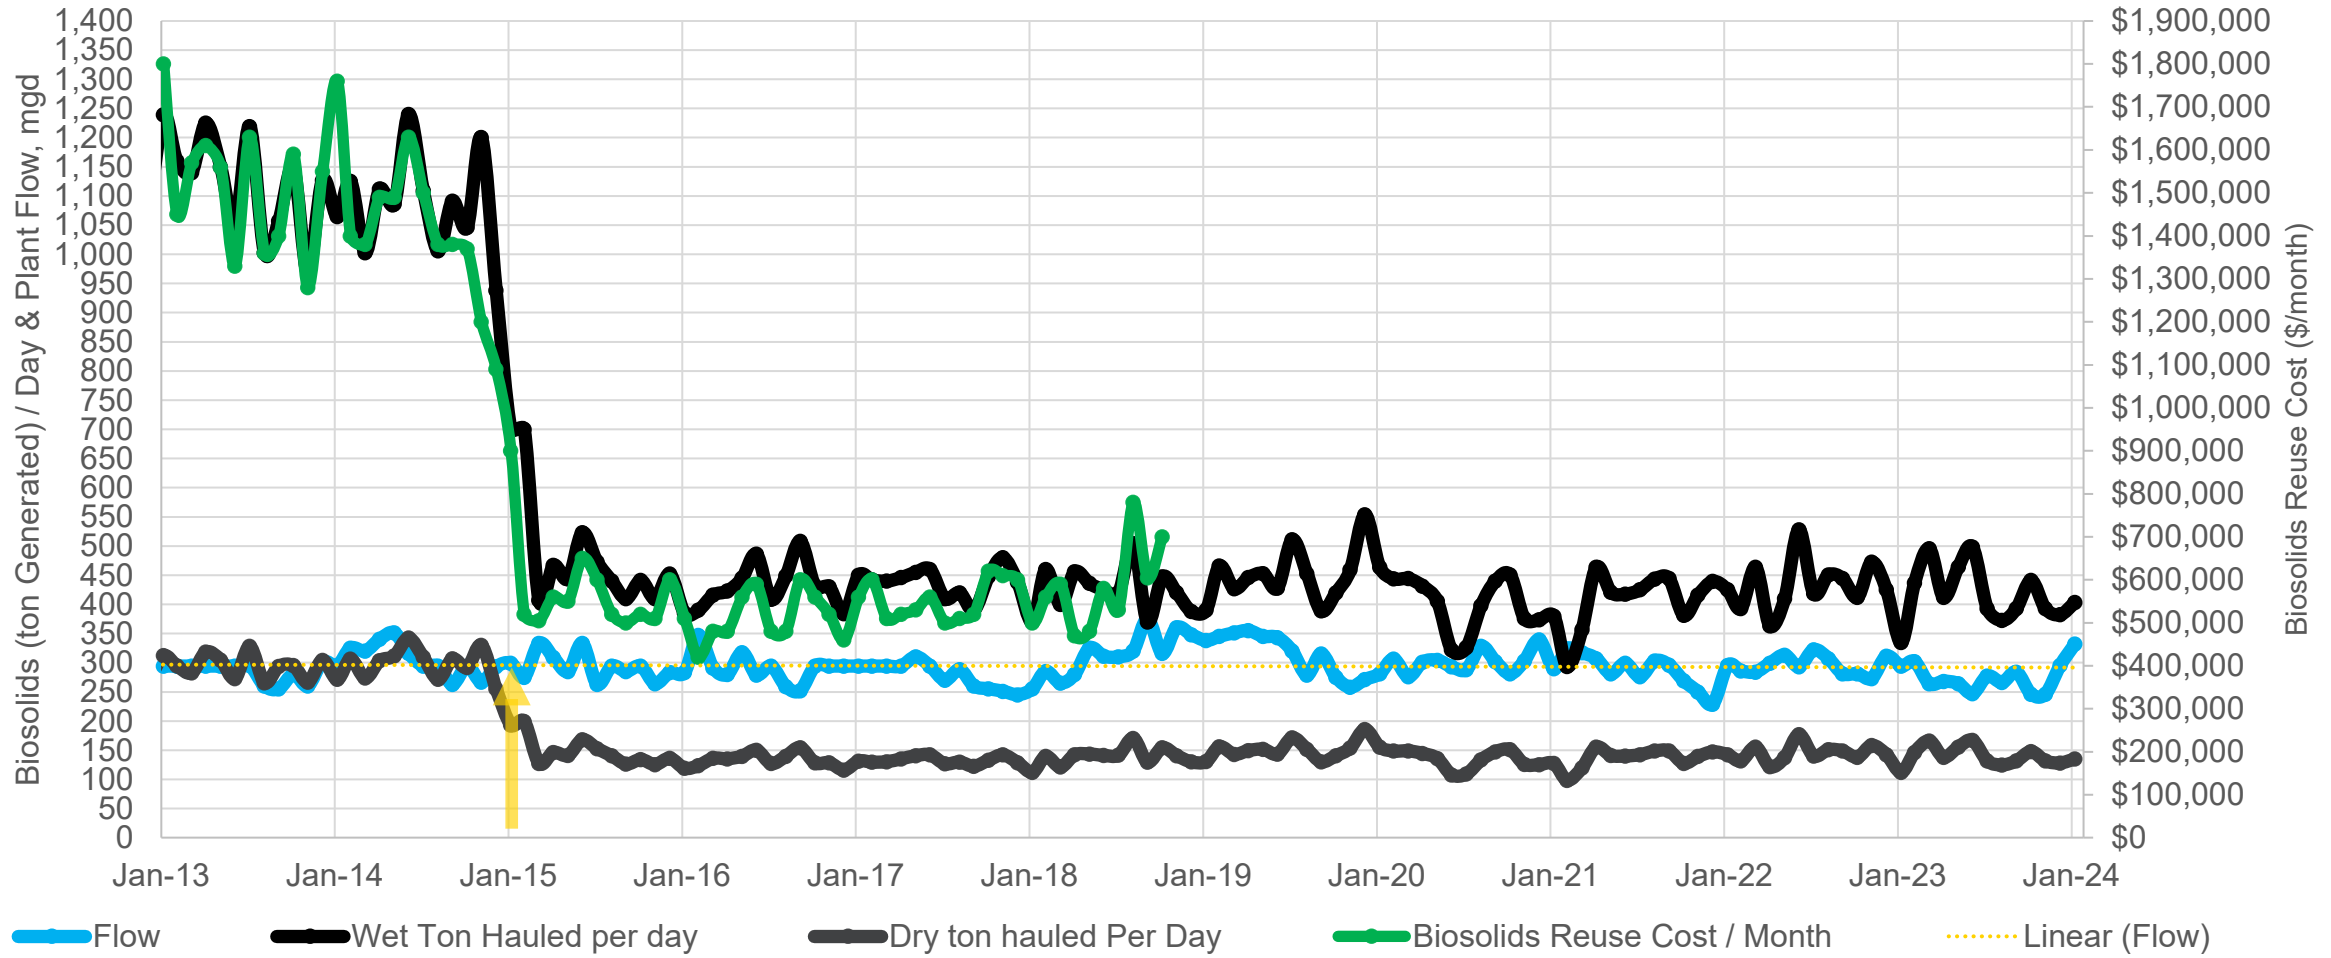
Washington, DC Blue Plains WWTP

Kiewit Engineering Group
Washington DC WASA Blue Plains WWTP Cambi THP

Operations Start: January 2013

Flow Rate: 400 mgd

Biosolids Reduction and Hauling: 500 tons/day; lower transportation costs and environmental impact

Cost Savings: \$1 million/month on biosolids reuse

Increased Biosolids Dryness: Consistent improvement in biosolids dryness percentage, resulting in reduced hauling volume and potential for further treatment or beneficial use.

Optimized Plant Operation: Correlation between plant flow and biosolids generation suggests effective process control and energy efficiency.

Stable Biogas Production: Consistent output year-round.

Energy Potential: Significant biogas for electricity, heat, or other uses.

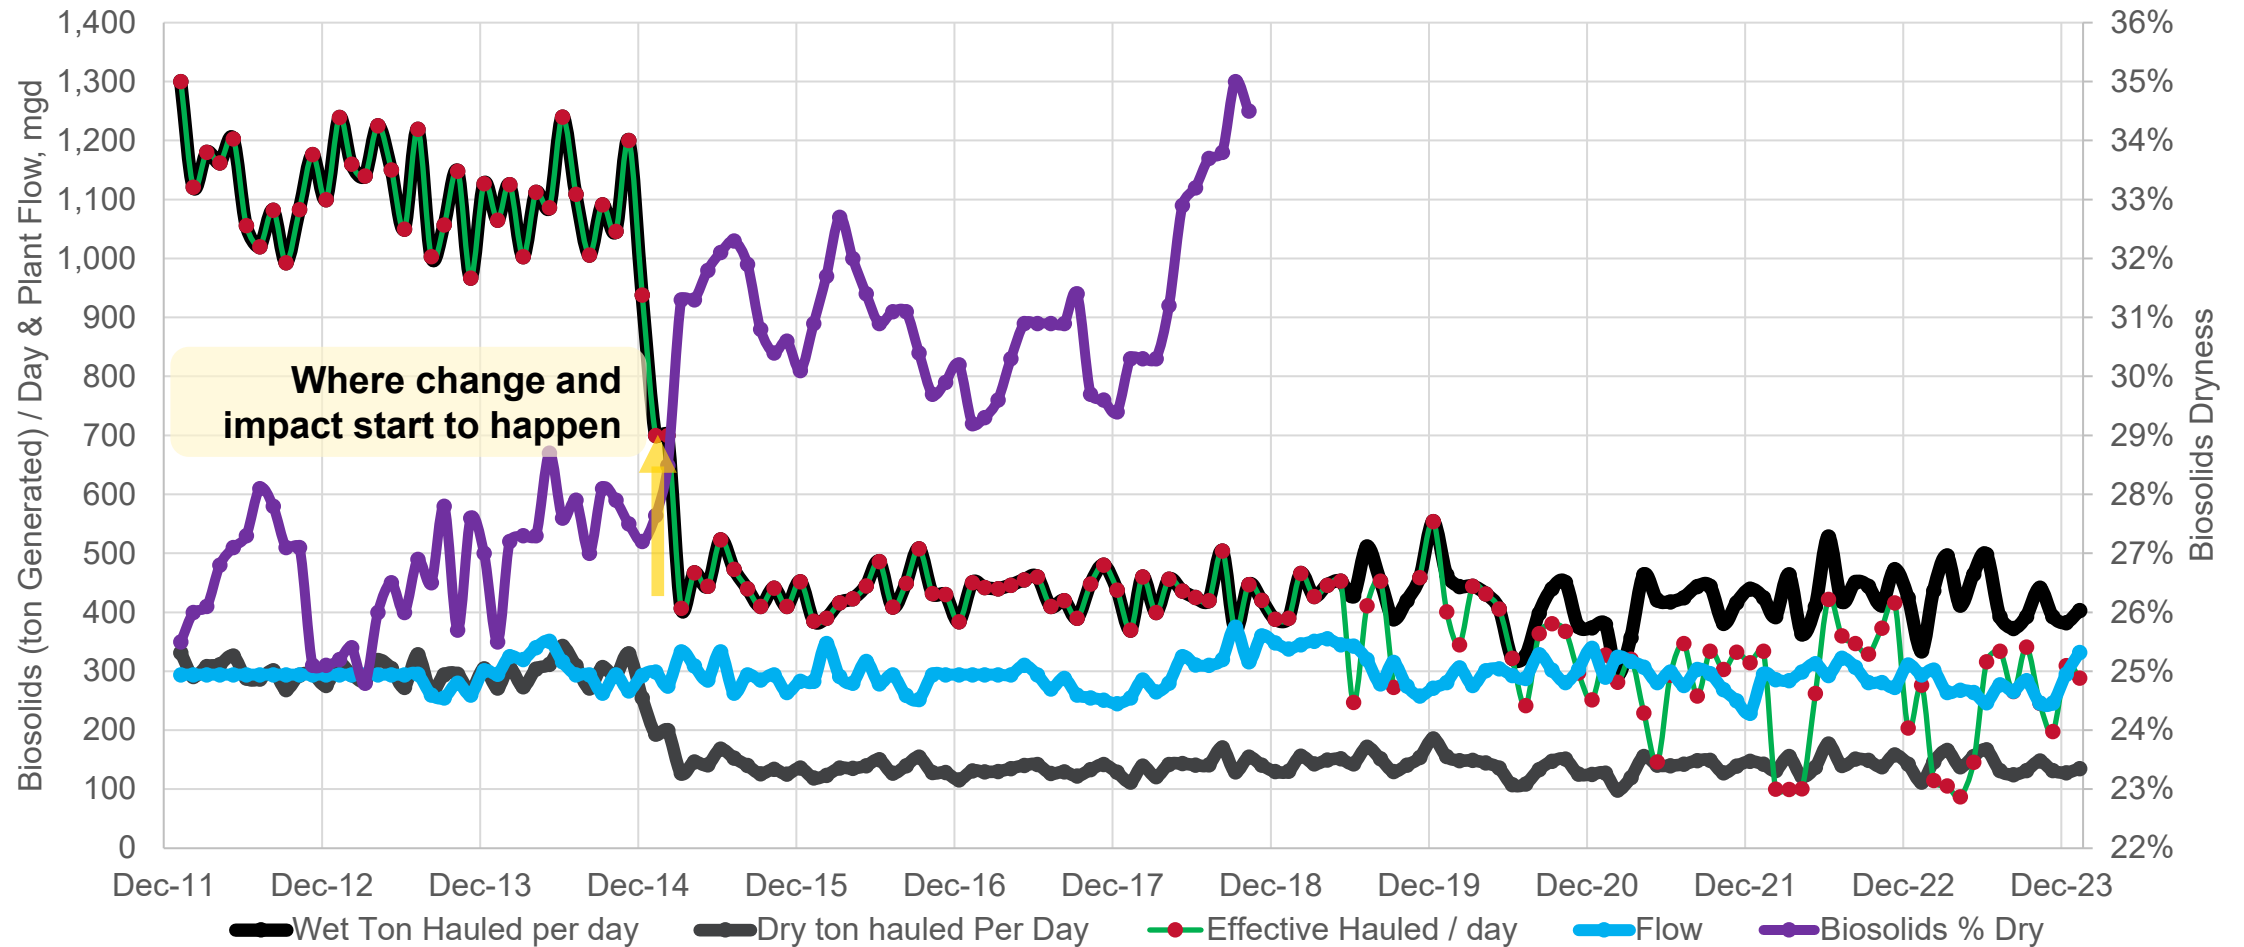
Washington, DC Blue Plains WWTP

Kiewit Engineering Group
Washington DC WASA - Blue Plains Cambi THP

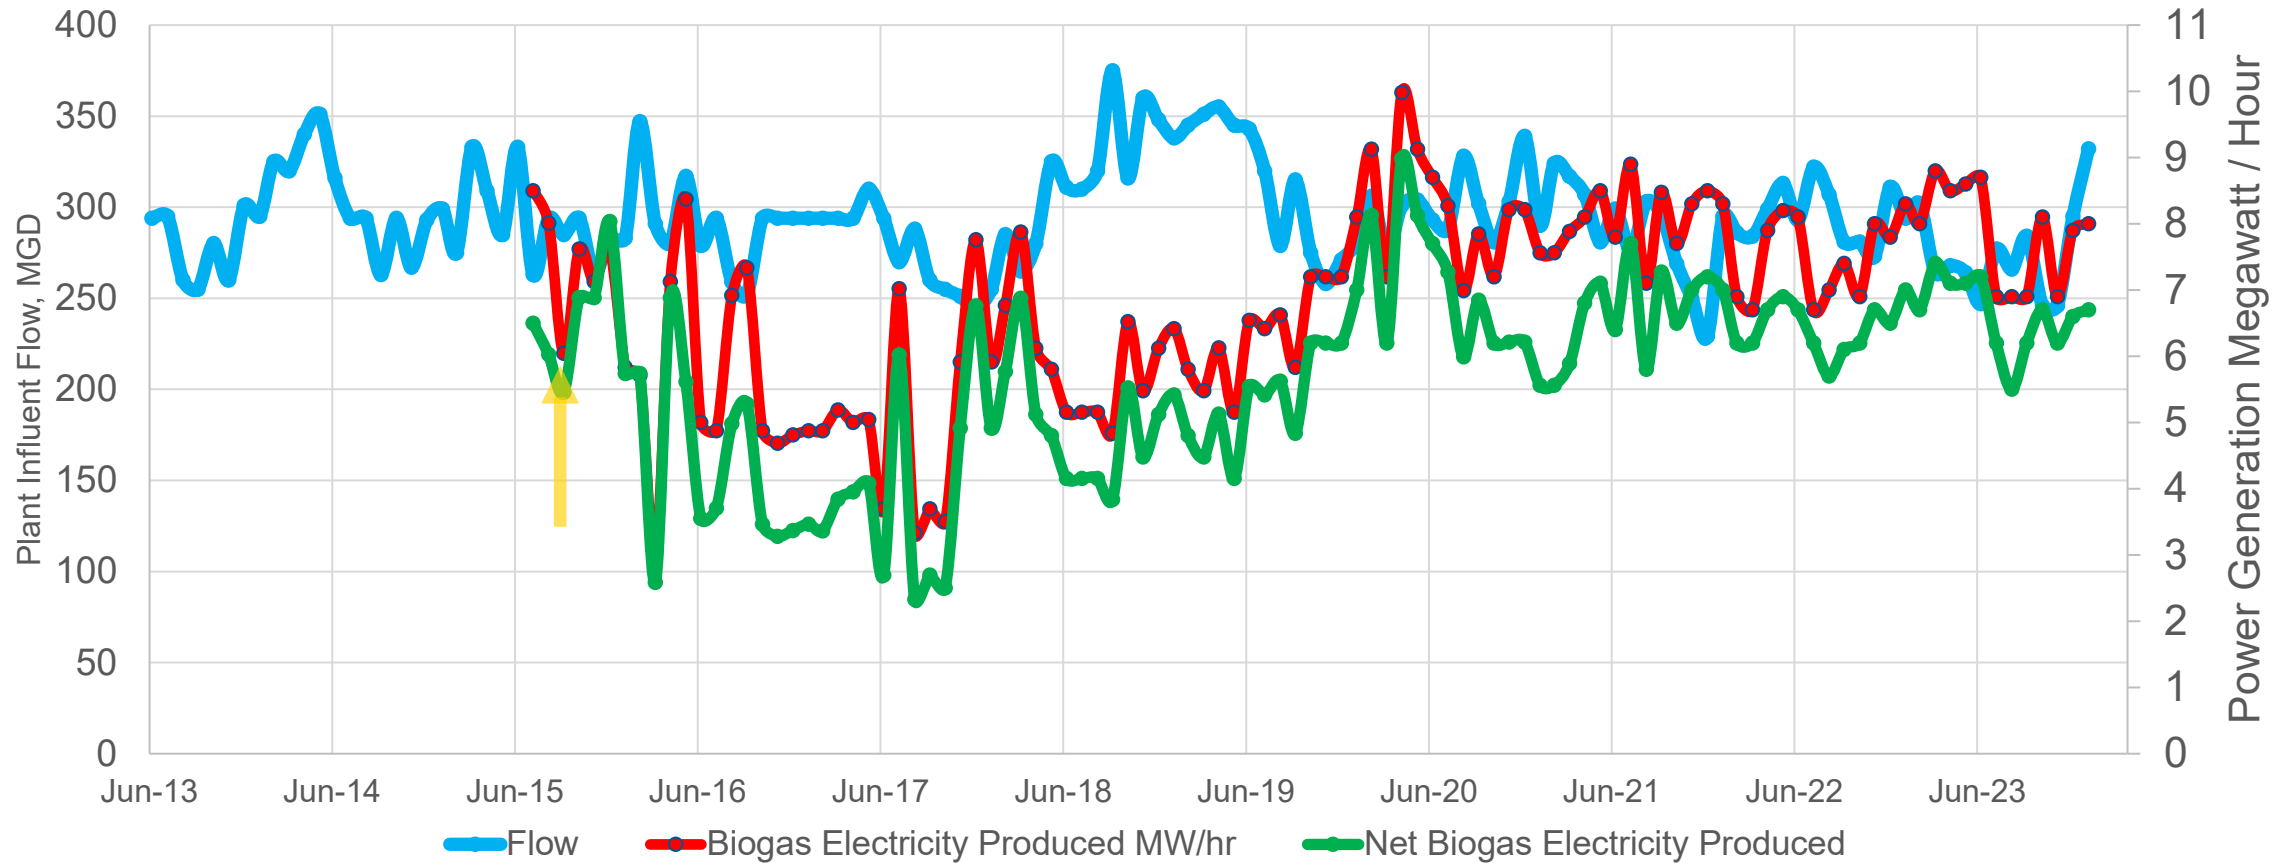
Washington, DC Blue Plains WWTP

Kiewit Engineering Group
Washington DC Water Blue Plains WWTP Effluent Flow

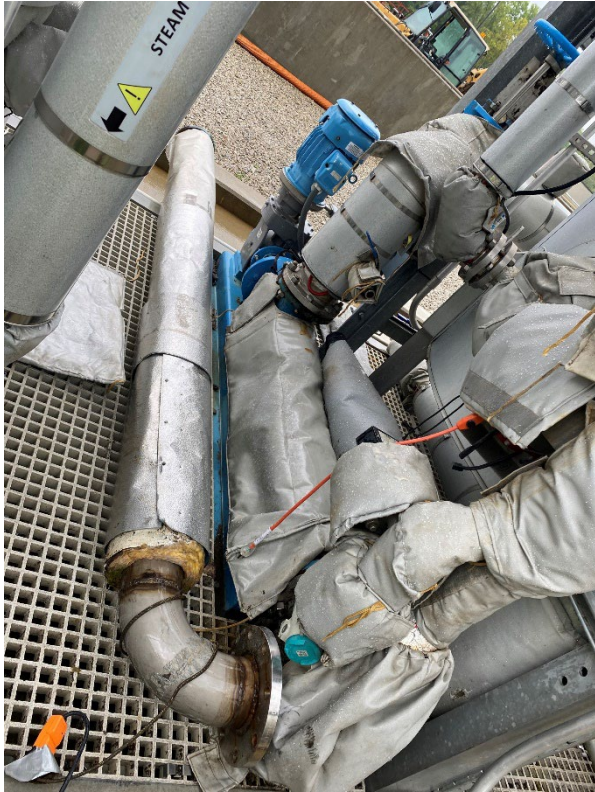
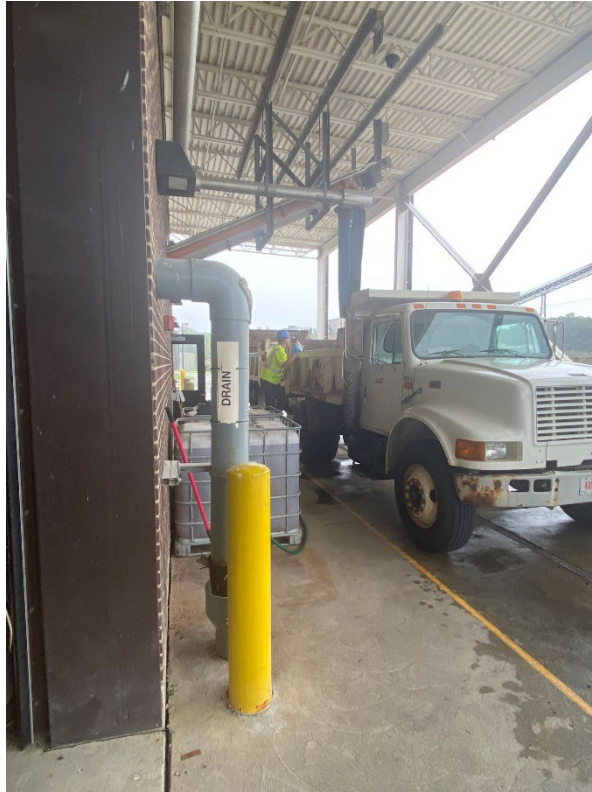
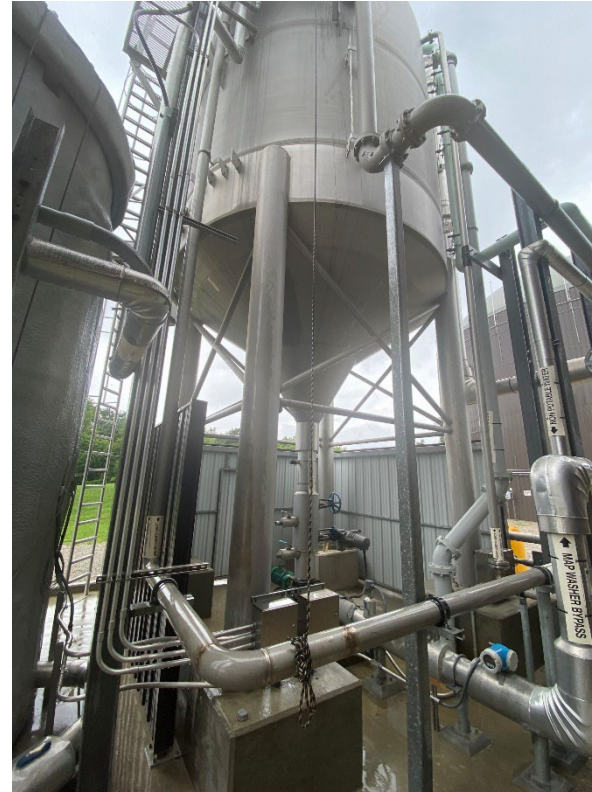
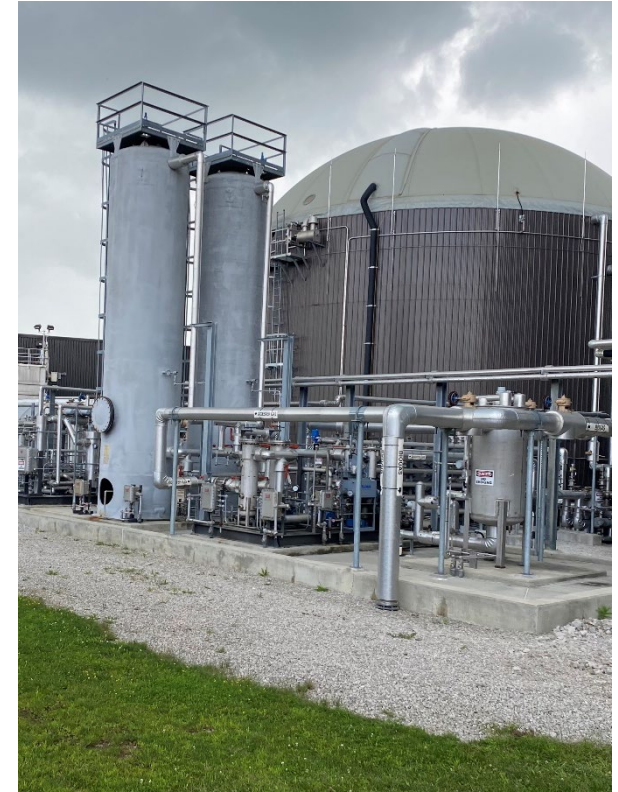
MEDINA, OH

- THP reactor was exposed to elements and froze in winter
- Poor maintenance access
- Control panels were exposed to elements and needed to install tent to block wind and rain
- Wet cake bin was exposed to elements
- Biogas engine generator had common exhaust header, so condensation formed in exhaust duct and leaked into off-duty generator, causing severe corrosion and damage
- Very tight and poor maintenance access in pre-dewatering and final dewatering building
- Frequent progressing cavity pump stator replacement

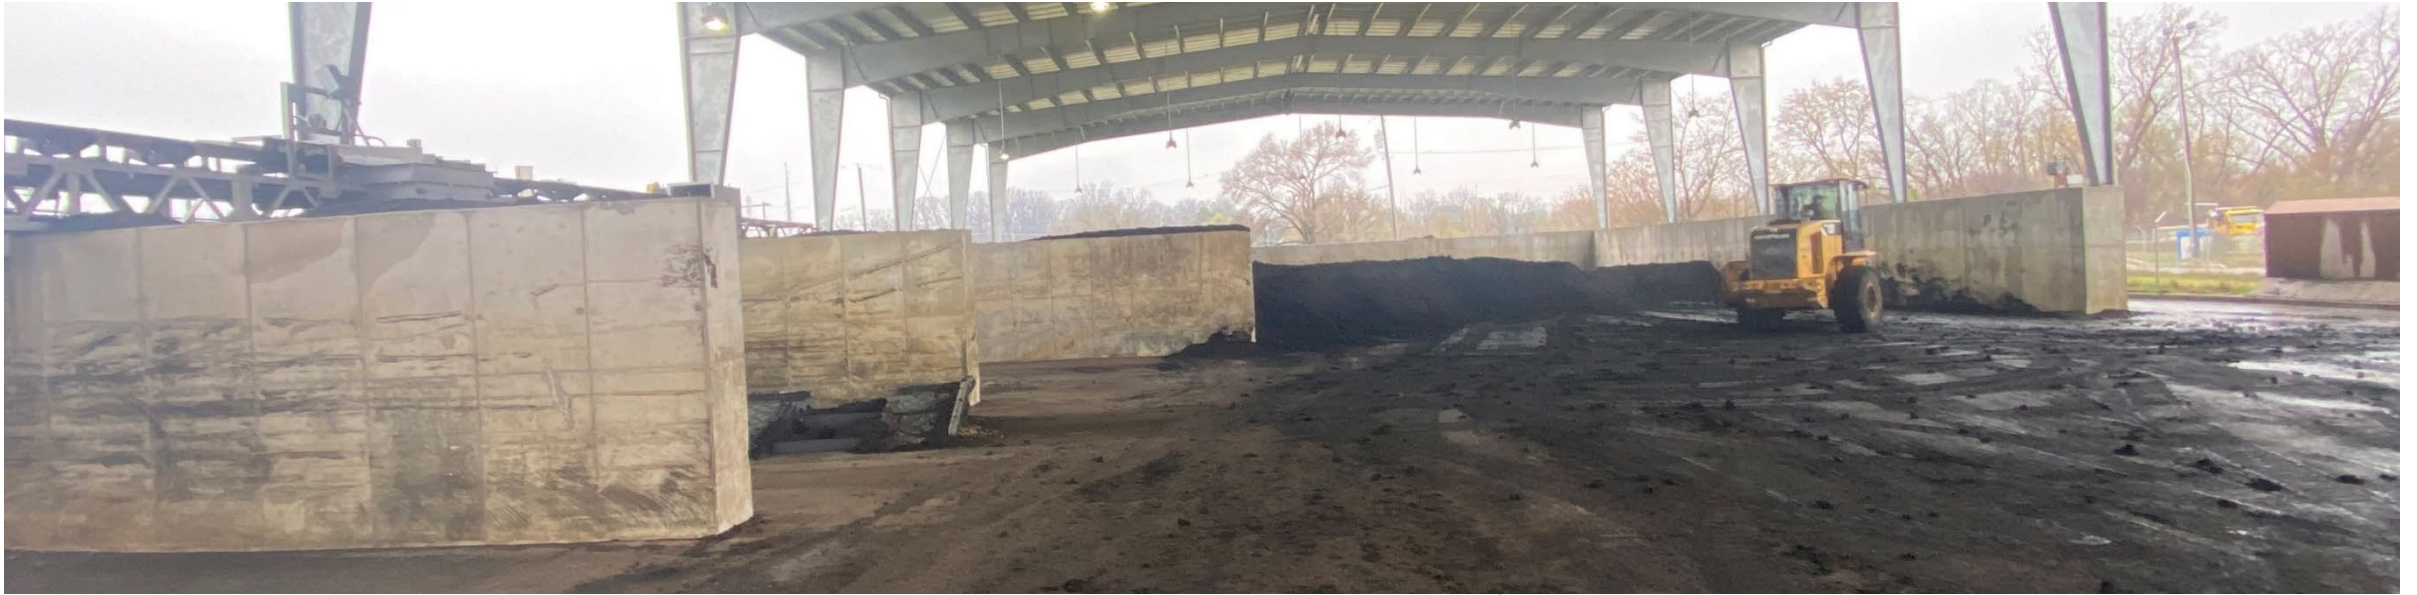
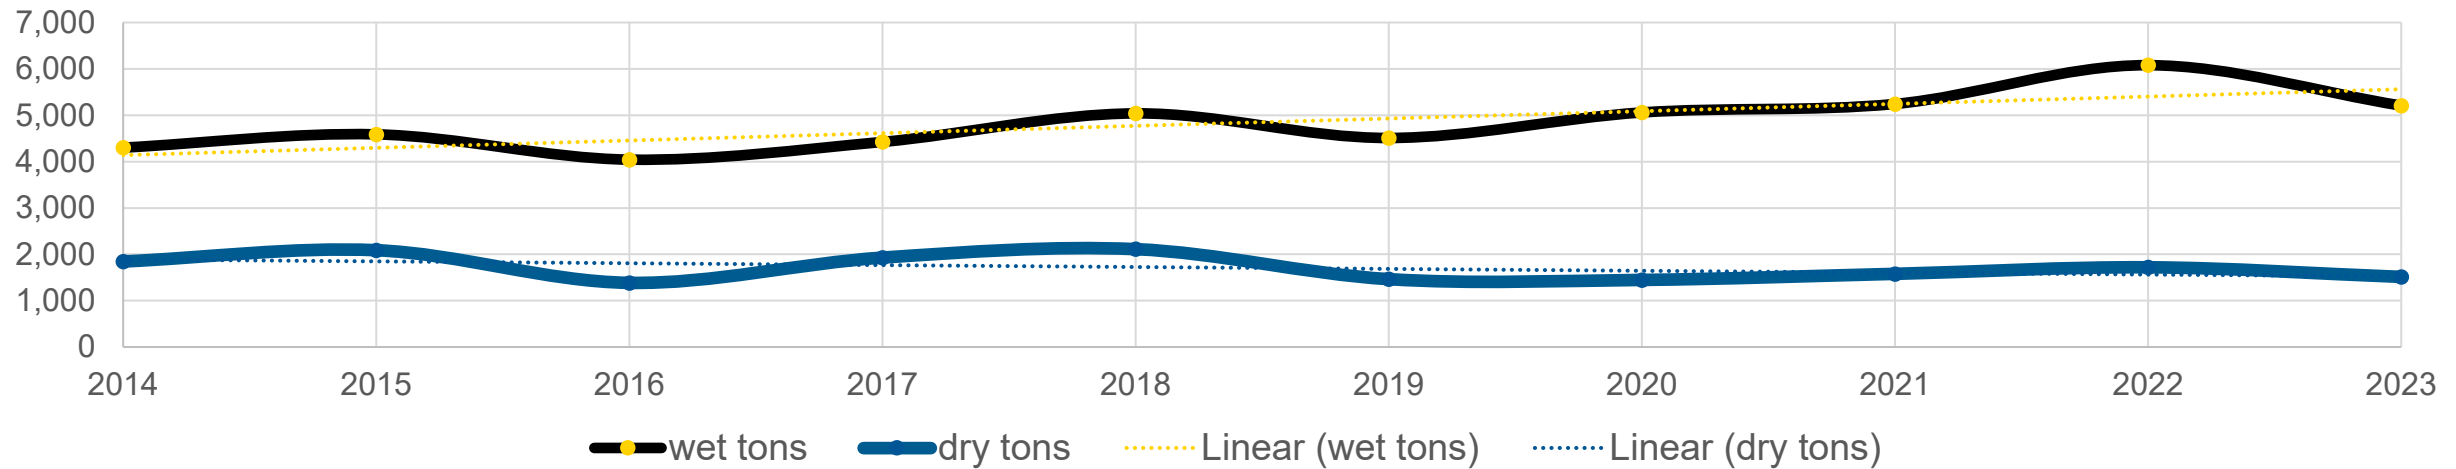
MEDINA, OH (SOLIDS TOTALS)

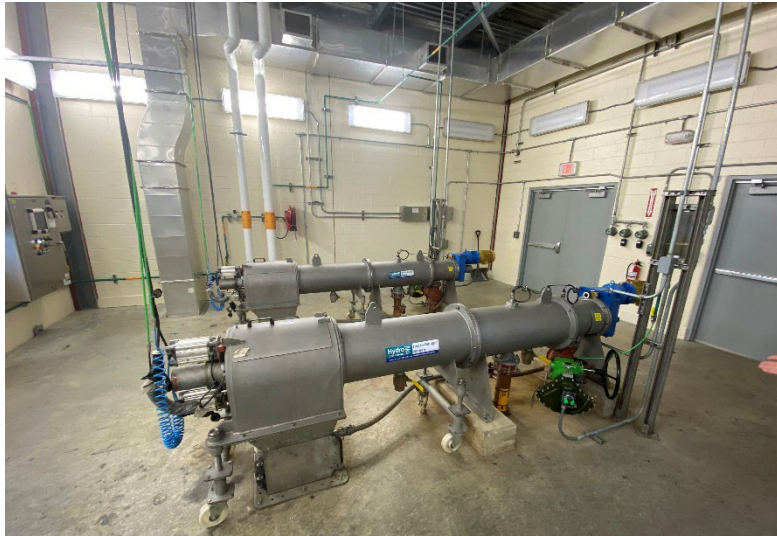
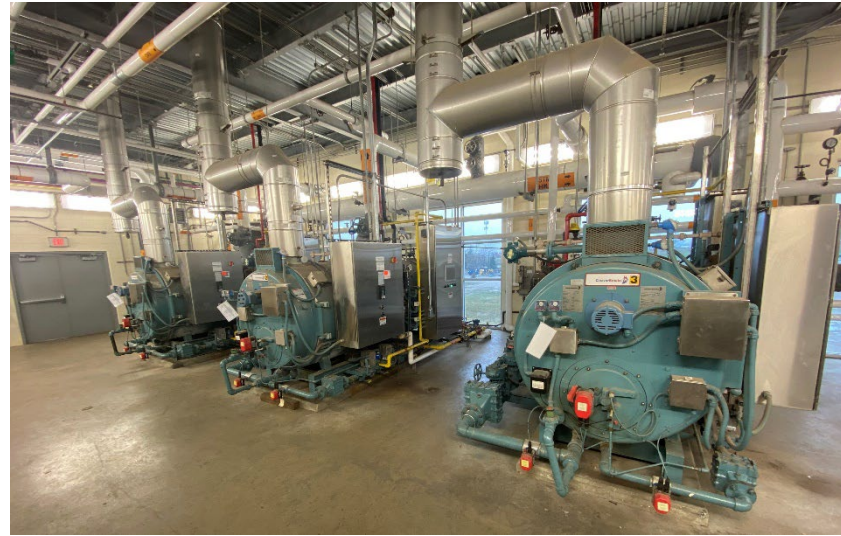
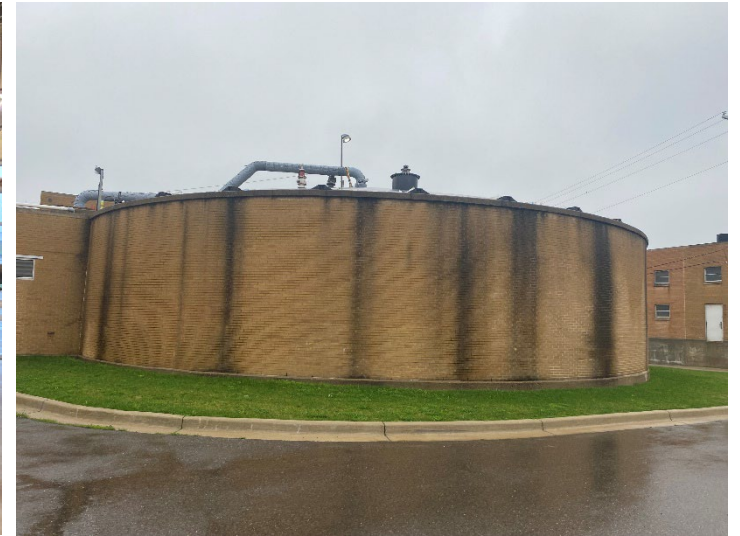
OAKLAND COUNTY (CLINTON RIVER, MI)

- No training and commissioning support provided by contracted team
- Pre-dewatering sludge blend tanks are too small
- Lacked inspection ports for THP reactors
- Air changes per hour in steam boiler room were inadequate, and the boiler room was so hot, workers could not enter to work there
- No spare capacity for pulper or flash tank provided
- Foul gas skid and biosolids belt conveyors froze in winter months
- No spare foul gas skid spare parts
- Hydrogen sulfide gas buildup below pre-dewatering equipment caused maintenance hazards and corrosion issues
- Control room was not sealed from process flows, and air conditioner units wore out constantly
- Excess polymer dose caused digester foaming
- Annual Cambi THP system shutdown caused odor issues and was expensive to haul odorous class B cake
