Striking a Balance in the North: How Edmonton Gets the Most from Its Water Transmission Main Condition Assessment Program

EWS WTM Condition Assessment Program

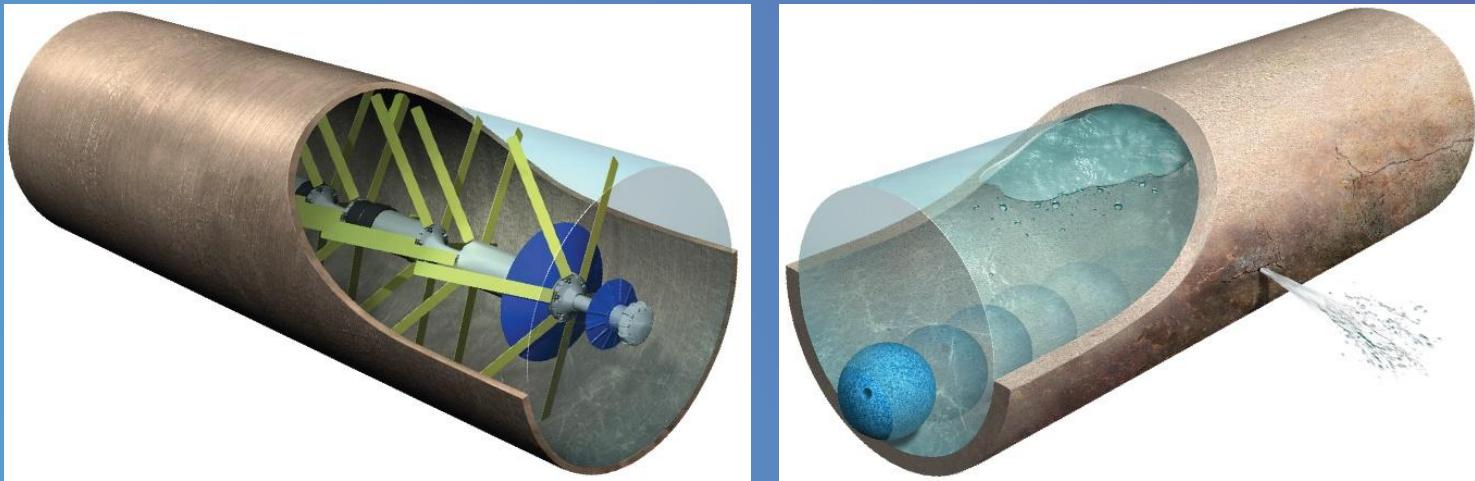
Inline Inspection tools

Inline electromagnetic (left) and acoustic (right) free-swimming inspection tools

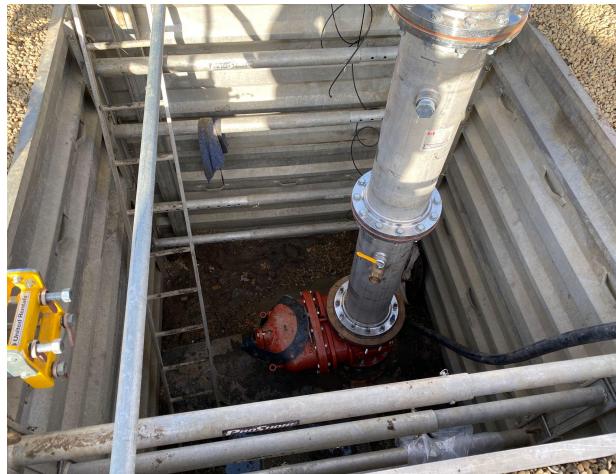
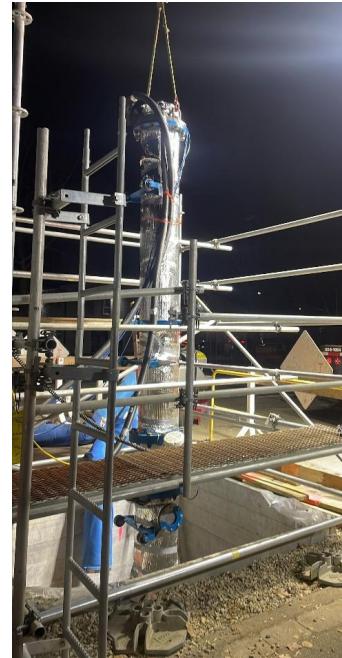
- Each year, EWS usually plans two weeks in the Spring and two weeks in the Fall to prepare and inspect its water transmission main network.
- Planning is detailed and preparation typically includes construction of new launch and retrieval points.
- EWS creates access points by wet tapping the main and installing a 400 mm (16") valve to allow for live tool launch and retrieval – no line shutdowns are required for the preparation or inspection.

Wet tap with launch tube (left) and insulated retrieval/extraction tube (right)

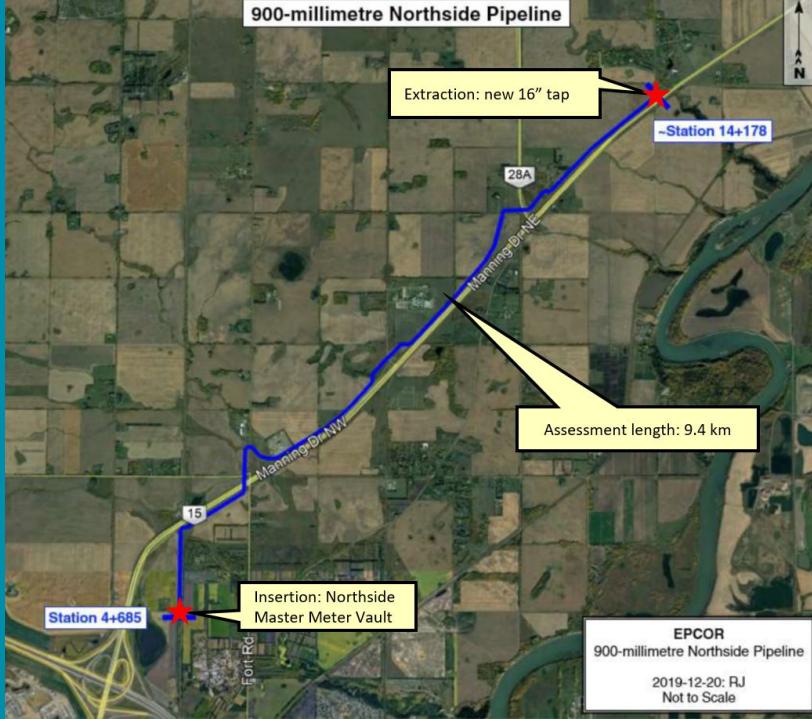
2019 Pilot Project

Pipeline	Diameter/ material	Inspection distance (meters)	No. of pipes inspected	Pressure (psi)	Pipes with broken wire wraps (BWW)	Leaks
Northside Pipeline	900mm/ C301-L	9,416	1,361	Min 47.7 Avg 57.6 Max 66.6	10	3 (1 joint, 2 barrel)

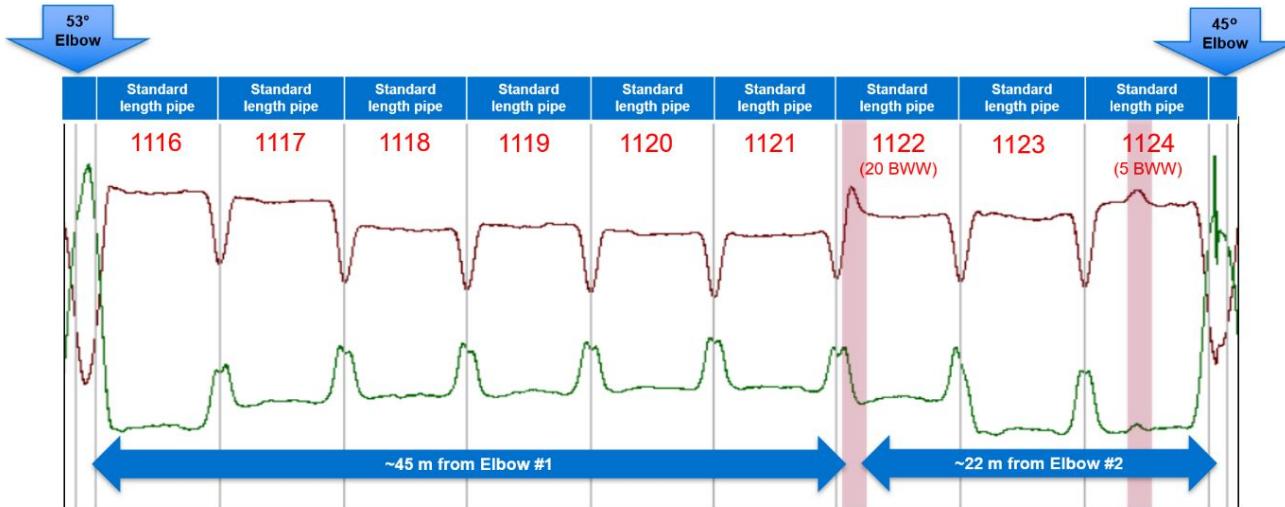
EM Inspection Data

1.

Most commonly, the mortar coating cracks, either through mishandling, accident, poor manufacturing, erosion, or just age.

2.

Water seeps in and corrodes the wires. Wires break, creating a weak spot.

3.

Internal water pressure overwhelms the concrete core. The steel gives way, and the pipe bursts.
