USING MICROBIAL SOURCE TRACKING IN AN URBAN SETTING TO AID IN THE IDENTIFICATION OF STORM/SANITARY LATERAL CROSS-CONNECTIONS.

Graham Banting and Leanne Teslak – EPCOR Water Services Inc.

National Water and Wastewater Conference – Tuesday, November 4, 2025

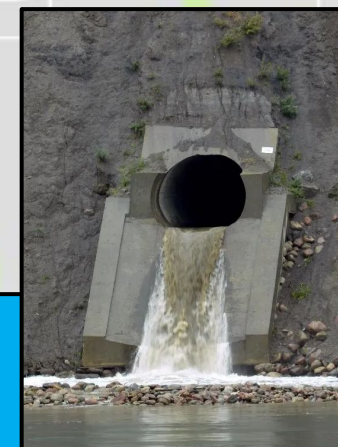
Storm sewer Outfalls

- Cross connections (Xcons) lead to loadings into river (nutrients, solids, pathogens)
- How to monitor outfalls? (*E. coli* higher at WTP#1)

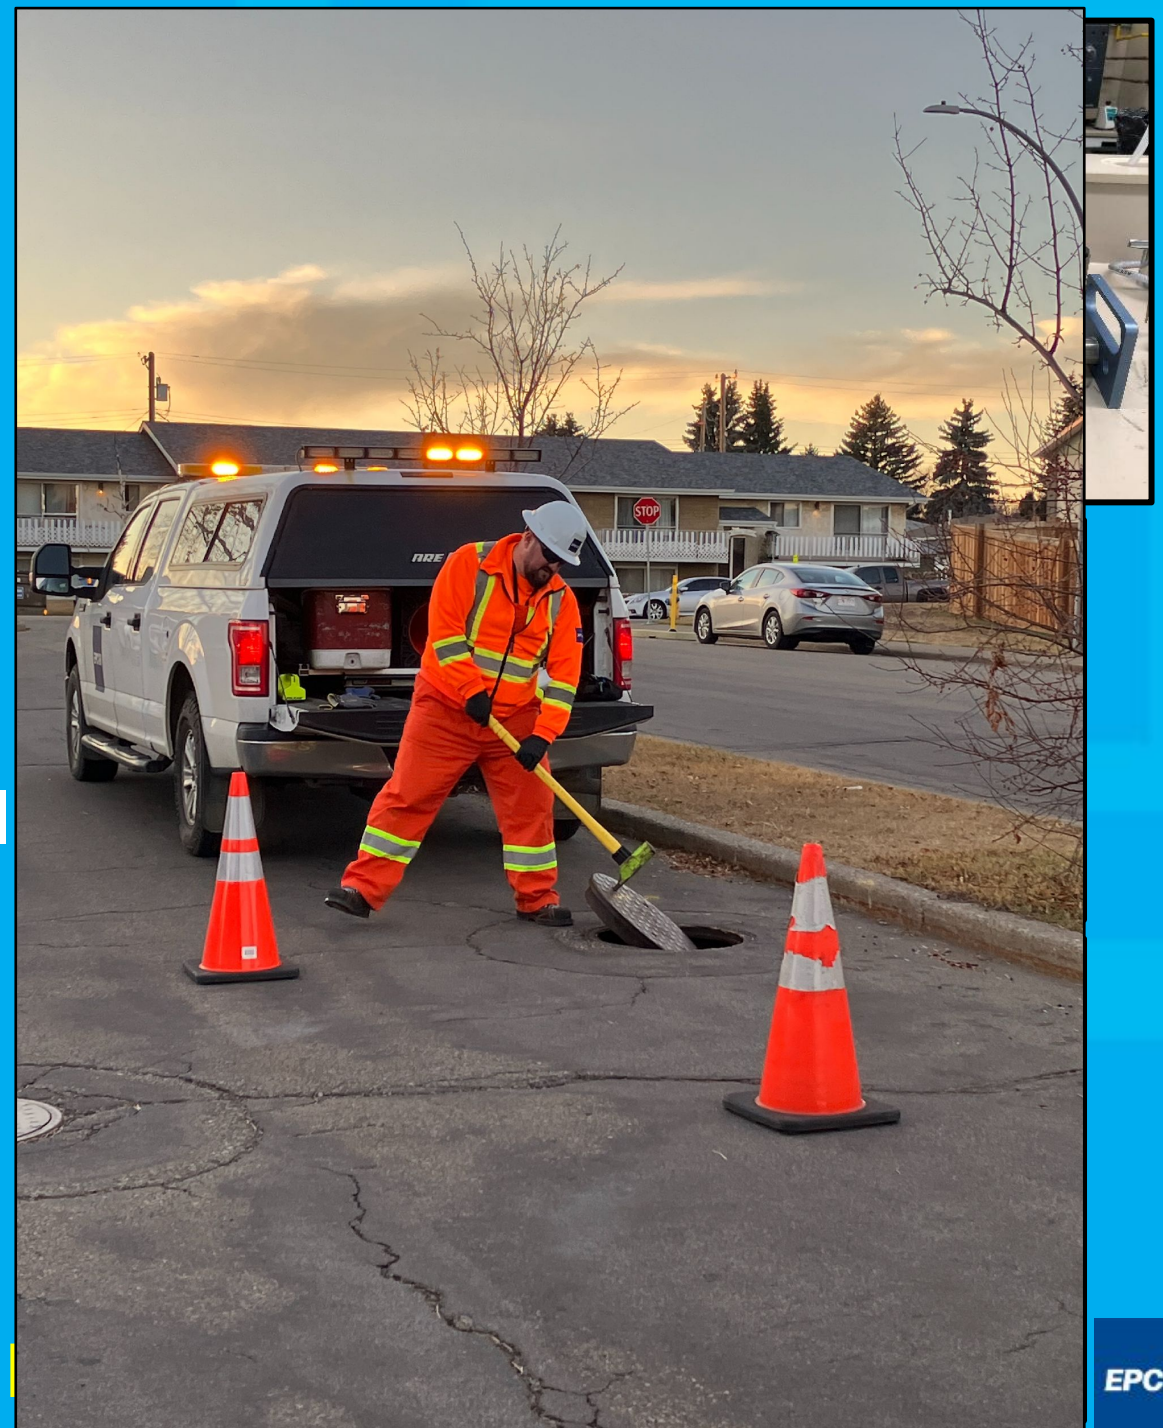
Sample Processing

- Collect stormwater sample (outfalls and manholes)
 - Transport to lab
 - Filter sample onto polycarbonate membranes
-
- Extract DNA (no purification, bead mill)
 - Perform qPCR (software quantifies)
 - Lab process takes < 6 hours
 - Can test for multiple targets on same DNA extracts
 - *We test for *Enterococcus* (general) & *E. coli**

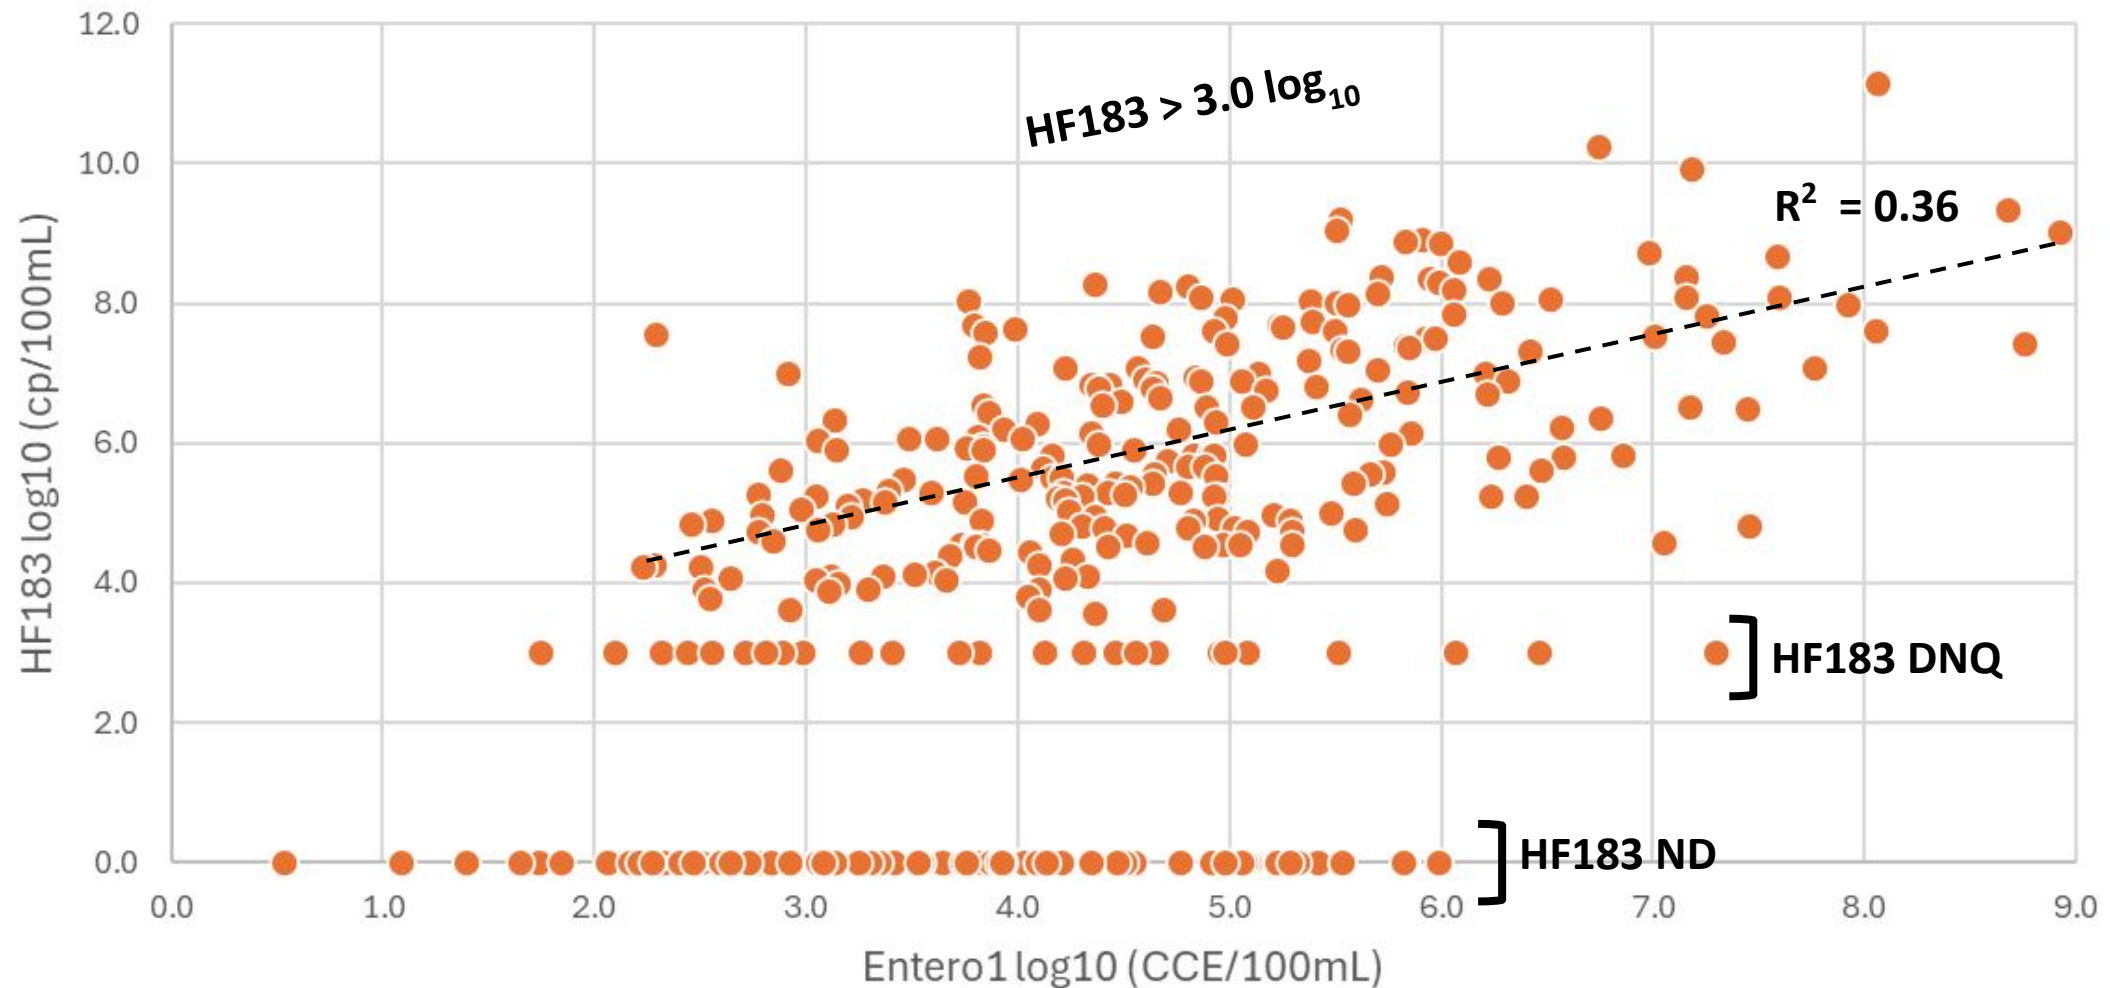
Enteroc1 vs. HF183 (2024-2025 storm water)

Enterococcus vs. HF183 in storm water

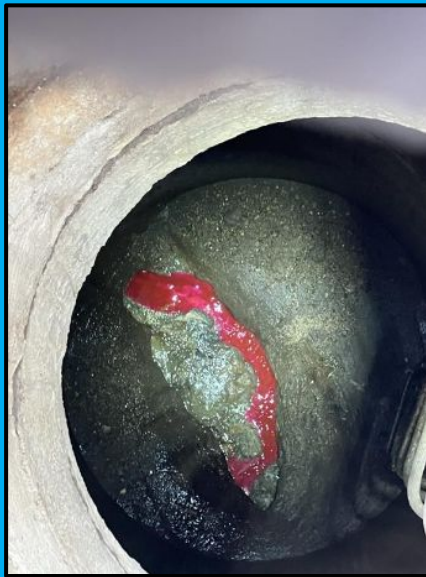
Dye Testing

- Flush environ. safe dye(s) down toilets in premise
- Monitor storm and sanitary manholes outside
- Presence of dye in the storm MH is positive confirmation of a cross connection
- On private side, owner is responsible for repair

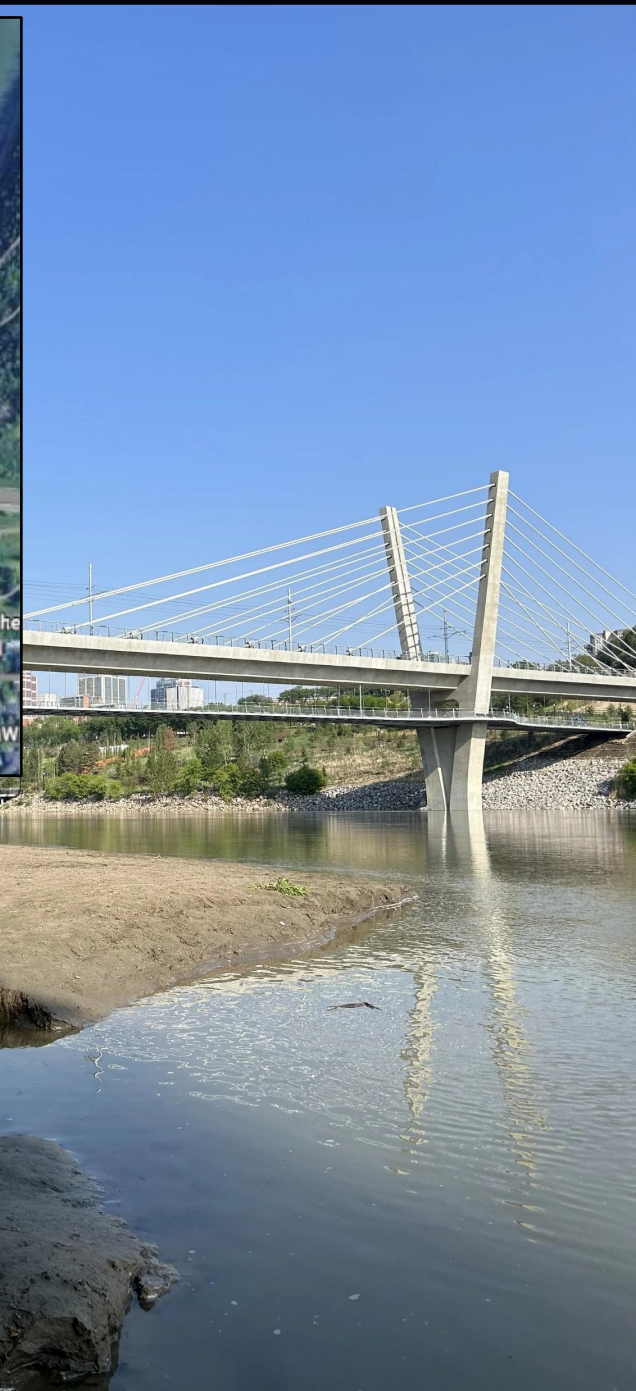
- What is 'Accidental Beach'?
- Construction of LRT bridge pilings altered river flow
- Created sand bars in the river
- Not an official recwater beach

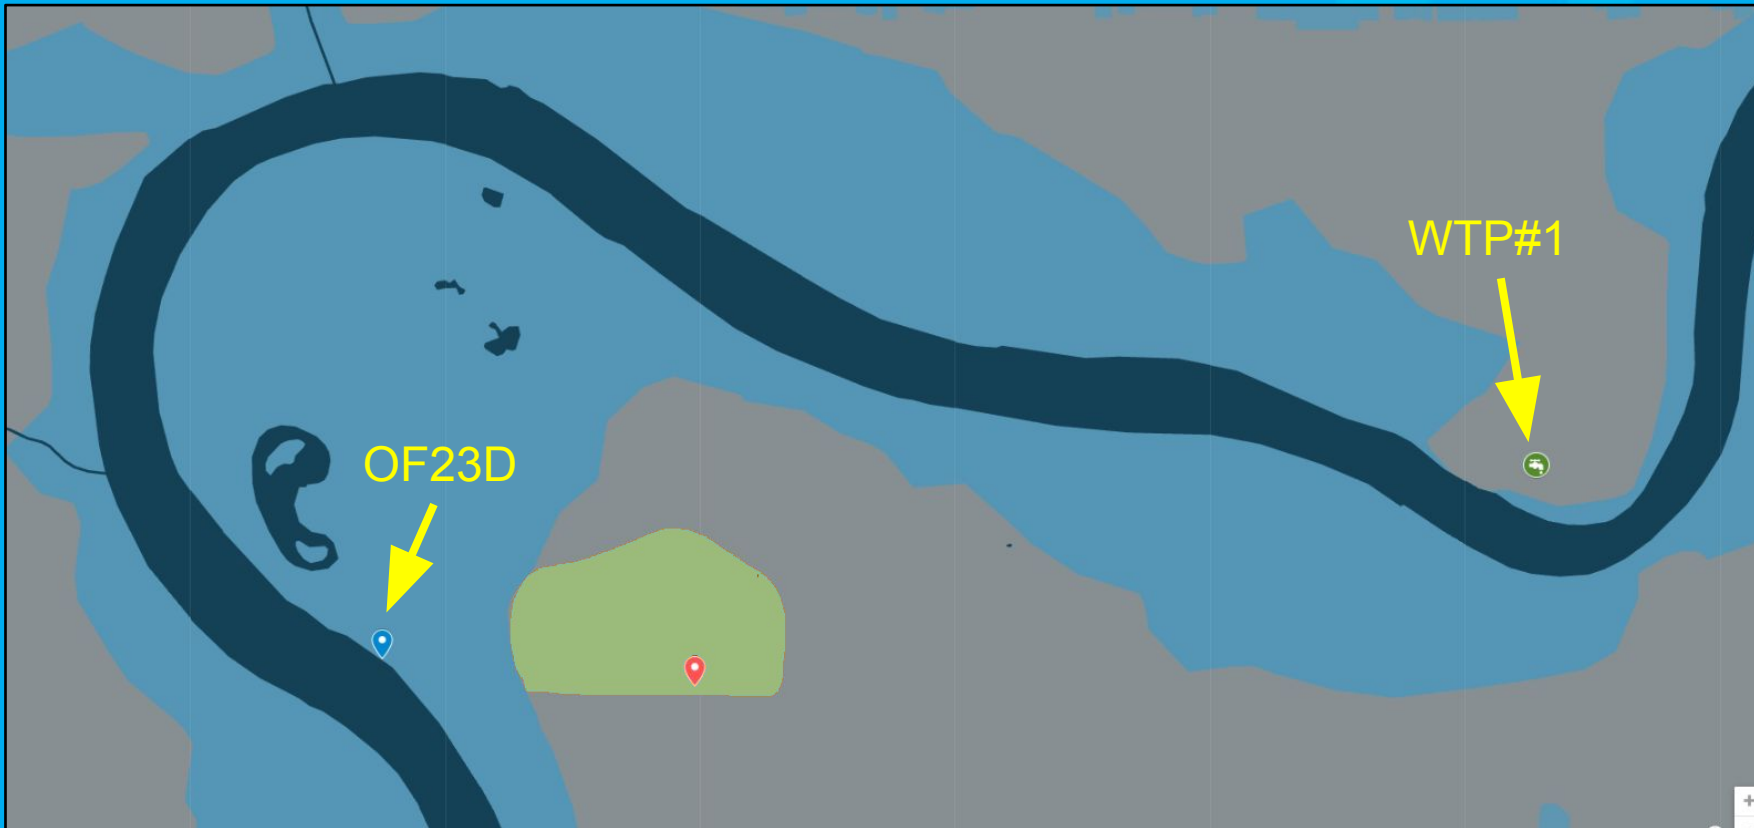
Case Study #3

- OF23D = 11 km of pipe (small)
- HF183 @ 7.8×10^6 cp/100 mL (~5% sewage)
- Xcon identified 1.1 km from outfall in 3 story condo complex

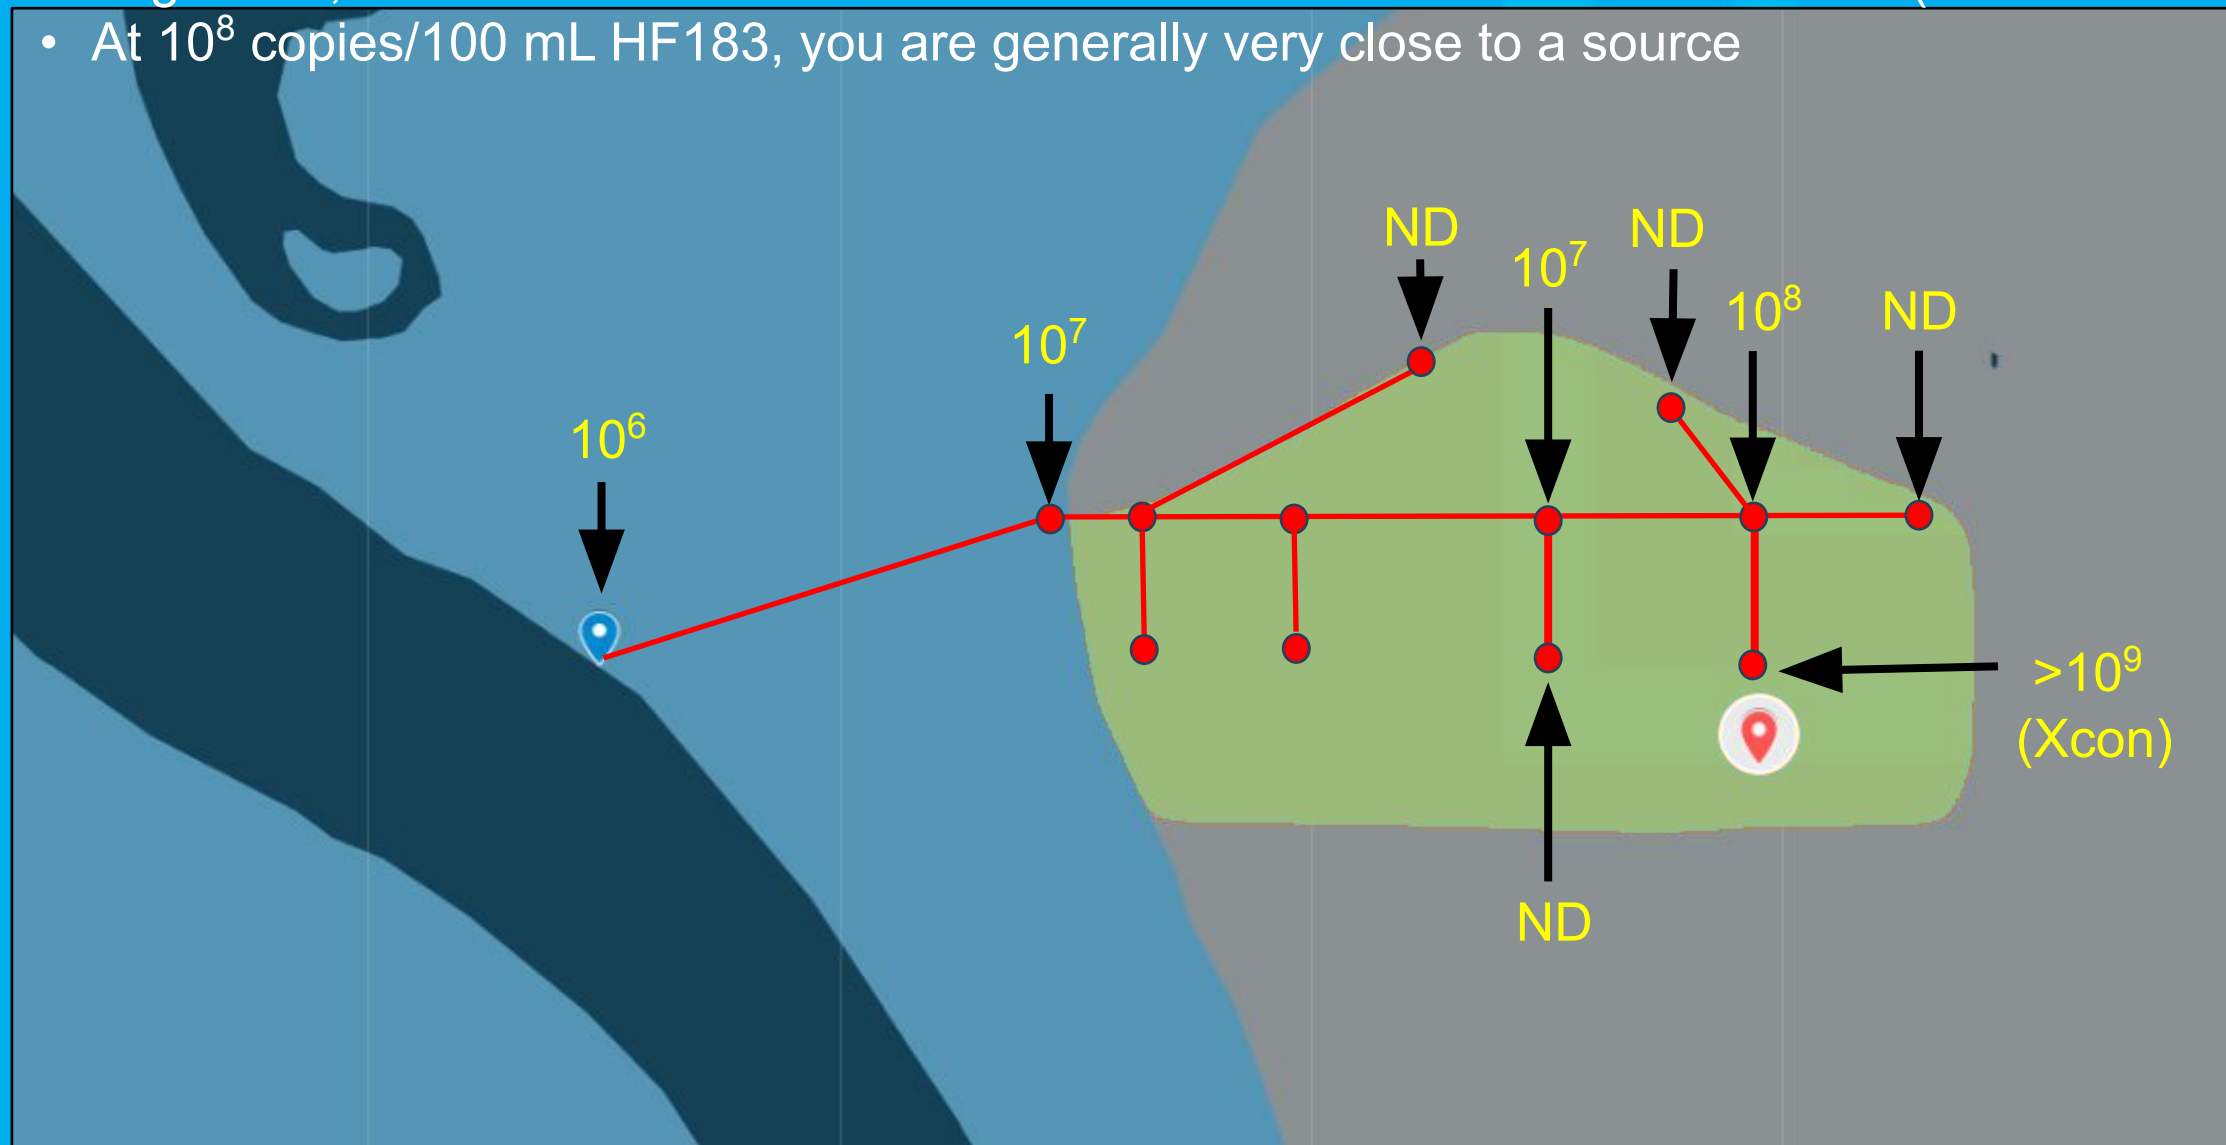
Case Study #3

- In general, we see at least 100x increase of HF183 from outfall to the source (in small networks)
- At 10^8 copies/100 mL HF183, you are generally very close to a source

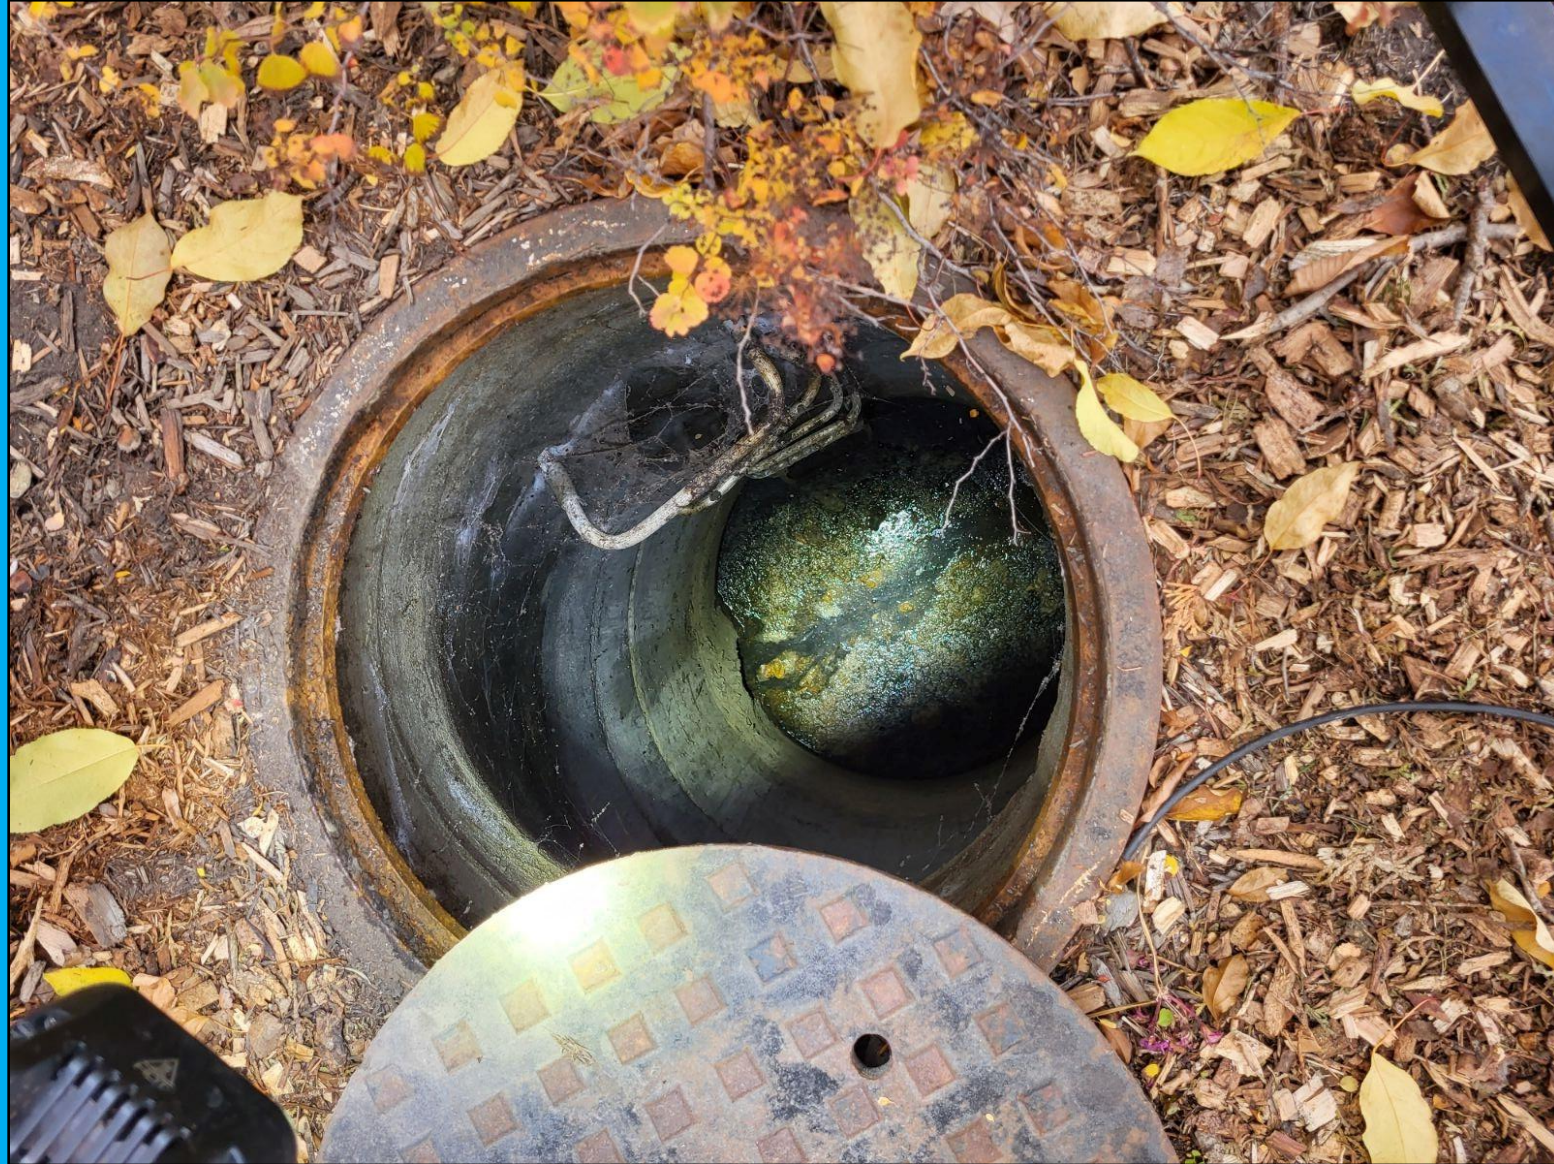
Case Study #3

- Storm MH on private side had visible sewage
- Restrictor plate kept most of the solids in MH
- Xcon in plumbing stack inside condo
- Repaired Nov, 2024
