SPEAKING NOTES ON ASBESTOS-CEMENT WATER PIPES

Revised February 2026

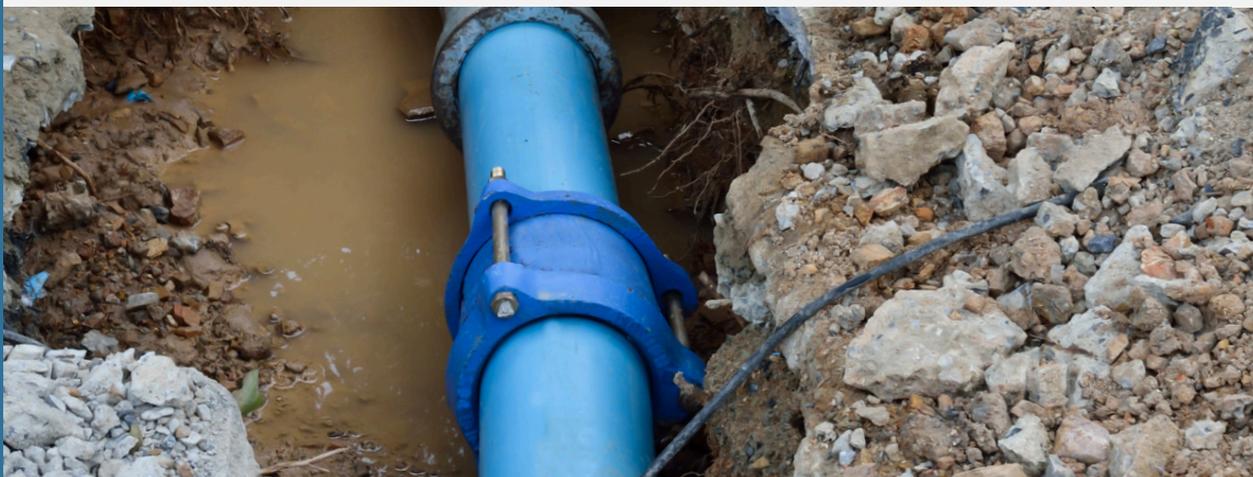
Asbestos cement (A-C) pipe was widely used by water utilities for water conveyance pipes for a brief period during the 1940's through to the 1960's due to its low cost, durability, resistance to corrosion, and lightweight nature. A-C pipe is no longer installed and has not been installed in municipal water systems for many years. While there is not an aggressive plan to seek out and remove A-C pipe, it is recommended, and is a generally accepted practice, that A-C pipe be removed and replaced during any construction that exposes such pipe.

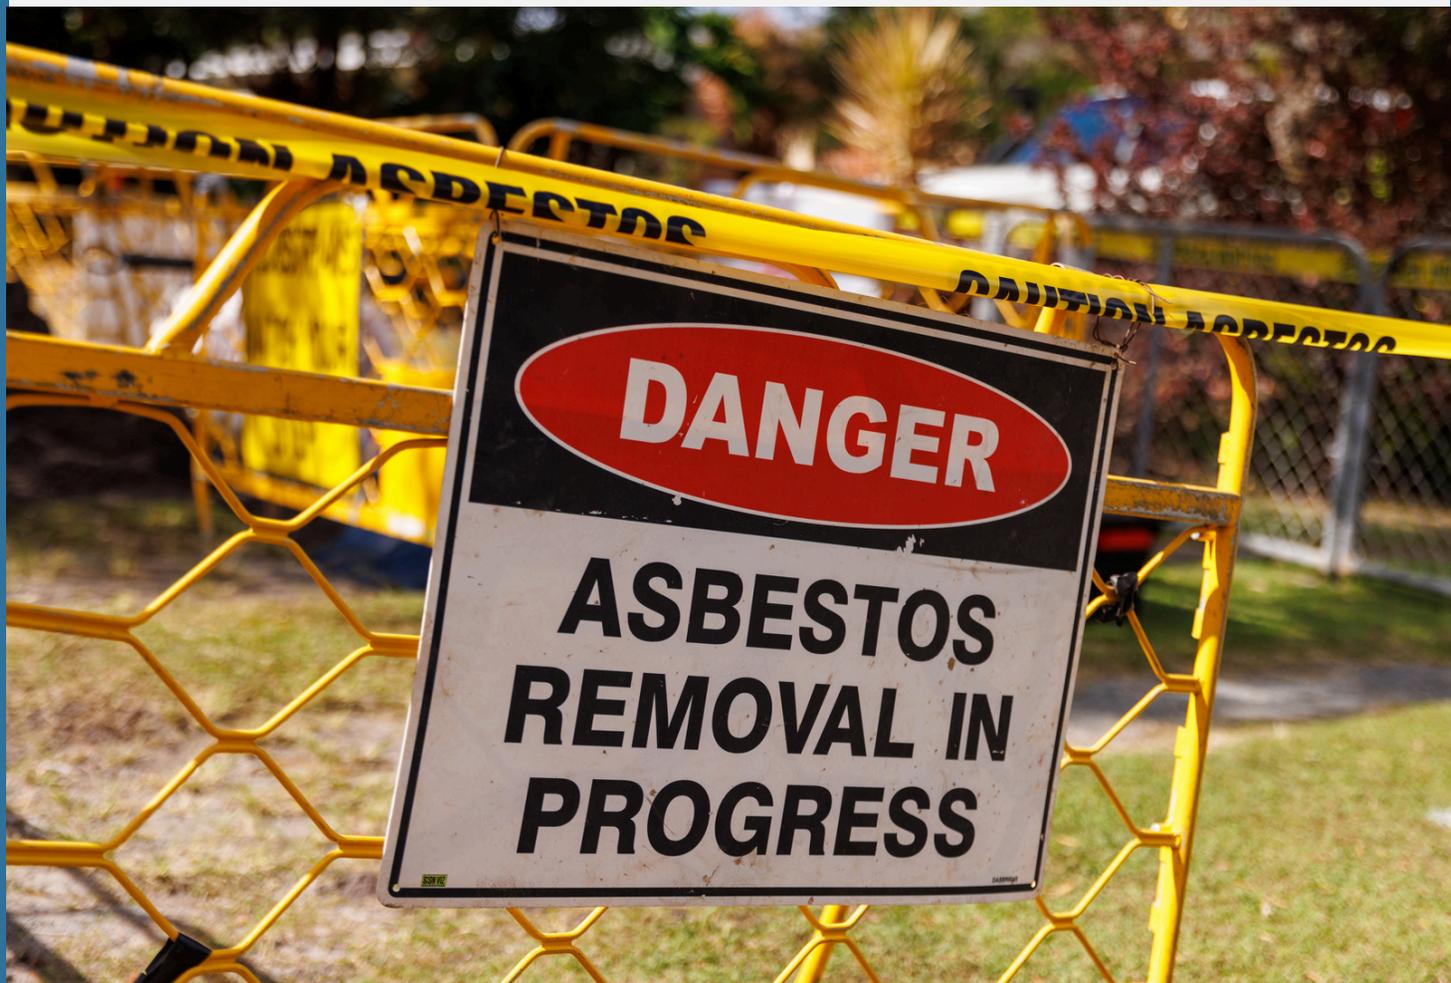
As noted, asbestos is hazardous when fibres are airborne and inhaled. This risk exists when A-C water pipe is cut during a repair or removal. As such, utilities must follow safe work practices when disturbing A-C pipe during repair and replacement works to mitigate or eliminate the release of asbestos fibres. Additionally, utility workers must wear appropriate personal protective equipment (PPE) when completing such works to minimize the risk of exposure due to the release of fibres in airborne dust. The standard practice is to only use hand tools for A-C pipe cutting and keep surfaces wet while repair is in progress to reduce the release of fibres and, in turn, potential exposure to fibres.

- Hand-cutting of the pipe with constant watering of the cut site
 - Damming of the cut site to capture any fibres from the cut
 - Flushing, disinfection and testing in accordance with AWWA Standard C651.
