RESERVOIR MANAGEMENT USING ADENOSINE TRIPHOSPHATE (ATP)

**Graham Banting¹, Michael McCracken²,
Rasha Maal-Bared¹**

¹ Quality Assurance and Environment, EWSI

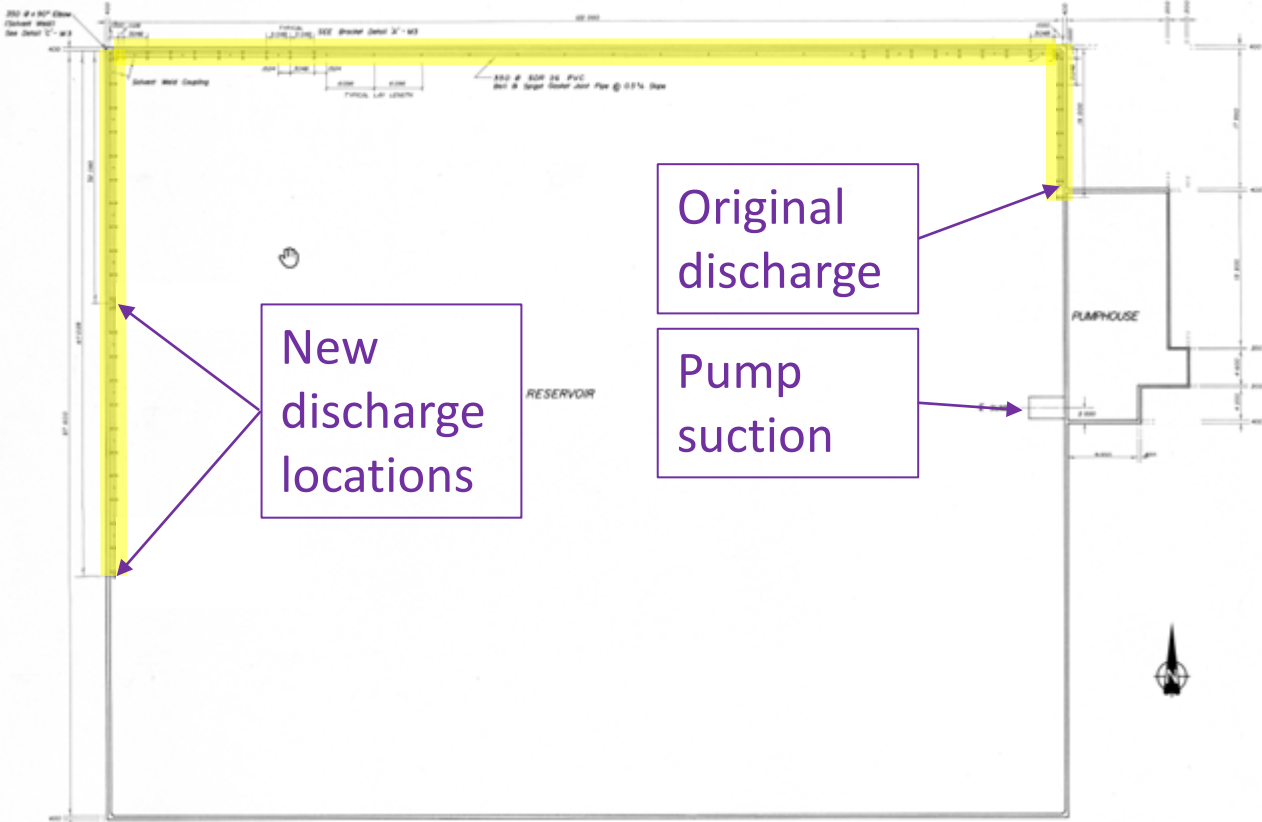
In 1987, the fill line was extended to the back side of the reservoir.

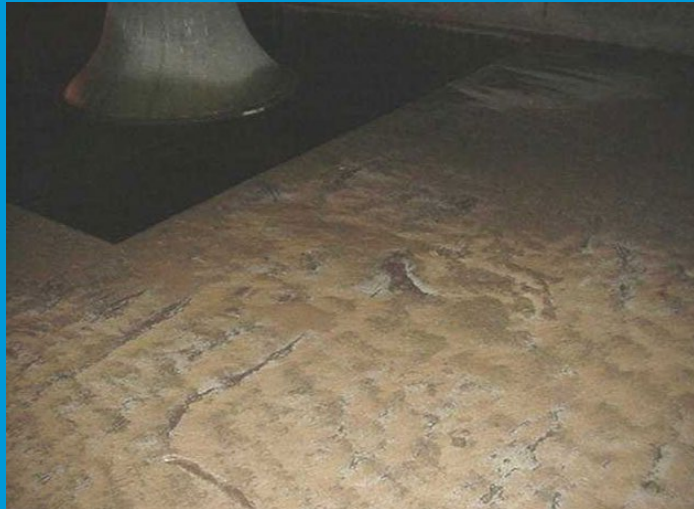
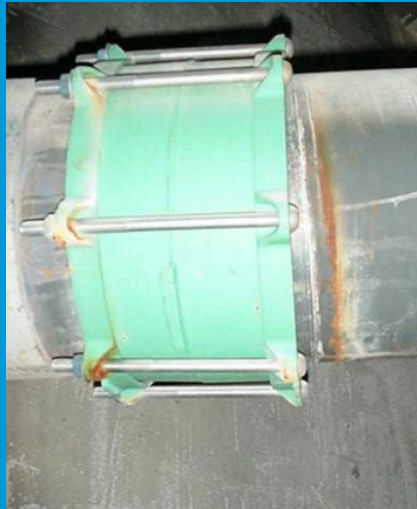
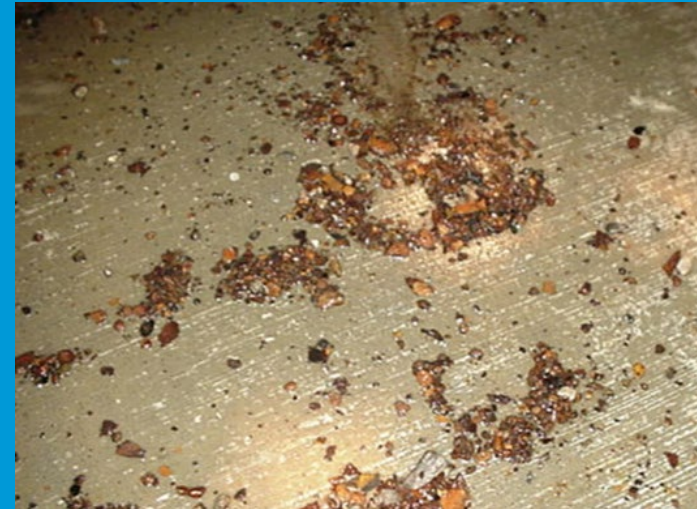
Inspection in 2002 - no notes, only photos:

- Typical sludge deposition
- Some movement on fill line noted
- Some debris from fill line in Reservoir

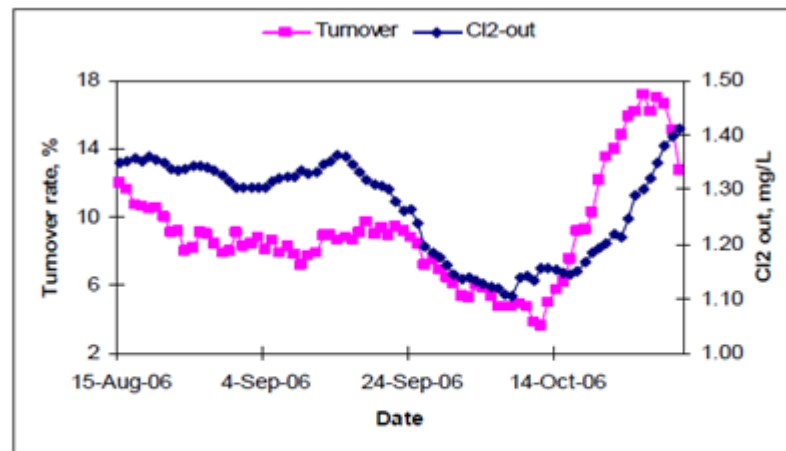
Figure 2 Daily Turn Over Rate and Total Chlorine Residual (out) Variation with Time (14 Days Moving Average)

In 2007, correlations between reservoir chlorine out readings and a variety of parameters were examined. Increases in turnover rate were the practical outcome.

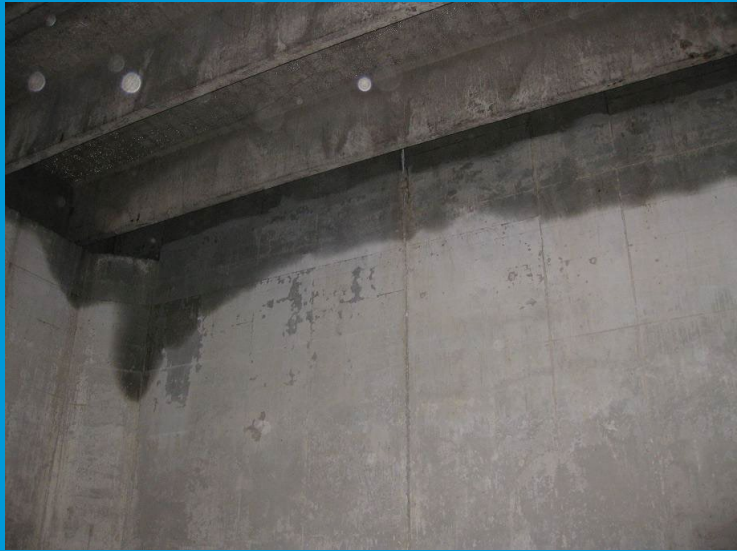
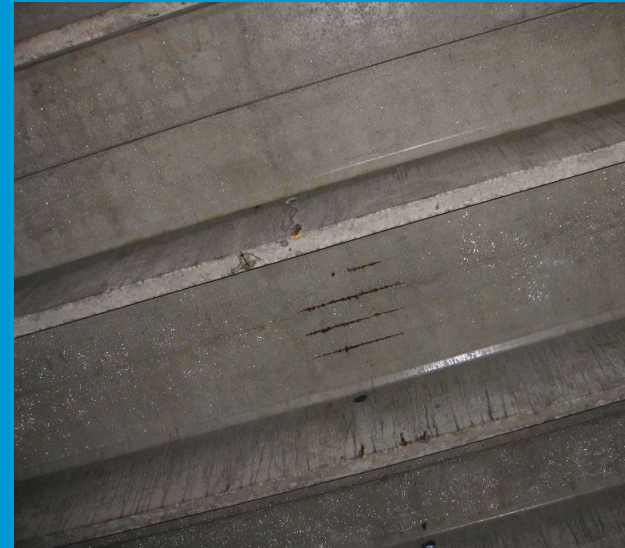
2009 Inspection

- Edge Leakage Noted
- Concerns with construction quality of the precast roof noted

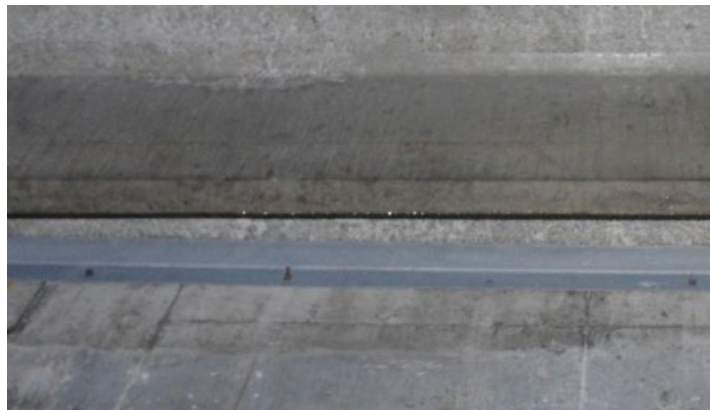
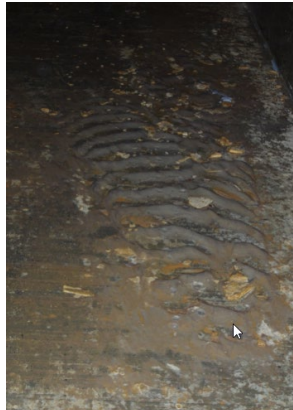
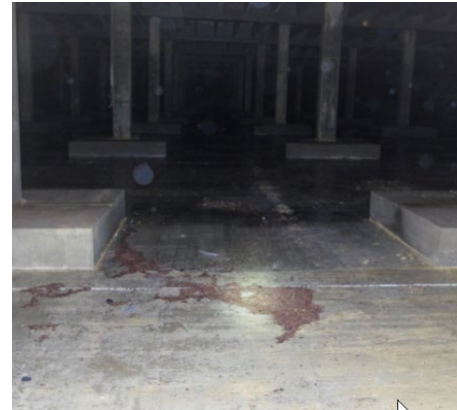
2020 pre-clean inspection

- Active ingress noted
- Water impoundment on top of reservoir noted
- Samples collected of sludge ingress for ATP measurement
- Sediment found at worst ingress point

Summary of ATP results for pre-clean inspection of reservoir:

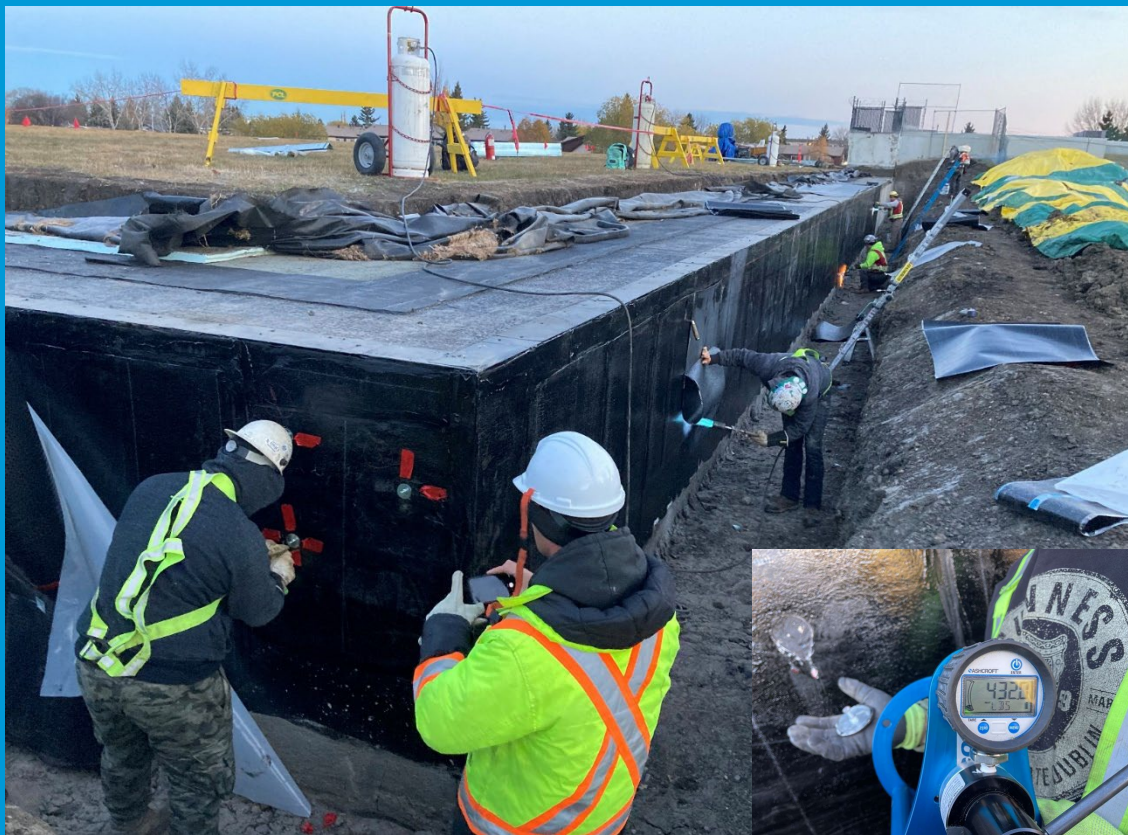
September 2021

- Edge repair of roof membrane
- Membrane extended beyond beam pockets
- Pull testing of membrane to confirm bond strength

April 2022

- Reservoir returned to service
