Beavers, Birdwatchers And A Critical Wastewater Forcemain Can Coexist!

Metro Vancouver – Liquid Waste Services

Sperling Avenue Forcemain

Summary: Sperling Avenue Forcemain Condition Assessment Project

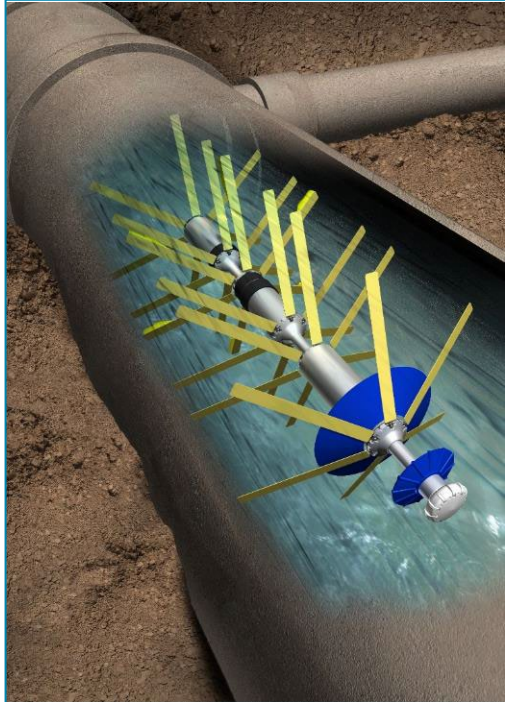
Validated Pipe Defect

PIPEDIVER INSPECTION
1 defect (approx. 3.5 in x
3.5 in) with 45% wall loss

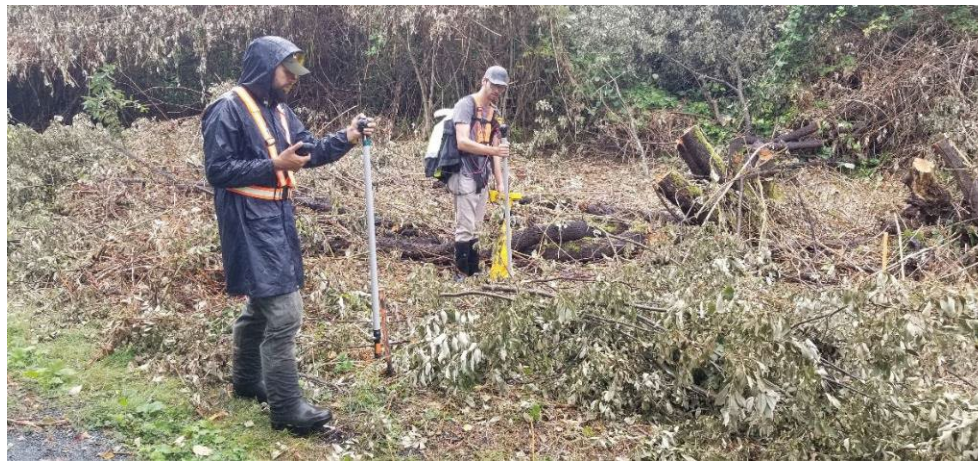
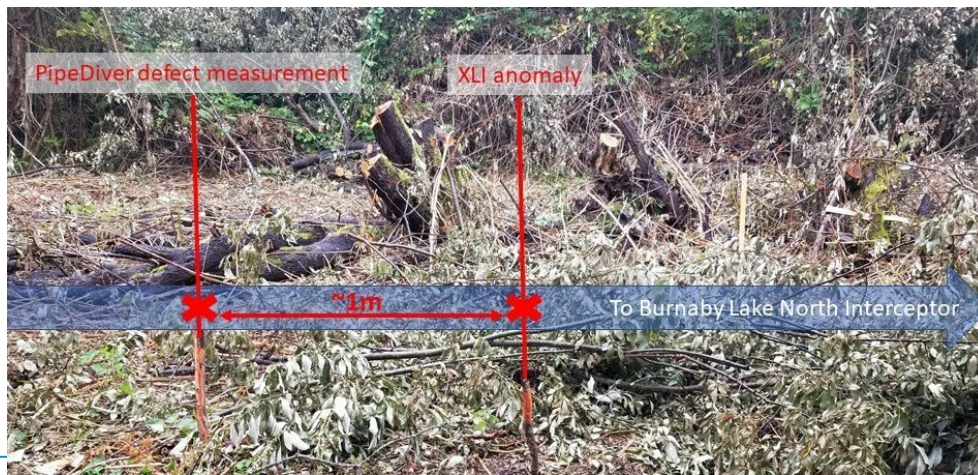
Sperling Avenue Forcemain – Above-ground Inspection (XLI)

SPECTRUM XLI INSPECTION
Detected a large coating
defect near PipeDiver wall
loss and 1 additional
coating defect
