Looking back at Calgary's 1950mm (78") PCCP Feeder Main Failure

November 3, 2025

Presented by:
Justin Hebner
Pure Technologies Ltd., a Xylem brand

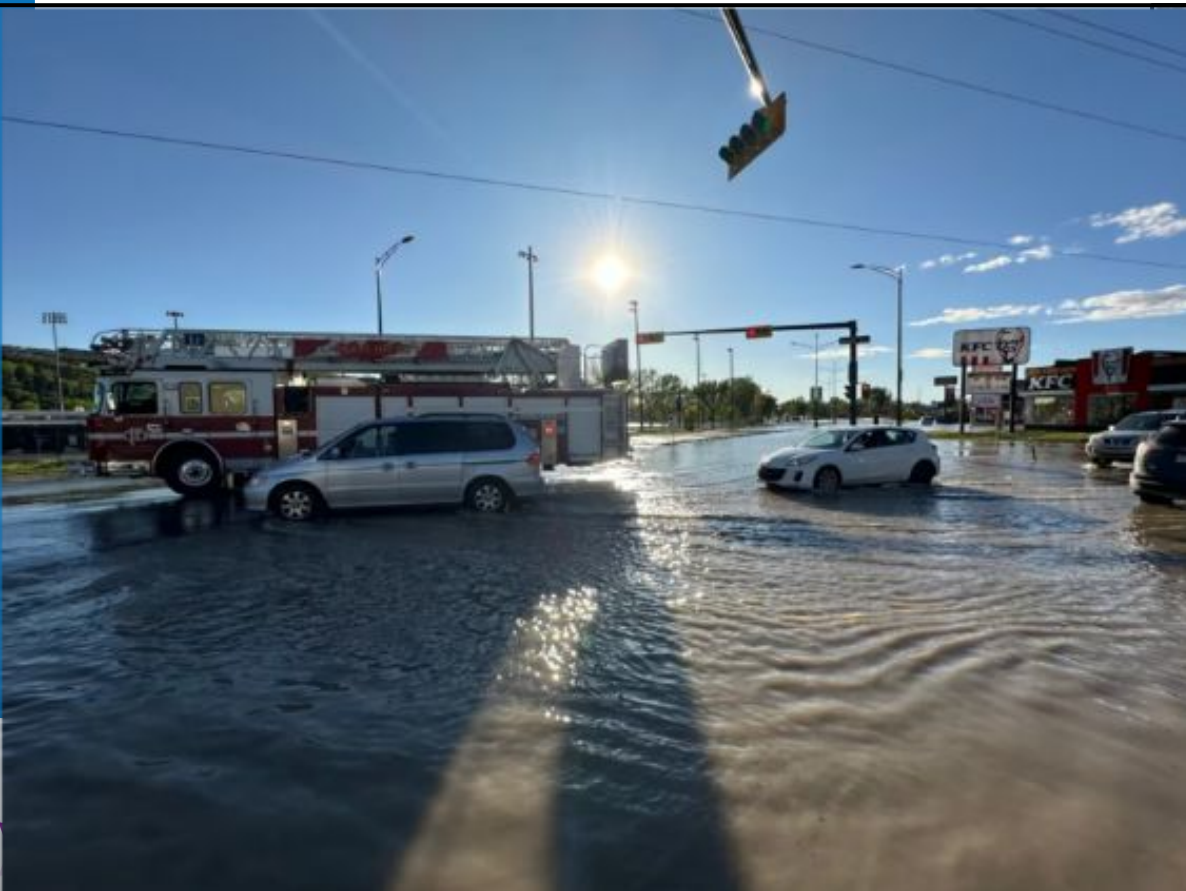
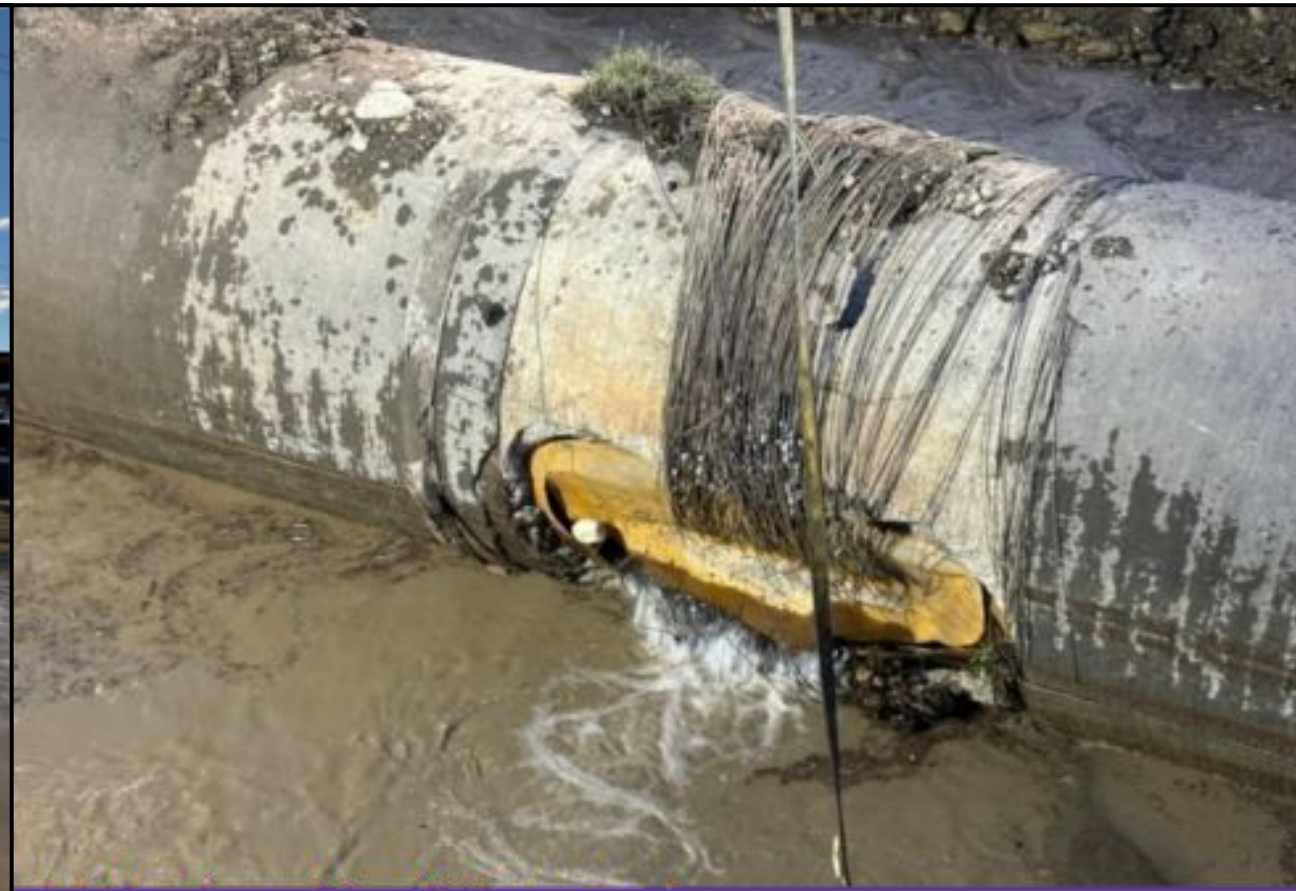
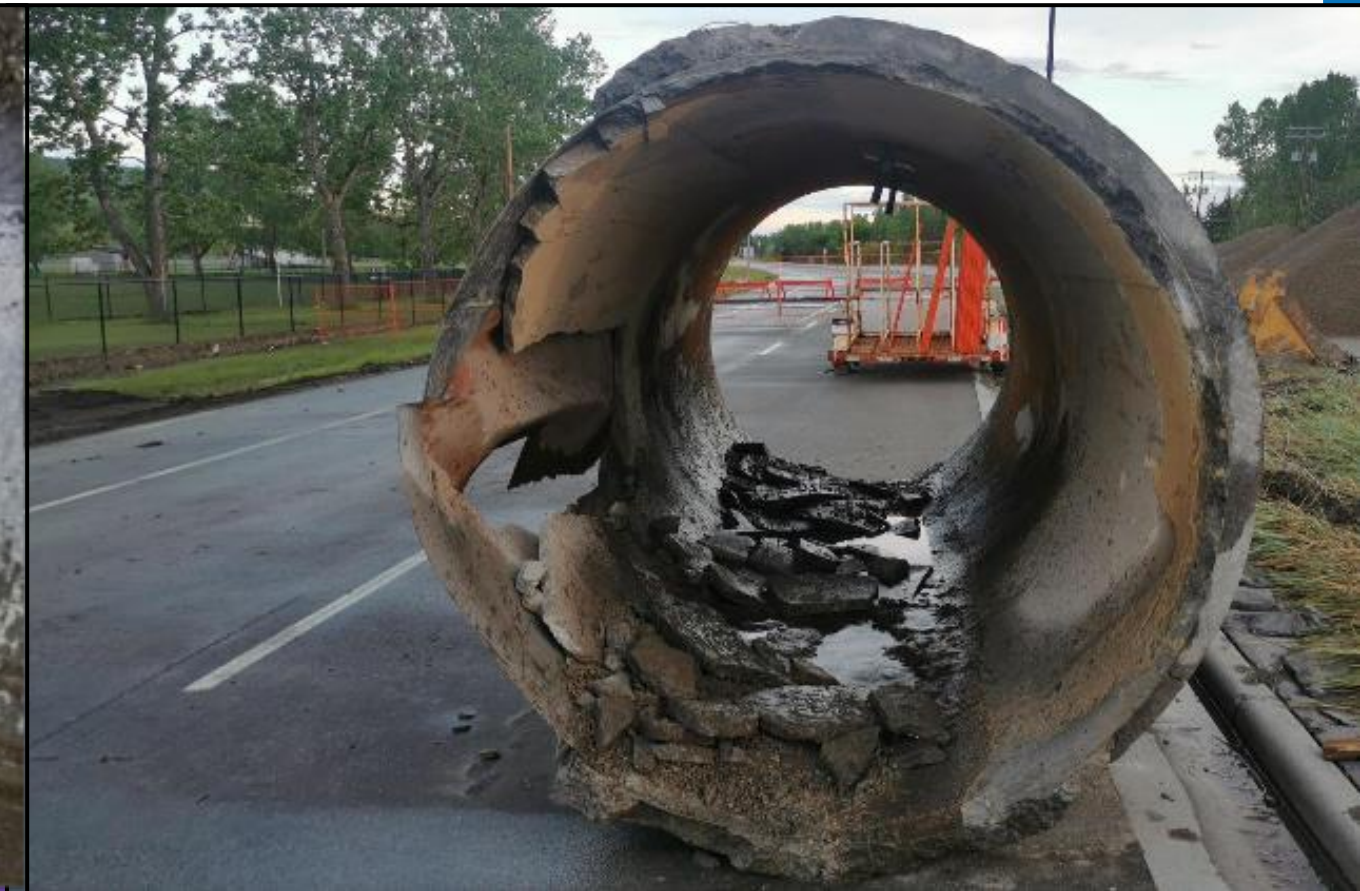
2024 Failure – Bearspaw South Feeder Main

- On June 5, the 1950mm (78”) C301-E PCCP Bearspaw South Feeder Main failed
- Supplies up to 60% of City’s water – prompted Stage 4 Water Restrictions (53 days total)
- Condition assessment was scheduled for Fall 2024

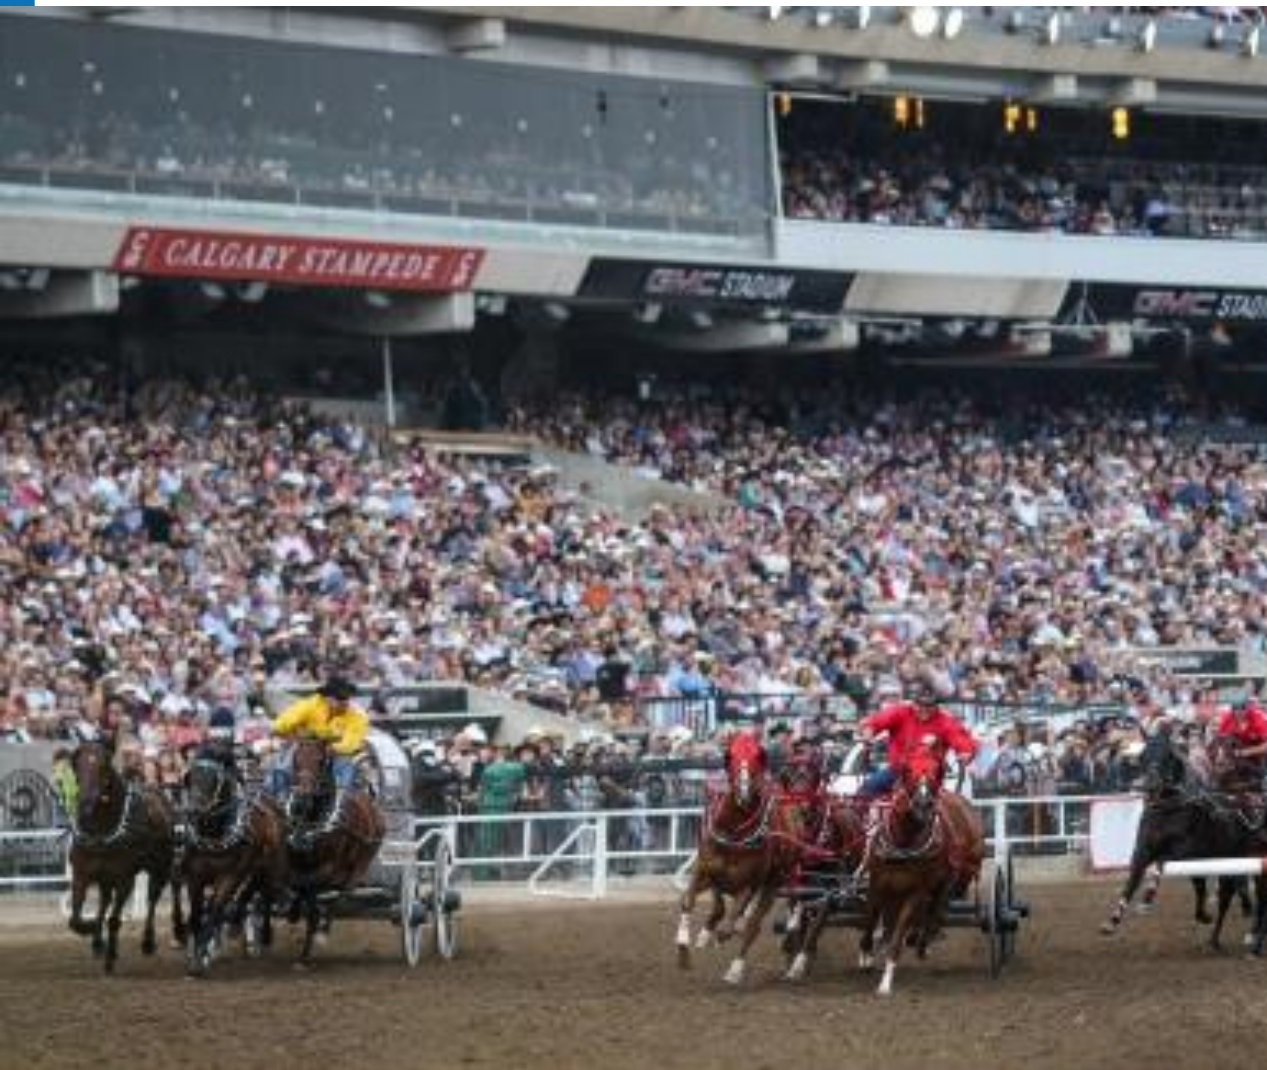
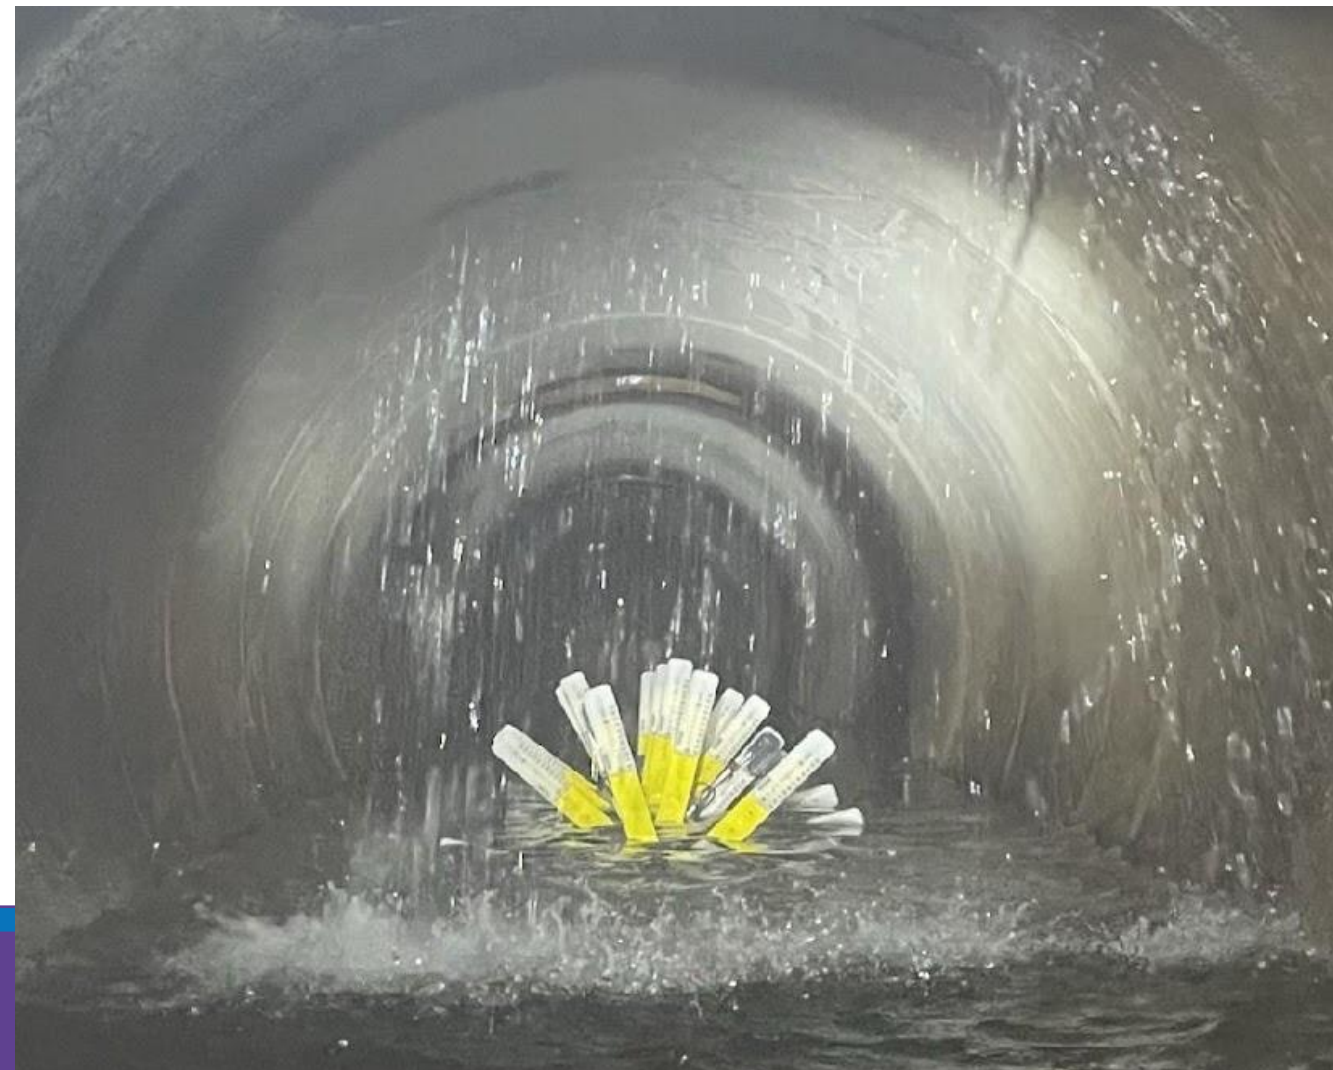
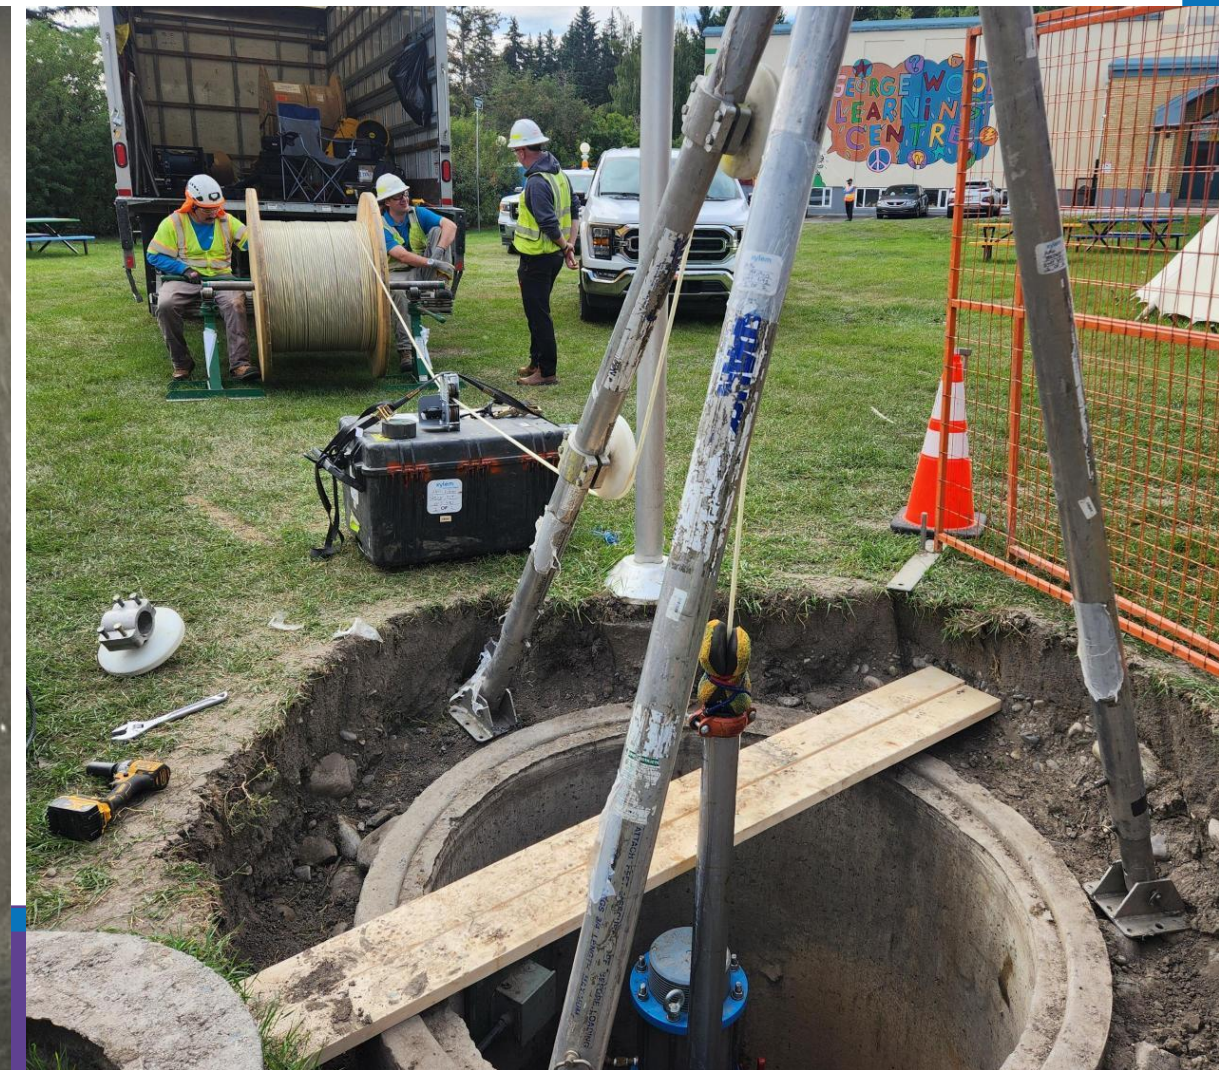
What happened?

- June 5, 2024: BPSFM catastrophic failure.
- Week of June 17: failure repaired; 5 “hot spots” identified/repaired.
- July 5: BPSFM brought back into service; more assessment and monitoring system installed.

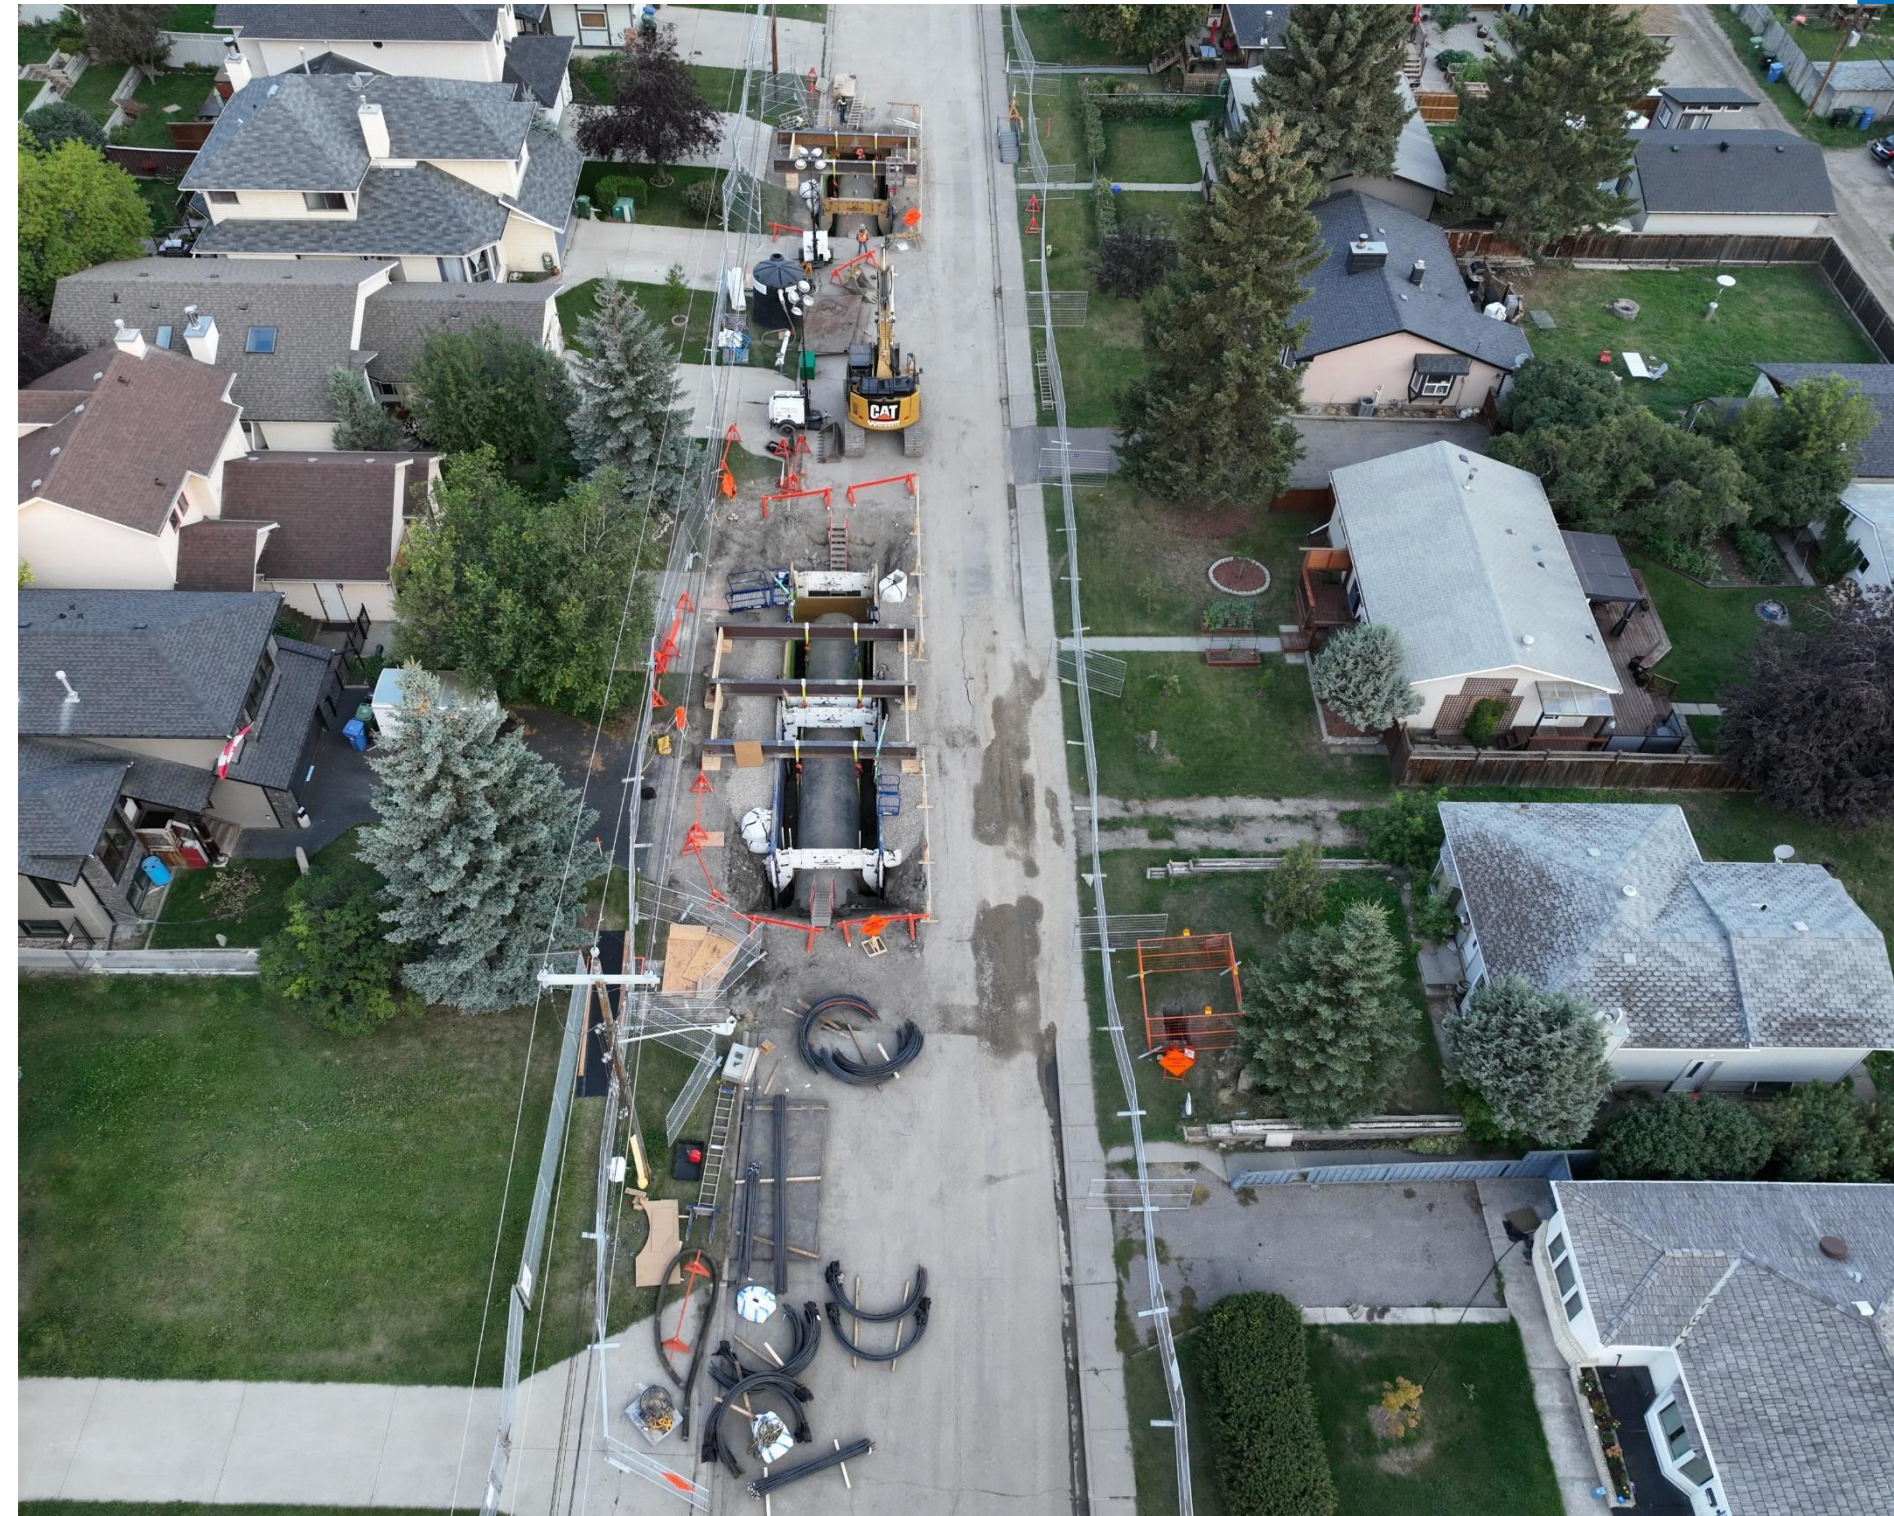
What happened?

- June 5, 2024: BPSFM catastrophic failure.
- Week of June 17: failure repaired; 5 “hot spots” identified/repaired.

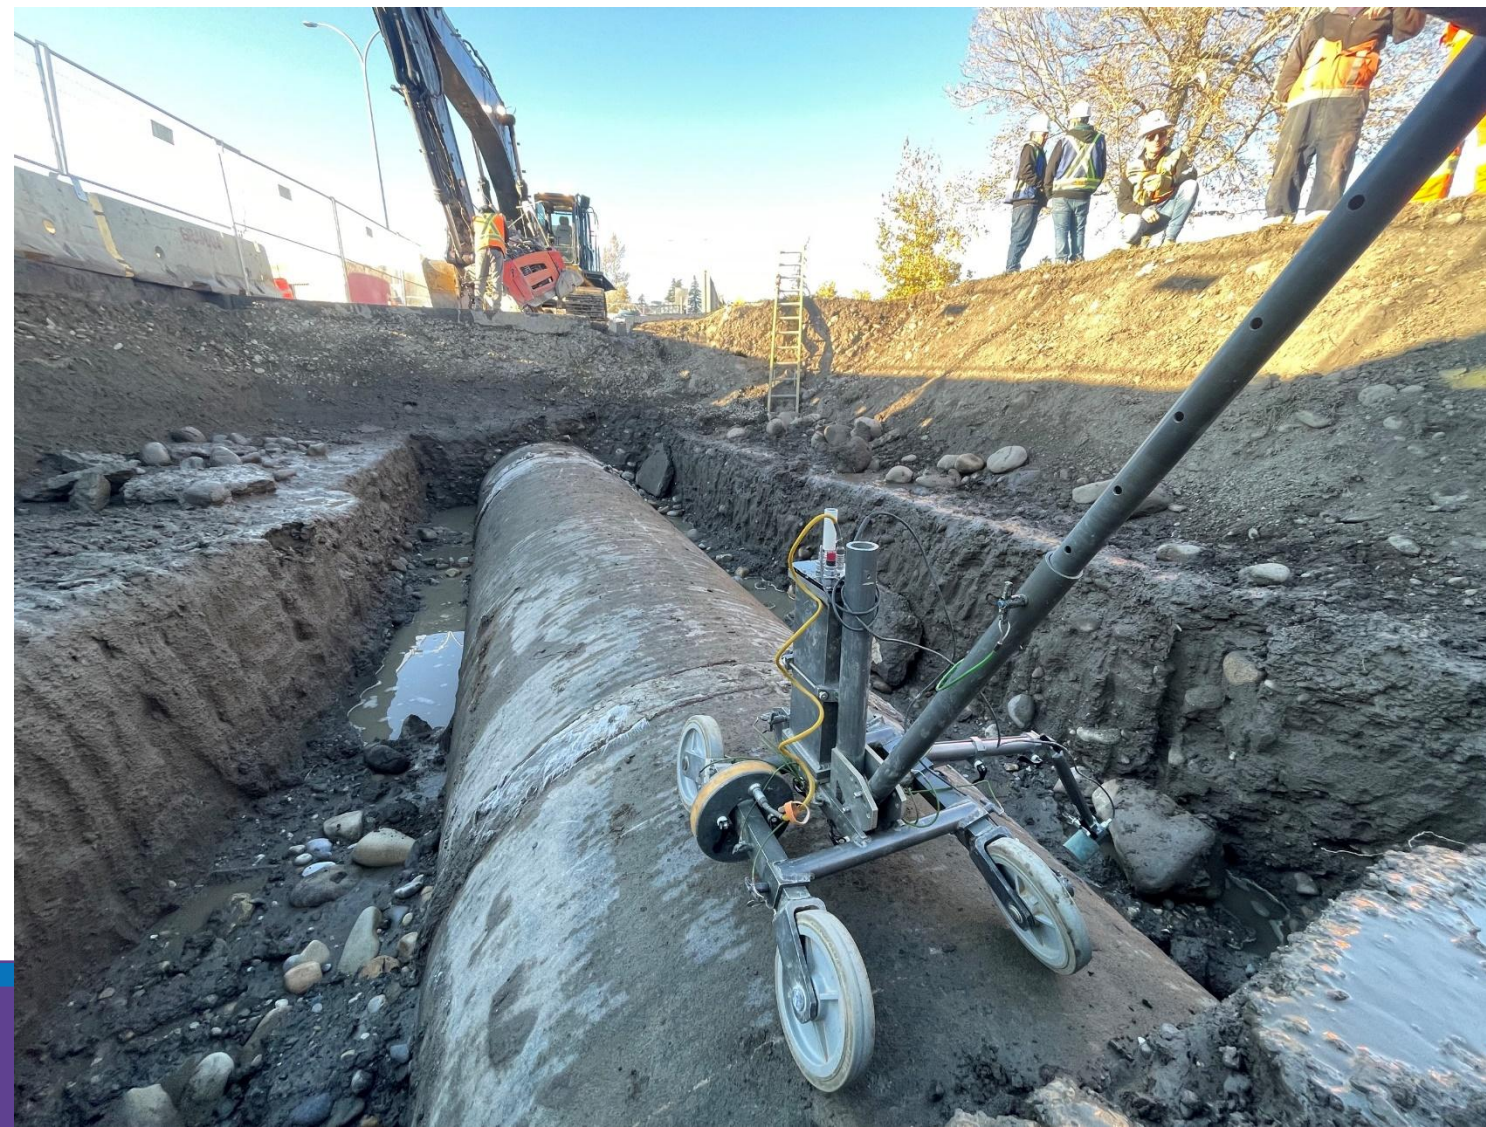
What happened?

- June 5, 2024: BPSFM catastrophic failure.
- Week of June 17: failure repaired; 5 “hot spots” identified/repaired.
- July 5: BPSFM brought back into service; more assessment and monitoring system installed.
- August/September: additional repair work on 21 segments (identified by PipeDiver).
- Mid-October: 2 additional 1500mm segments (identified by PipeDiver) repaired (29 total).
