# From Risk Proactive Assessme Prioritized

Crofton Mill's Critical Water Supply Pipeline

November 03, 2025

# Crofton Mill Water Supply Pipeline

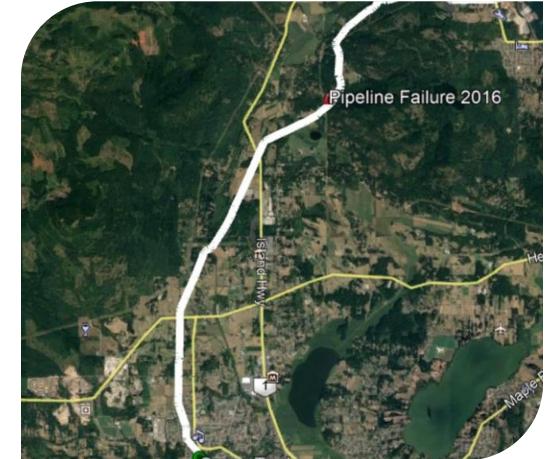
April 2016 Failure

**Location: STA 324 + 64  
(Section 2)**

June 2017 Failure

**Location: STA 17 + 96  
(Section 1)**

February 2020 Failure

**Location: Upstream of  
Somenos Road Crossing**

**2016: Farming area, low  
depth of cover, external  
corrosion**  
**2017: Pipe was identified  
with distress in 2005**  
**2020 : Failed near anomalous  
pipe**
