Opportunistic Watermain Inspection and Sampling Protocol

Robinson
Consultants

Opportunistic Inspection & Sampling - Introduction

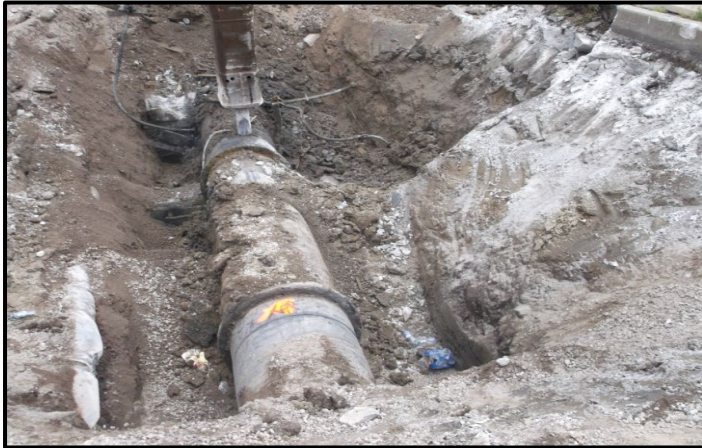
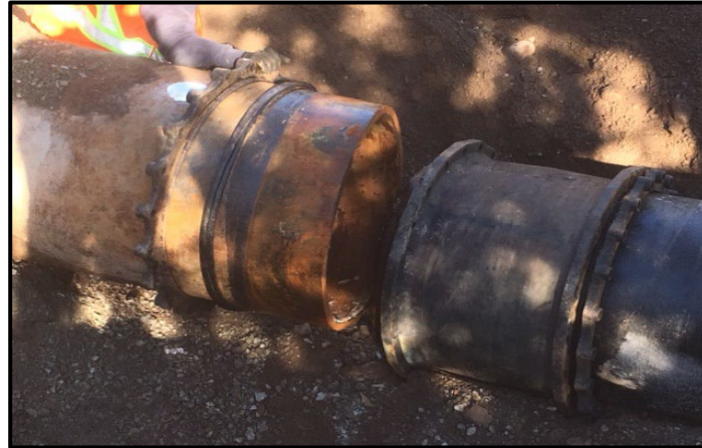
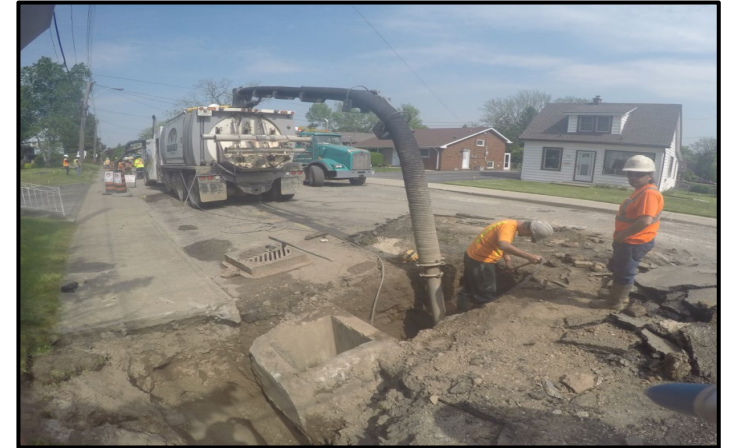
Opportunistic site inspection – scheduled maintenance, emergency repair, live connections, valve replacement etc.

- A visual inspection with accompanying photographs.
- Cleaning of the exterior surface of the pipe
- Photos taken for any surface defects identified
- Scraping of the pipe surface
- Collection of soil bedding and backfill samples.
- If available, collection of pipe sample for material testing.

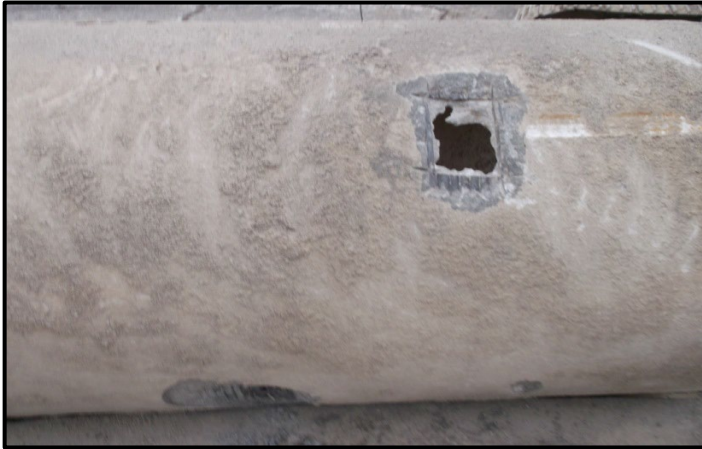
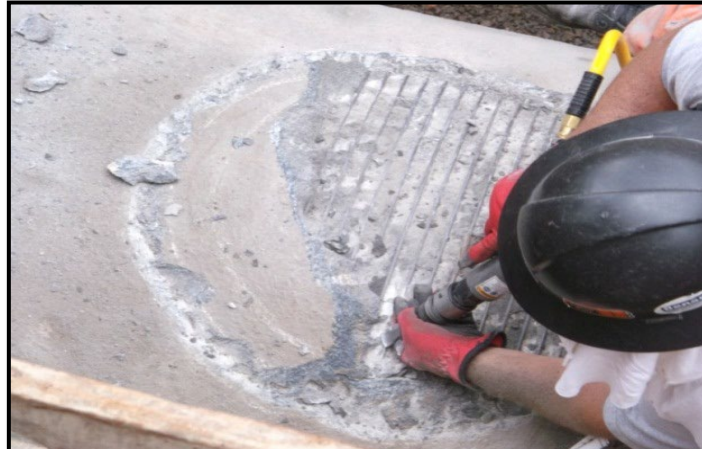
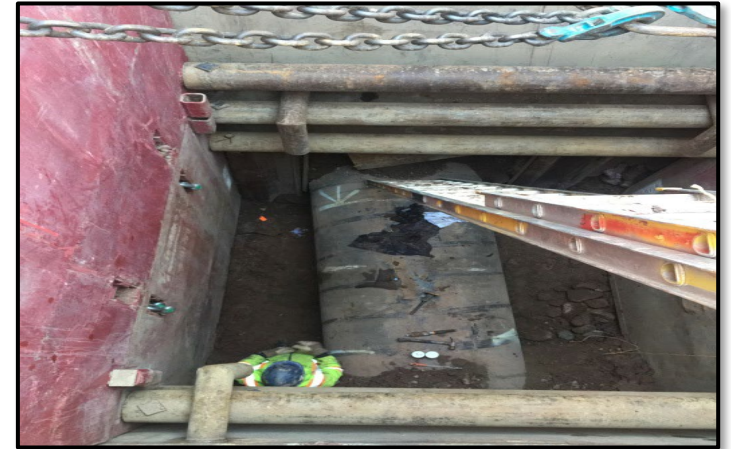
Opportunistic site inspection – scheduled maintenance, emergency repair, live connections, valve replacement etc.

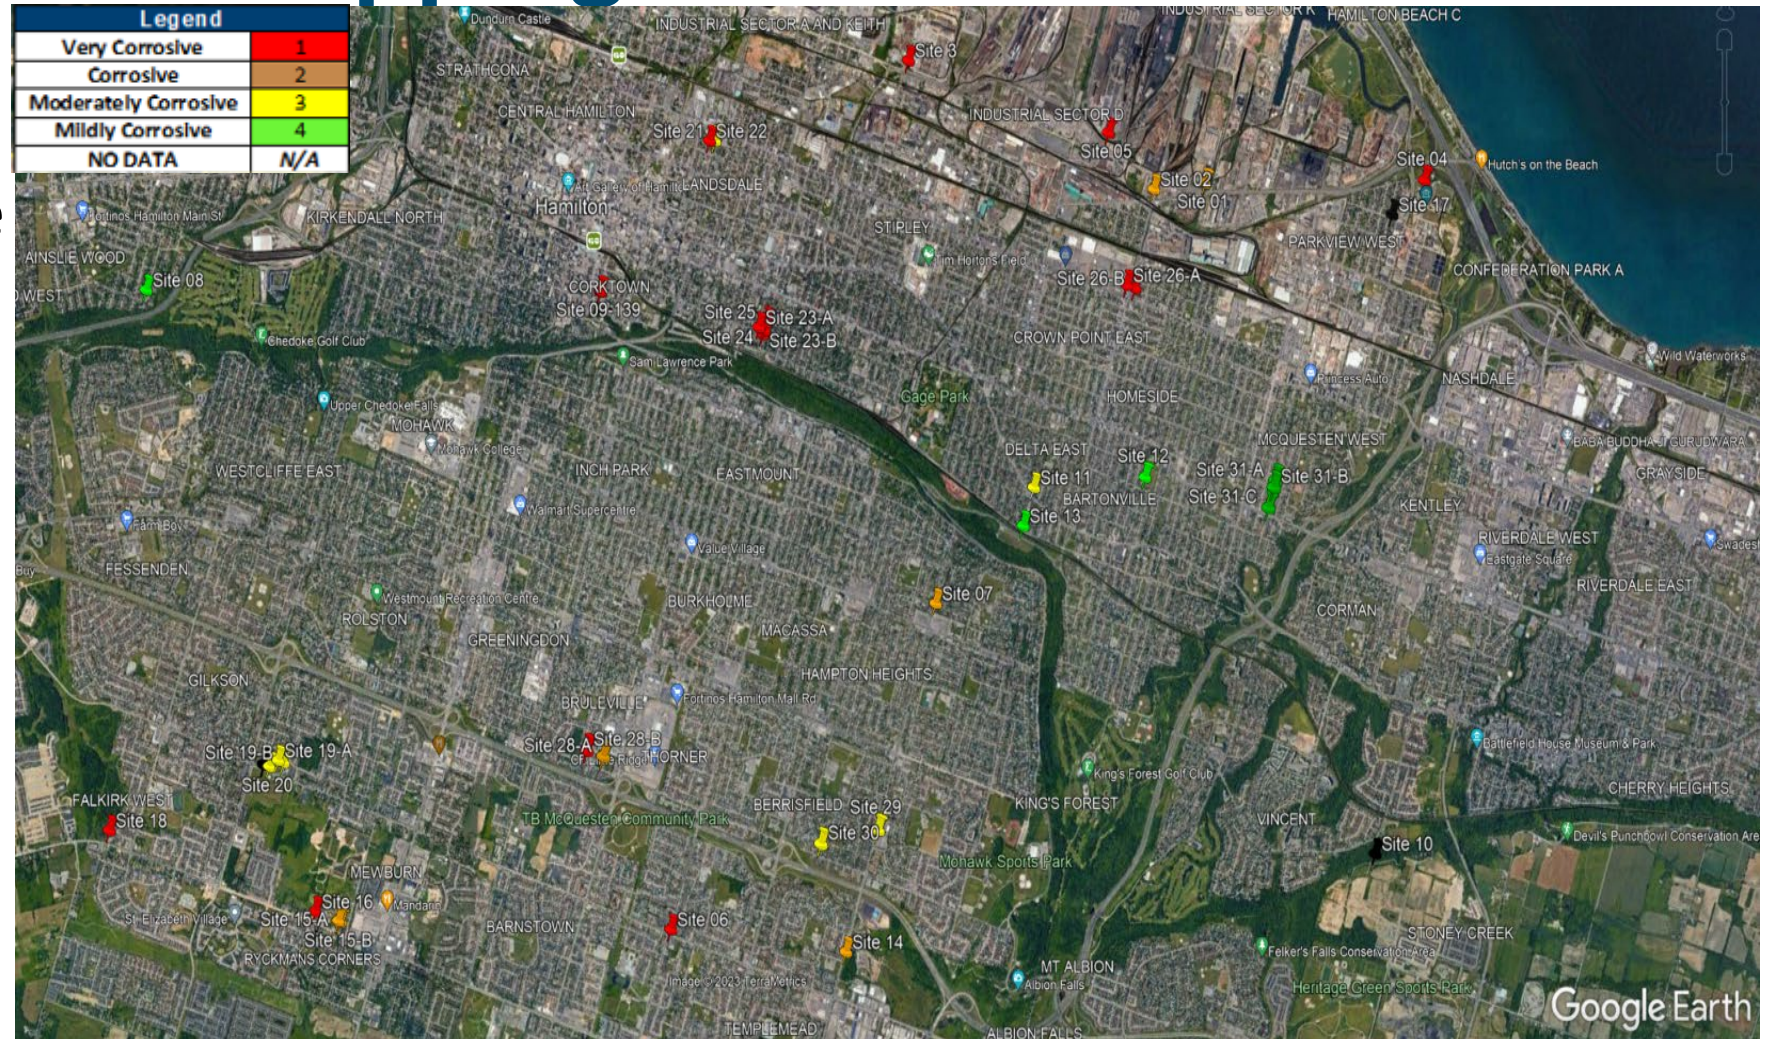
Corrosion risk level map generated based on using site specific risk table.

- The sample with the highest risk level was the governing risk factor for the site.

Corrosion Risk Matrix	
Very Corrosive	1
Corrosive	2
Moderately Corrosive	3
Mildly Corrosive	4
NO DATA	N/A
