**National Water and Wastewater Conference**

# **Extending the Life of Transmission Mains**

**Presented by Stewart Dickson, P. Eng**

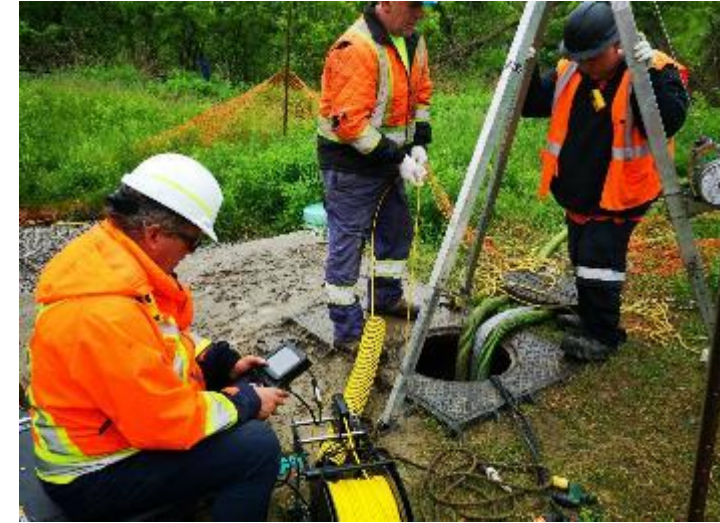
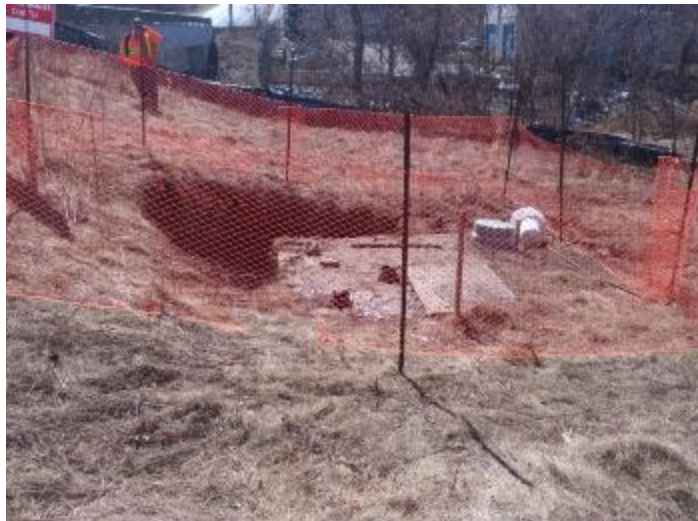
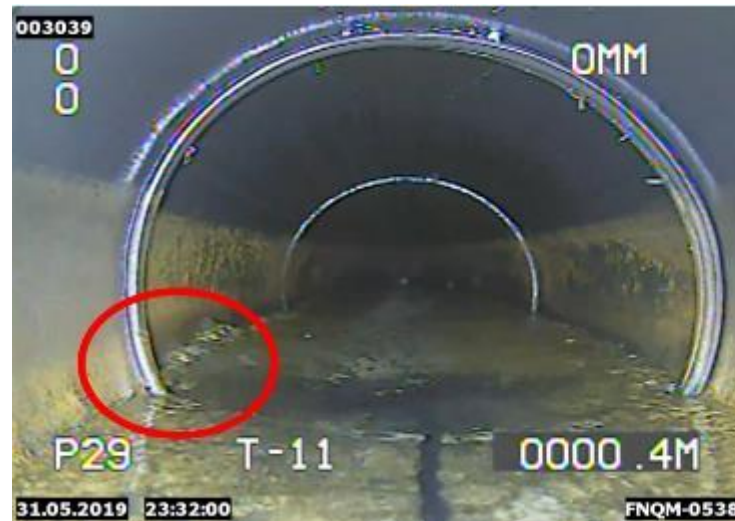
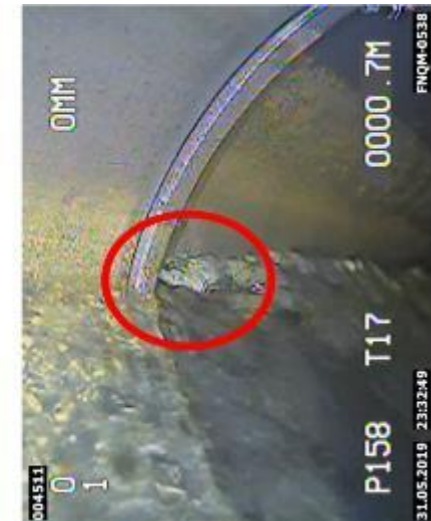
- Existing 400mm diameter (14") HDPE DR 13.5 watermain
- Originally Installed via HDD in 2010
- Sink hole had developed near drain chamber (5 m deep)
- Pipeline deep under the river
- Watermain was drained and inspected
- Found a leaking joint in HDPE pipe (butt fusion welded)

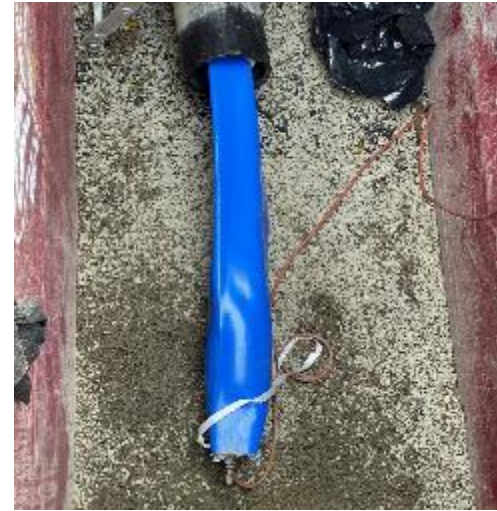
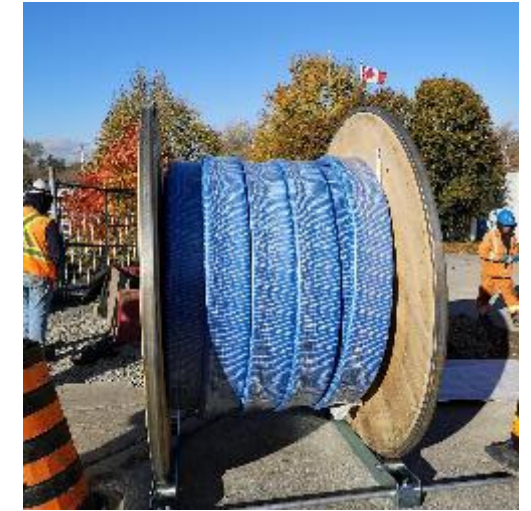
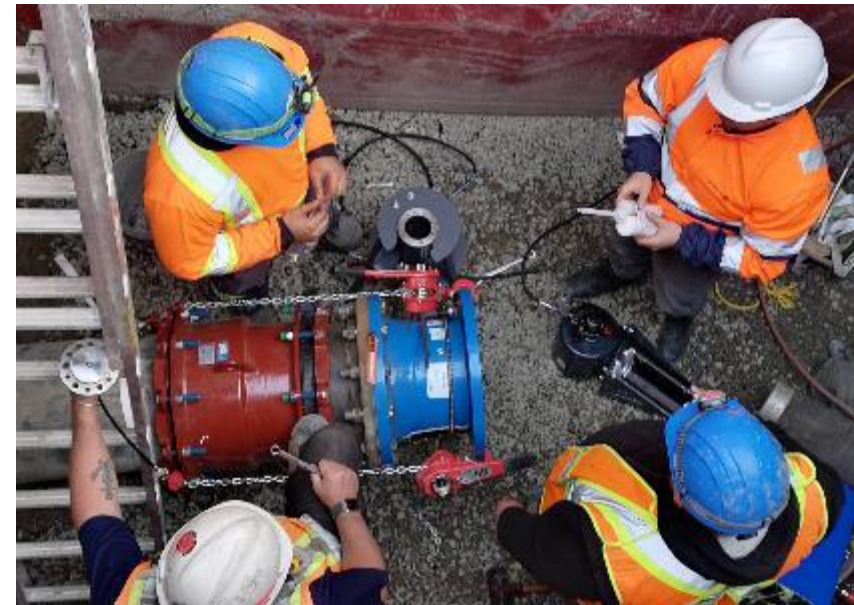
- Condition Assessment Inspection Tools needed to find the leak
- Since leak was not due to pipe failure, full replacement was not required
- Pipe relatively new, therefore structurally still adequate
- PrimusLine provided an economical, non-structural solution
- Installed from drain chamber to access shaft excavated where more accessible
- Leak detected in April 2020 and pipe back together in service in October 2020

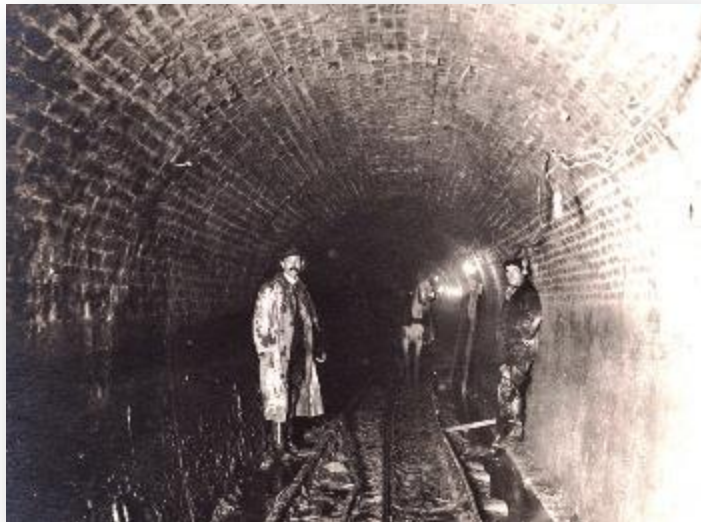
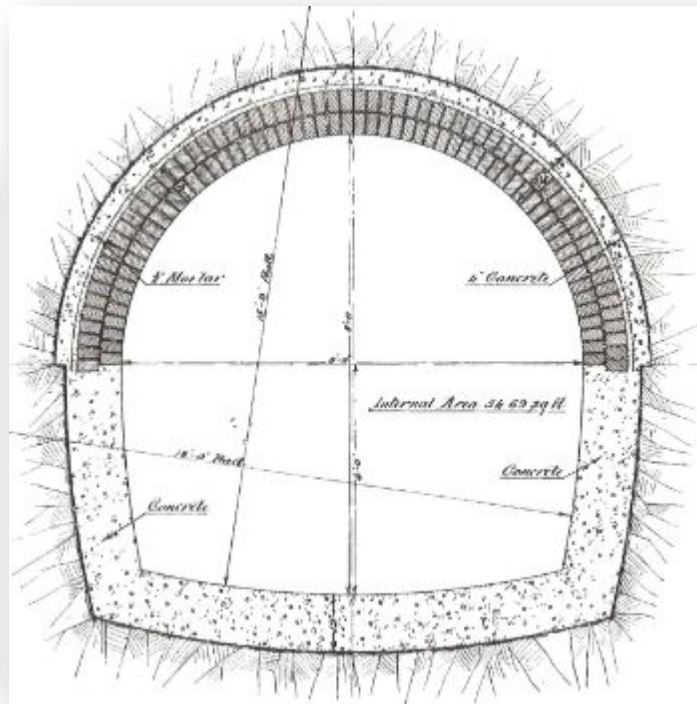
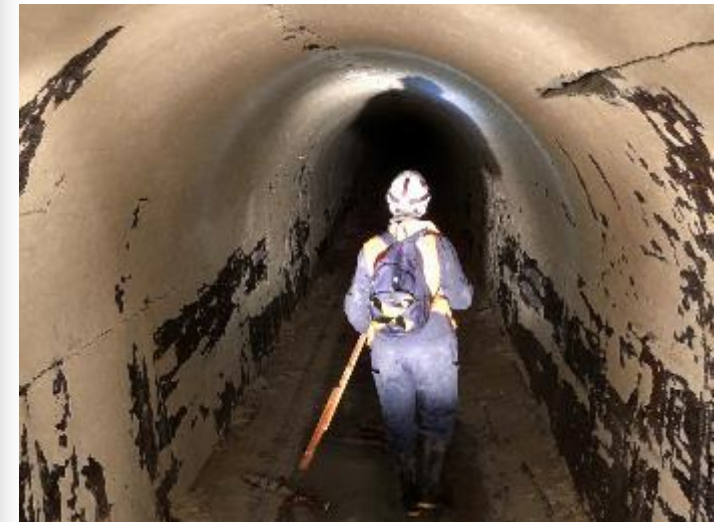
# CASE STUDY – City of Toronto

## Pipeline History

- Construction completed in 1906
- Dewatered and inspected in 1978 – measurements were smaller than on initial drawings
- ROV inspection completed in 2018 – showed sections failing and in immediate need of rehabilitation

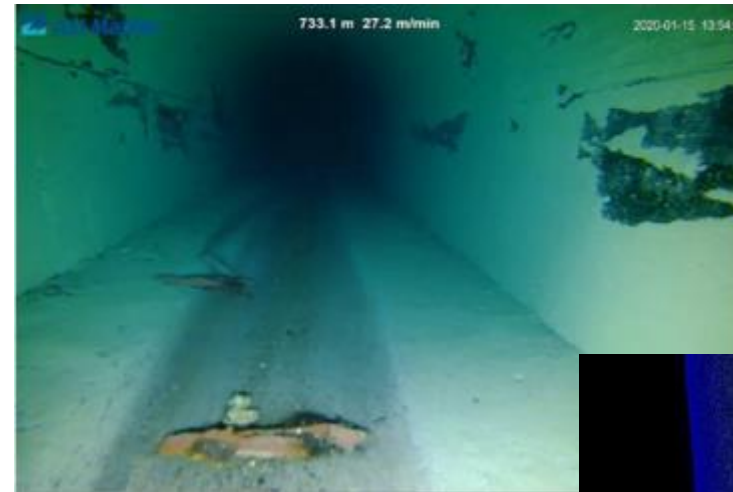
# CASE STUDY – City of Toronto

## Rehabilitation Design

- ROV with 3D sonar survey
  - Established extent of deformation and precise tunnel profile
- Reviewed constructability challenges and options
  - Identified access shaft locations
- Reviewed hydraulics and transients
  - Confirm minimum new inner diameter
- Reviewed several options for new tunnel liner:
  - Hobas/FRP pipe
  - Shotcrete
  - Concrete pressure pipe
  - CIP concrete
  - **Steel pipe with cement mortar lining - Preferred**

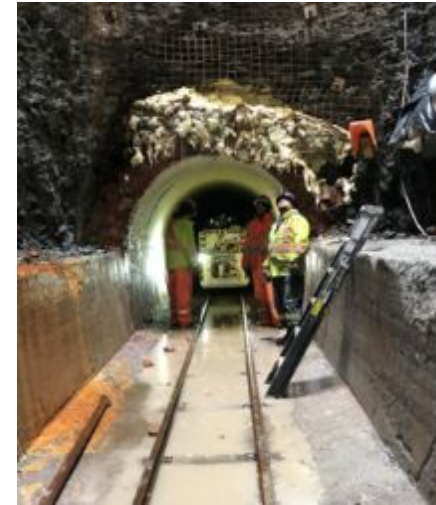
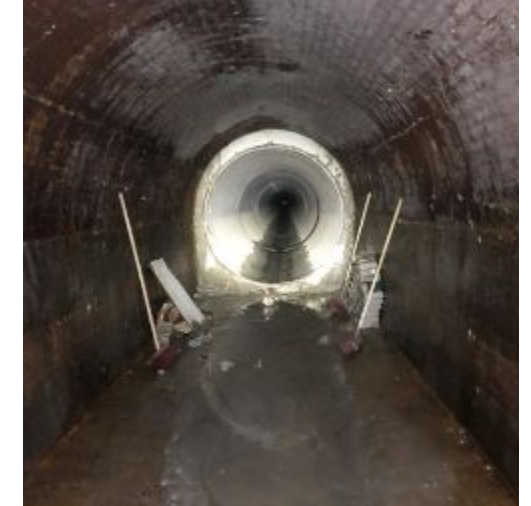
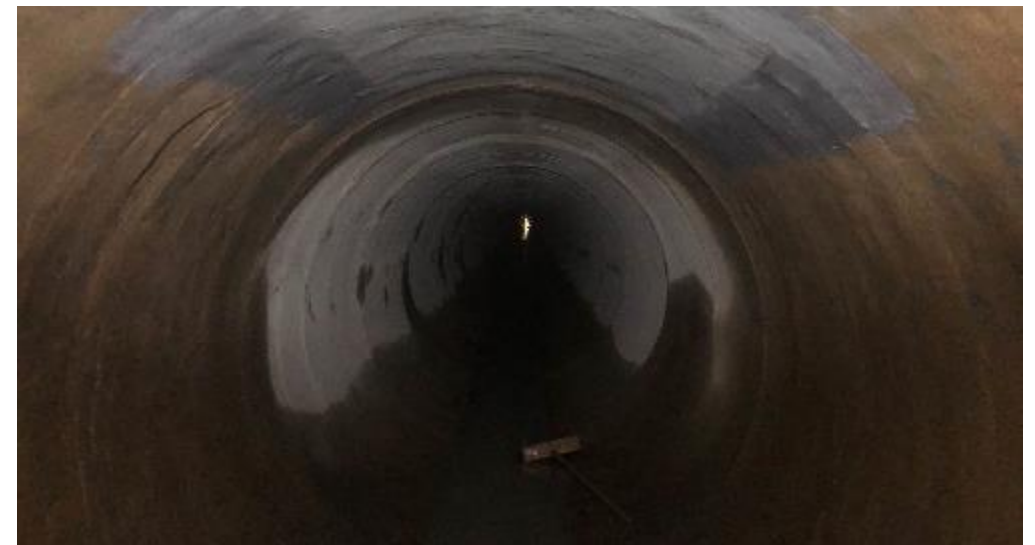
# CASE STUDY – City of Toronto

## Summary

- Limited Condition Assessments completed on this critical main
- 2018 Inspection indicated it was failing badly and needed immediate rehabilitation
- Full Structural solution was required due to condition of tunnel
- Due to gravity nature of the pipe, hydraulics was very important
- Cement lined pipe sliplined into the horeshoe shaped watermain provided fastest, most economical solution
- Entirely completed during winter/low demand timeline
